County of Fresno

Main Annex Jail
ADA Transition Plan

LARS ANDERSEN & ASSOCIATES, INC.

JUNE 30, 2014

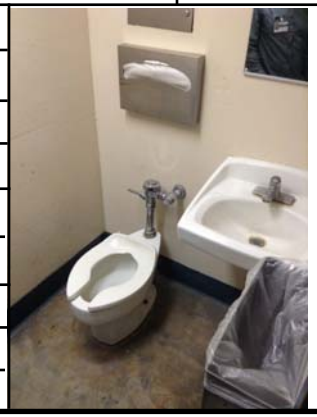
Issue	**Recommendation**
Required 60" diameter circle or 'T'-shaped clear floor space not provided within room	Provide required clearance

ADA Reference:	
304.3	
CBC Reference:	
11B-304.3	
Floor:	Basement
Room:	Staff Restroom
Location:	
Cost:	10000
Duration:	50 hrs

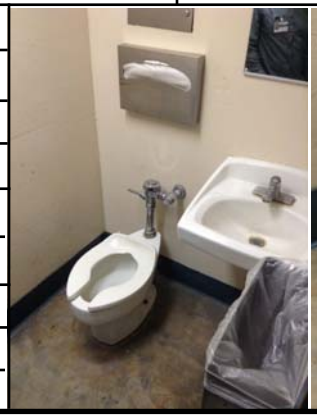
Issue	**Recommendation**
Seat height measured less than 17" AFF	Provide water closet per current standards

ADA Reference:
604.4
CBC Reference:
11B-604.4

Floor:	Basement
Room:	Staff Restroom
Location:	
Cost:	2000
Duration:	16 hrs

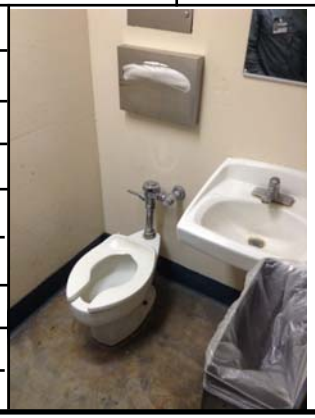
11	Main Annex Jail	**Priority:**	3

Category	Water Closets (GENERAL)

Issue	**Recommendation**
Flush controls not on open side of fixture (non-ambulatory accessible compartments)	Remove and replace water closet per current standards

ADA Reference:
604.6
CBC Reference:
11B-604.6

Floor:	Basement
Room:	Staff Restroom
Location:	
Cost:	2000
Duration:	16 hrs

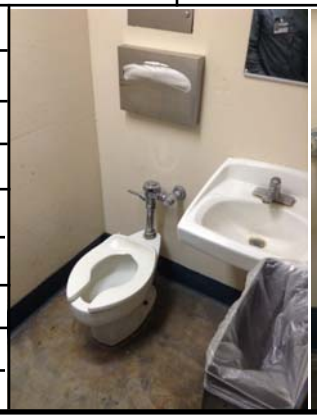
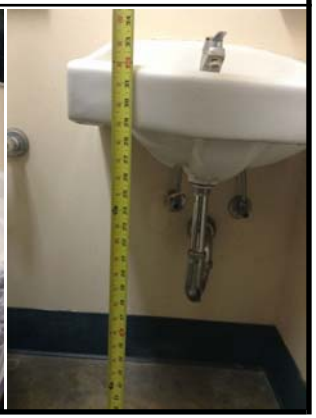
12	Main Annex Jail	**Priority:**	3

Category	Lavatories (ADULT)

Issue	**Recommendation**
Minimum 29" clearance under lavatory apron not provided (measured at front edge)	Reset lavatory as required

ADA Reference:
N/A
CBC Reference:
11B-606.2

Floor:	Basement
Room:	Staff Restroom
Location:	
Cost:	3000
Duration:	16 hrs

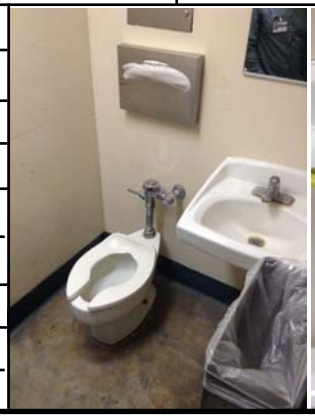
13	Main Annex Jail	**Priority:**	3
Category	Lavatories (GENERAL)

Issue	**Recommendation**
Lavatory not 18" minimum to centerline from side wall or partition	Relocate Lavatory as required; modification maybe required

ADA Reference:	
N/A	
CBC Reference:	
11B-606.6	
Floor:	Basement
Room:	Staff Restroom
Location:	
Cost:	1000
Duration:	8 hrs

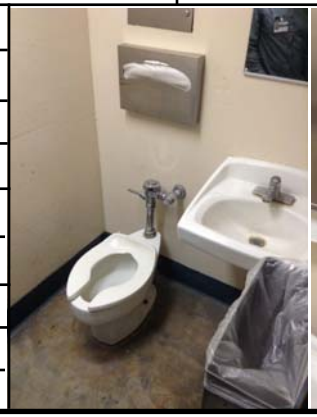
14	Main Annex Jail	**Priority:**	3
Category	Accessories

Issue	**Recommendation**
Soap dispenser measured over 40" AFF to operable part	Reset accessories to maximum 40" AFF to operating controls

ADA Reference:	
N/A	
CBC Reference:	
11B-603.5	
Floor:	Basement
Room:	Staff Restroom
Location:	
Cost:	50
Duration:	.5 hrs

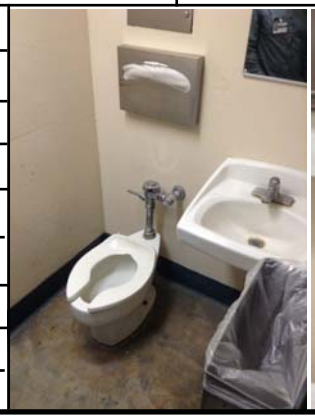
15	Main Annex Jail	**Priority:**	3
Category	Accessories

Issue	**Recommendation**
Towel dispenser measured over 40" AFF to operable part	Reset accessories to maximum 40" AFF to operating controls

ADA Reference:	
N/A	
CBC Reference:	
11B-603.5	
Floor:	Basement
Room:	Staff Restroom
Location:	
Cost:	50
Duration:	.5 hrs

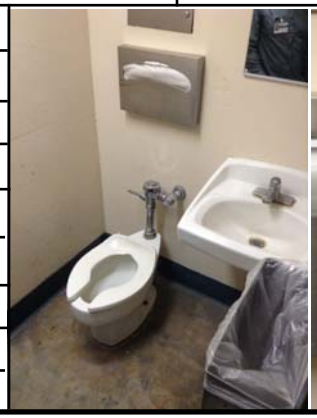
16	Main Annex Jail	**Priority:**	3
Category	Accessories

Issue	**Recommendation**
Toilet seat dispenser measured over 40" AFF to operable part	Reset accessories to maximum 40" AFF to operating controls

ADA Reference:	
N/A	
CBC Reference:	
11B-603.5	
Floor:	Basement
Room:	Staff Restroom
Location:	
Cost:	50
Duration:	.5 hrs

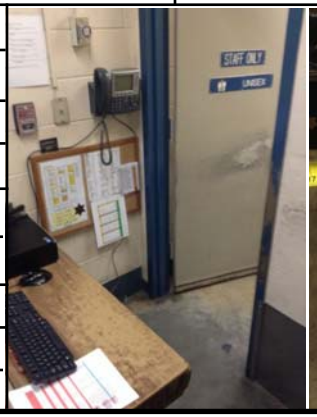
Issue	**Recommendation**
Accessible path of travel not provided	Provide accessible path of travel

ADA Reference:	
206.2.2	
CBC Reference:	
11B-206.2.2	
Floor:	Basement
Room:	Guard Station
Location:	
Cost:	4000
Duration:	20 hrs

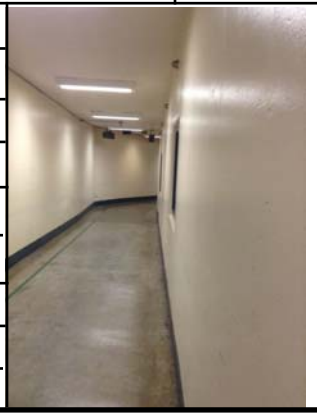
Issue	**Recommendation**
Audible Fire Alarm not provided in public or common use areas	Provide audible and visual fire alarm per current standards

ADA Reference:	
215.2	
CBC Reference:	
11B-215.2	
Floor:	Basement
Room:	Tunnel
Location:	To South
Cost:	See *4
Duration:	See *4

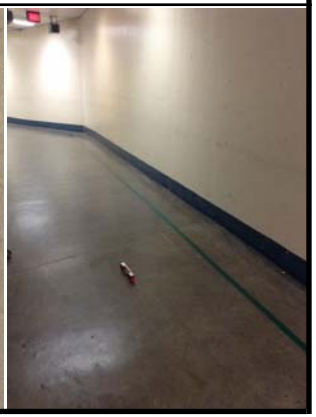
Issue	**Recommendation**
Directional slope of walk over 5.0%	Provide concrete walk with maximum 5.0% slope or provide pedestrian ramp with handrails

ADA Reference:	
403.3	
CBC Reference:	
11B-403.3	
Floor:	Basement
Room:	Tunnel
Location:	To South
Cost:	10000
Duration:	50 hrs

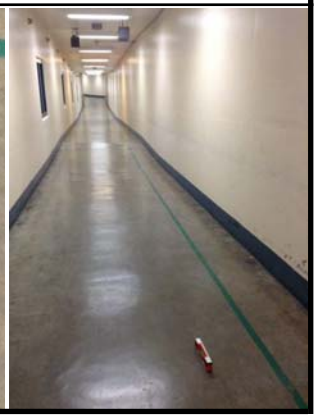
ADA Reference:	
403.3	
CBC Reference:	
11B-403.3	
Floor:	Basement
Room:	Tunnel
Location:	To South
Cost:	10000
Duration:	50 hrs

26	Main Annex Jail	**Priority:**	1
Category	Walks

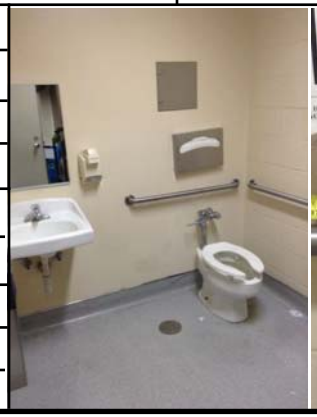
Issue	**Recommendation**
Sidewall grab bar minimum extension 54" from rear wall	Adjust as required and/or provide new bar per current standards

ADA Reference:
604.5.1
CBC Reference:
11B-604.5.1

Floor:	1st
Room:	Exam room
Location:	Restroom
Cost:	300
Duration:	1.5

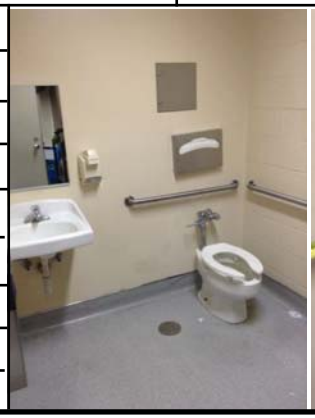
47	Main Annex Jail	**Priority:**	3

Category	Water Closets (GENERAL)

Issue	**Recommendation**
Rear wall grab bar not 24" minimum length from C/L of toilet towards open side	Adjust as required and/or provide new bar per current standards

ADA Reference:
604.5.2
CBC Reference:
11B-604.5.2

Floor:	1st
Room:	Exam room
Location:	Restroom
Cost:	300
Duration:	1.5

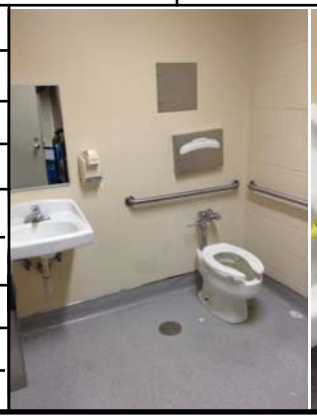
48	Main Annex Jail	**Priority:**	3

Category	Water Closets (GENERAL)

Issue	**Recommendation**
Water closet clearance not 60" wide measured perpendicular from the side wall	Provide required clearance or provide alternative accessible water closet

ADA Reference:
604.3.1
CBC Reference:
11B-604.3.1

Floor:	1st
Room:	Exam room
Location:	Restroom
Cost:	2000
Duration:	10 hrs

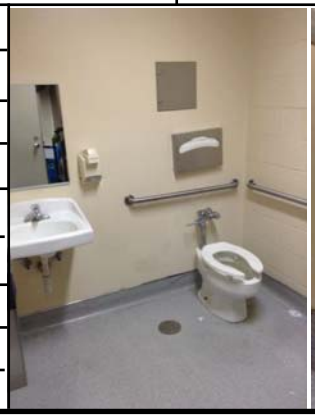
49	Main Annex Jail	**Priority:**	3
Category	Lavatories (GENERAL)

Issue	**Recommendation**
Drain and/or hot water piping not insulated (wrapped)	Insulate as required to protect against contact

ADA Reference:	
606.5	
CBC Reference:	
11B-606.5	
Floor:	1st
Room:	Exam room
Location:	Restroom
Cost:	50
Duration:	.25 hrs

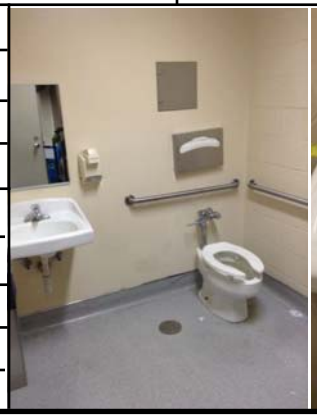
50	Main Annex Jail	**Priority:**	3
Category	Lavatories (GENERAL)

Issue	**Recommendation**
Lavatory not 18" minimum to centerline from side wall or partition	Relocate Lavatory as required; modification maybe required

ADA Reference:	
N/A	
CBC Reference:	
11B-606.6	
Floor:	1st
Room:	Exam room
Location:	Restroom
Cost:	1000
Duration:	8 hrs

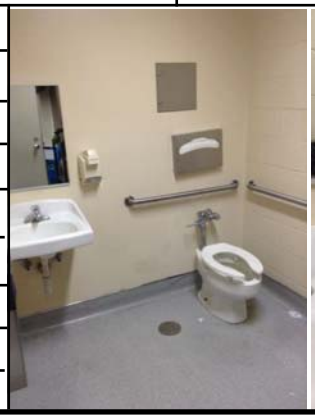
51	Main Annex Jail	**Priority:**	3
Category	Accessories

Issue	**Recommendation**
Mirror over lavatory or countertop measured over 40" AFF to the bottom edge of the reflecting surface	Reset mirror to maximum 40" AFF to reflecting surface

ADA Reference:	
603.3	
CBC Reference:	
11B-603.3	
Floor:	1st
Room:	Exam room
Location:	Restroom
Cost:	100
Duration:	1 hr

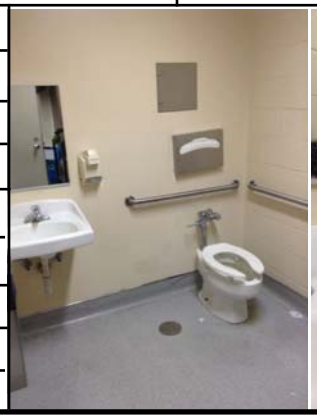
52	Main Annex Jail	**Priority:**	3
Category	Accessories

Issue	**Recommendation**
Soap dispenser measured over 40" AFF to operable part	Reset accessories to maximum 40" AFF to operating controls

ADA Reference:	
N/A	
CBC Reference:	
11B-603.5	
Floor:	1st
Room:	Exam room
Location:	Restroom
Cost:	50
Duration:	.5 hrs

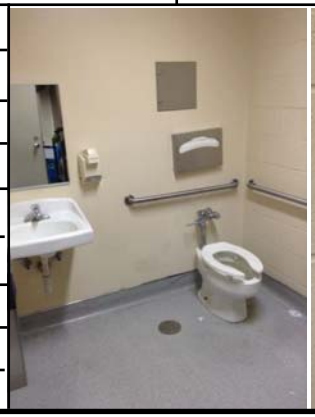
53	Main Annex Jail	**Priority:**	3

Category	Accessories

Issue	**Recommendation**
Towel dispenser measured over 40" AFF to operable part	Reset accessories to maximum 40" AFF to operating controls

ADA Reference:	
N/A	
CBC Reference:	
11B-603.5	
Floor:	1st
Room:	Exam room
Location:	Restroom
Cost:	50
Duration:	.5 hrs

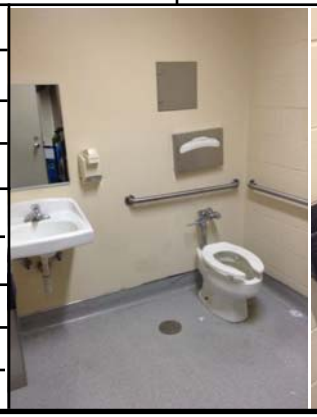
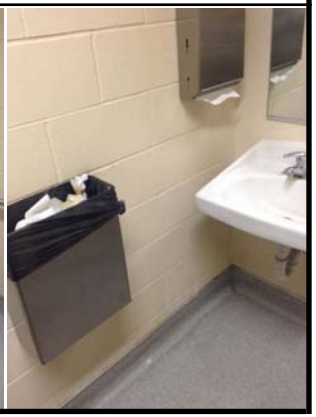
54	Main Annex Jail	**Priority:**	3

Category	Lavatories (GENERAL)

Issue	**Recommendation**
Minimum 30" x 48" clear floor space not provided	Provide 30" X 48" clearance

ADA Reference:	
606.2	
CBC Reference:	
11B-606.2	
Floor:	1st
Room:	Exam room
Location:	Restroom
Cost:	500
Duration:	2 hrs

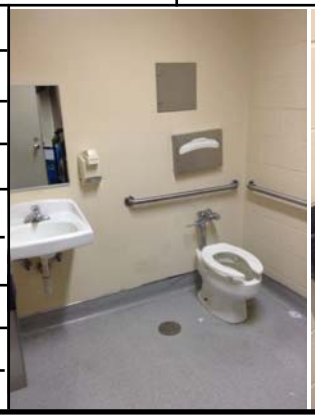
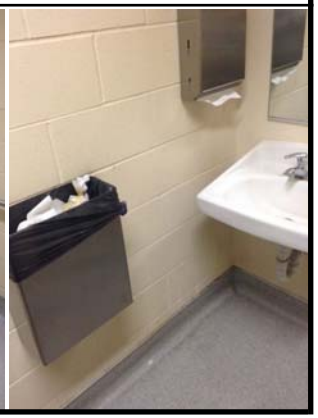
55	Main Annex Jail	**Priority:**	1

Category	Protruding Objects

Issue	**Recommendation**
Objects with leading edges more than 27" and no more than 80" AFF shall protrude 4" maximum horizontally into the circulation path	Provide required clearance/adjust as required

ADA Reference:	
307.2	
CBC Reference:	
11B-307.2	
Floor:	1st
Room:	Exam room
Location:	Restroom
Cost:	1000
Duration:	4 hrs

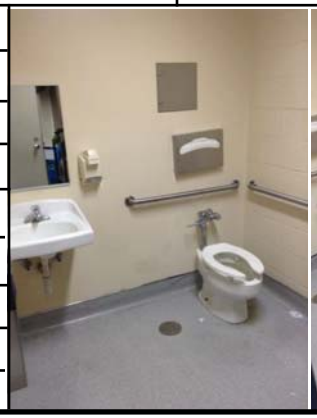
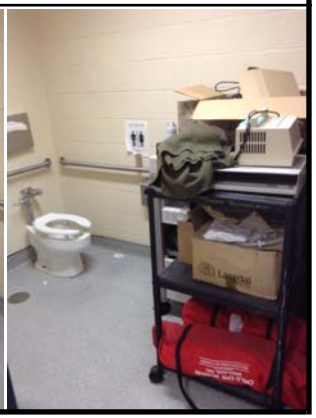
56	Main Annex Jail	**Priority:**	4

Category	Accessible Clearance

Issue	**Recommendation**
Required 60" diameter circle or 'T'-shaped clear floor space not provided within room	Provide required clearance

ADA Reference:	
304.3	
CBC Reference:	
11B-304.3	
Floor:	1st
Room:	Exam room
Location:	Restroom
Cost:	10000
Duration:	50 hrs

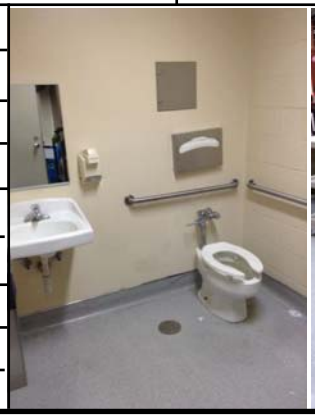
57	Main Annex Jail	**Priority:**	2

Category	Reach Range

Issue	**Recommendation**
Switch measured over 48" AFF / measure to top of switch box	Provide occupancy room sensor or lower switch

ADA Reference:	
308.2.1	
CBC Reference:	
11B-308.2.1	
Floor:	1st
Room:	Exam room
Location:	Restroom
Cost:	See *6
Duration:	See *6

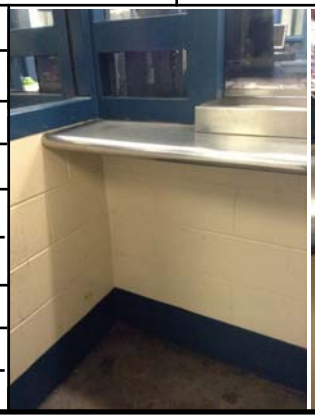
Issue	**Recommendation**
Counter height measured over 34" AFF (parallel approach)	Recess a portion of the counter to be 34" maximum AFF

ADA Reference:	
N/A	
CBC Reference:	
11B-904.4.1	
Floor:	1st
Room:	Booking
Location:	
Cost:	4000
Duration:	20 hrs

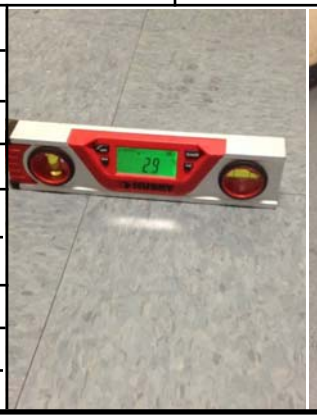
Issue	**Recommendation**
Cross slope of walk over 2.083% (1:48)	Provide concrete walk with maximum 2.0% slope cross slope where cross slope exceeds 2.0%

ADA Reference:	
403.3	
CBC Reference:	
11B-403.3	
Floor:	1st
Room:	Intoxilizer
Location:	
Cost:	5000
Duration:	40 hrs

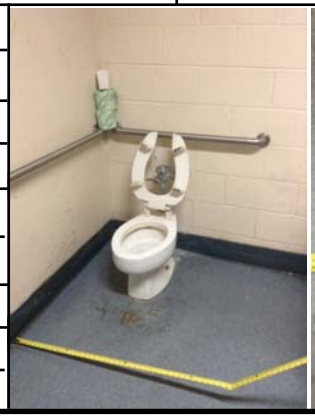
Issue	**Recommendation**
Water closet clearance not 60" wide measured perpendicular from the side wall	Provide required clearance or provide alternative accessible water closet

ADA Reference:	
604.3.1	
CBC Reference:	
11B-604.3.1	
Floor:	1st
Room:	Intoxilizer
Location:	
Cost:	8000
Duration:	40 hrs

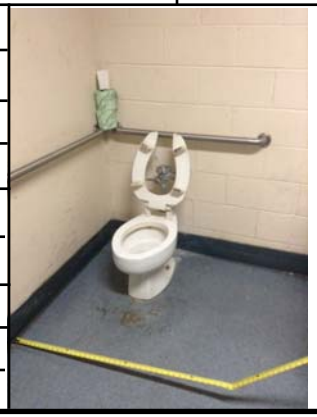
Issue	**Recommendation**
Flush controls not on open side of fixture (non-ambulatory accessible compartments)	Remove and replace water closet per current standards

ADA Reference:	
604.6	
CBC Reference:	
11B-604.6	
Floor:	1st
Room:	Intoxilizer
Location:	
Cost:	2000
Duration:	16 hrs

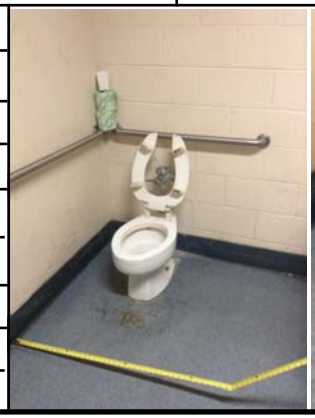
Issue	**Recommendation**
Seat height measured less than 17" AFF	Provide water closet per current standards

ADA Reference:	
604.4	
CBC Reference:	
11B-604.4	
Floor:	1st
Room:	Intoxilizer
Location:	
Cost:	2000
Duration:	16 hrs

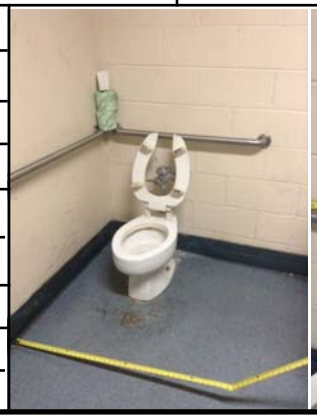
Issue	**Recommendation**
Rear wall grab bar not 24" minimum length from C/L of toilet towards open side	Adjust as required and/or provide new bar per current standards

ADA Reference:	
604.5.2	
CBC Reference:	
11B-604.5.2	
Floor:	1st
Room:	Intoxilizer
Location:	
Cost:	300
Duration:	1.5

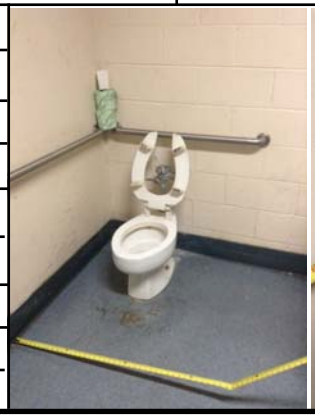
Issue	**Recommendation**
Sidewall grab bar minimum extension 54" from rear wall	Adjust as required and/or provide new bar per current standards

ADA Reference:	
604.5.1	
CBC Reference:	
11B-604.5.1	
Floor:	1st
Room:	Intoxilizer
Location:	
Cost:	300
Duration:	1.5

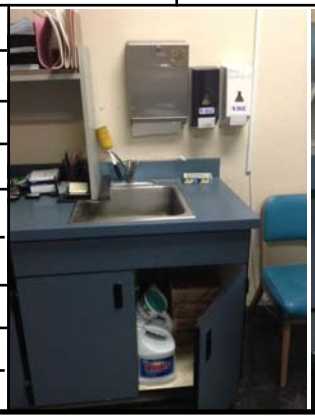
Issue	**Recommendation**
Height of rim or counter measured over 34" AFF	Reset sink/or provide maximum 34" AFF counter

ADA Reference:	
606.3	
CBC Reference:	
11B-606.3	
Floor:	1st
Room:	Finger Prints /
Location:	
Cost:	1000
Duration:	8 hrs

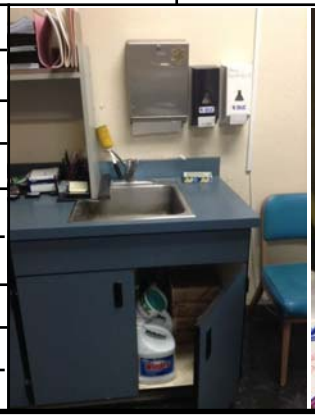
Issue	**Recommendation**
Drain and/or hot water piping not insulated (wrapped)	Insulate piping as required to protect against contact

ADA Reference:	
606.5	
CBC Reference:	
11B-606.5	
Floor:	1st
Room:	Finger Prints /
Location:	
Cost:	50
Duration:	.25 hrs

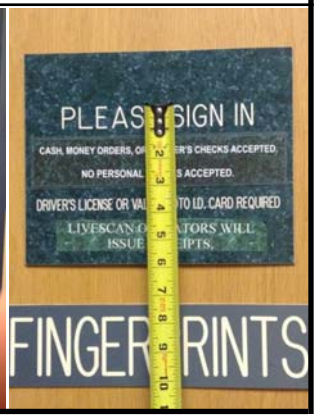
ADA Reference:	
703.5.5	
CBC Reference:	
11B-703.5.5	
Floor:	1st
Room:	Finger Prints /
Location:	
Cost:	See *1
Duration:	See *1

111	Main Annex Jail	**Priority:**	1
Category	Interior Signage

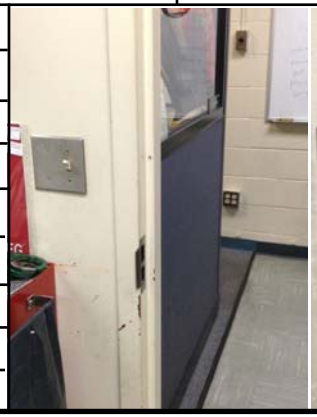
Issue	**Recommendation**
Switch measured over 48" AFF / measure to top of switch box	Provide occupancy room sensor or lower switch

ADA Reference:	
308.2.1	
CBC Reference:	
11B-308.2.1	
Floor:	1st
Room:	Services Unit
Location:	Sargent
Cost:	See *6
Duration:	See *6

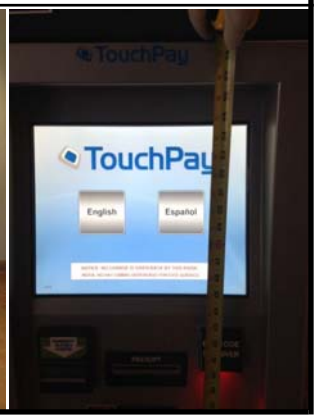
ADA Reference:	
308.2.1	
CBC Reference:	
11B-308.2.1	
Floor:	1st
Room:	Lobby
Location:	
Cost:	See *12
Duration:	See *12

157	Main Annex Jail	**Priority:**	2
Category	Counters

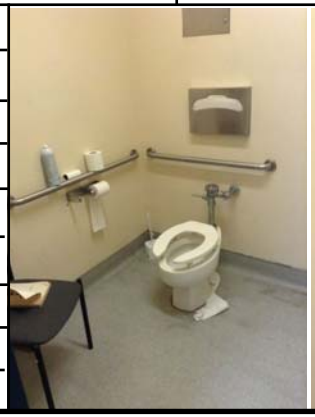
Issue	**Recommendation**
Operable part requires tight grasping, pinching or twisting of the wrist	Remove and replace operable part

ADA Reference:	
309.4	
CBC Reference:	
11B-309.4	
Floor:	1st
Room:	Line-Up
Location:	Restroom
Cost:	500
Duration:	1 hr

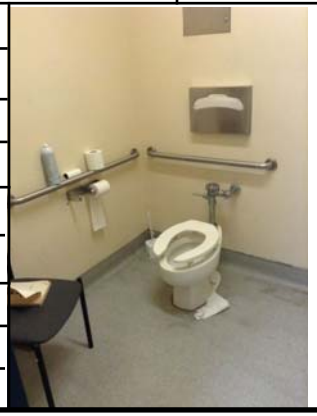
Issue	**Recommendation**
Flush controls not on open side of fixture (non-ambulatory accessible compartments)	Remove and replace water closet per current standards

ADA Reference:	
604.6	
CBC Reference:	
11B-604.6	
Floor:	1st
Room:	Line-Up
Location:	Restroom
Cost:	2000
Duration:	16 hrs

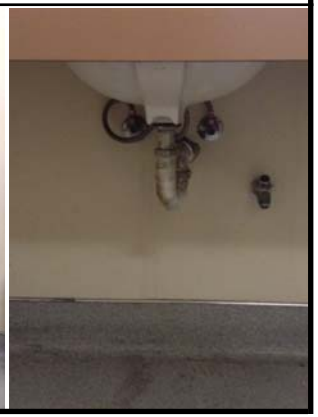
ADA Reference:	
606.5	
CBC Reference:	
11B-606.5	
Floor:	1st
Room:	Staff Restroom
Location:	Men
Cost:	50
Duration:	.25 hrs

182	Main Annex Jail	**Priority:**	3
Category	Accessories

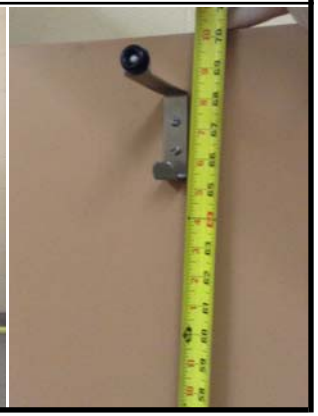
Issue	**Recommendation**
Coat hook measured over 48" AFF	Reset hook to maximum 48" AFF

ADA Reference:	
603.4	
CBC Reference:	
11B-603.4	
Floor:	1st
Room:	Staff Restroom
Location:	Men
Cost:	100
Duration:	1 hr

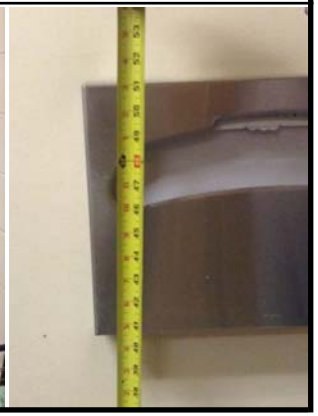
Issue	**Recommendation**
Toilet seat dispenser measured over 40" AFF to operable part	Reset accessories to maximum 40" AFF to operating controls

ADA Reference:	
N/A	
CBC Reference:	
11B-603.5	
Floor:	1st
Room:	Staff Restroom
Location:	Men
Cost:	50
Duration:	.5 hrs

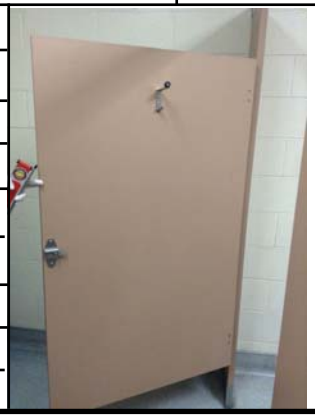
Issue	**Recommendation**
Lever, pull or push type handle on inside face near latch of door not provided	Provide required handle per current standards

ADA Reference:	
604.8.2.2	
CBC Reference:	
11B-604.8.2.2	
Floor:	1st
Room:	Staff Restroom
Location:	Women
Cost:	500
Duration:	1 hr

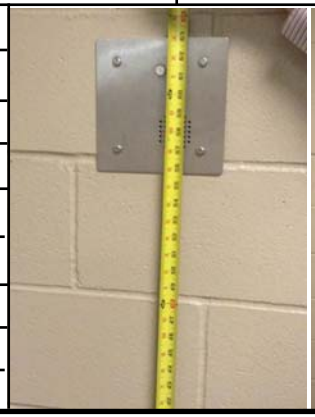
Issue	**Recommendation**
Maximum 48" AFF reach range exceeded /(forward unobstructed reach, 10" maximum reach depth)	Provide required reach range

ADA Reference:	
308.2.1	
CBC Reference:	
11B-308.2.1	
Floor:	1st
Room:	Corridor
Location:	Sally Port
Cost:	See *6
Duration:	See *6

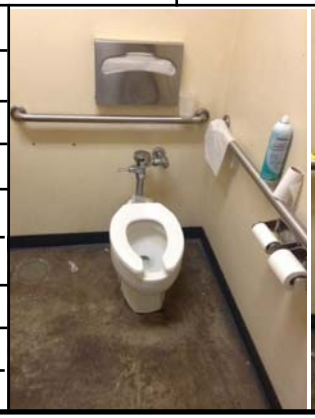
Issue	**Recommendation**
Sidewall grab bar less than 24" from front of toilet to far edge	Adjust as required and/or provide new bar per current standards

ADA Reference:	
N/A	
CBC Reference:	
11B-604.5.1	
Floor:	1st
Room:	Inmate Clothing
Location:	Restroom
Cost:	300
Duration:	1.5

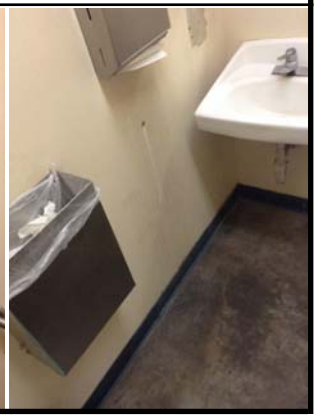
ADA Reference:	
606.2	
CBC Reference:	
11B-606.2	
Floor:	1st
Room:	Inmate Clothing
Location:	Restroom
Cost:	500
Duration:	2 hrs

222	Main Annex Jail	**Priority:**	1
Category	Interior Signage

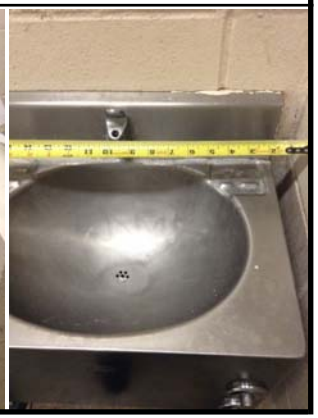
ADA Reference:	
N/A	
CBC Reference:	
11B-606.6	
Floor:	1st
Room:	Line-Up
Location:	
Cost:	See ID #230
Duration:	See ID #230

232	Main Annex Jail	**Priority:**	1
Category	Corridors/Hallways

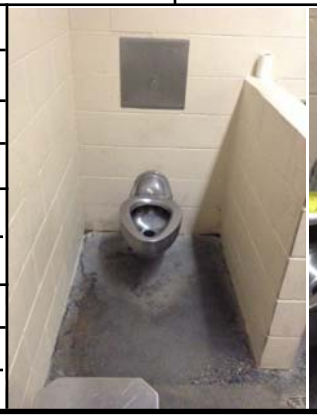
Issue	**Recommendation**
Water closet clearance not 60" wide measured perpendicular from the side wall	Provide required clearance or provide alternative accessible water closet

ADA Reference:	
604.3.1	
CBC Reference:	
11B-604.3.1	
Floor:	1st
Room:	Pre-release - B
Location:	
Cost:	8000
Duration:	40 hrs

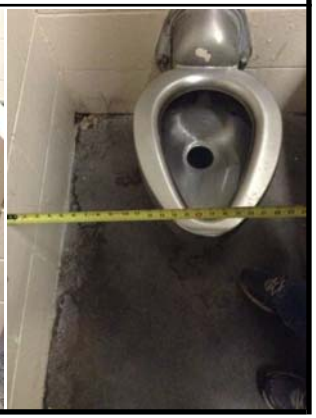
Issue	**Recommendation**
Centerline of toilet not 17"-18" from sidewall or partition in wheel chair accessible toilet compartment	Relocate/adjust as required

ADA Reference:	
N/A	
CBC Reference:	
11B-604.2	
Floor:	1st
Room:	Pre-release - B
Location:	
Cost:	2000
Duration:	16 hrs

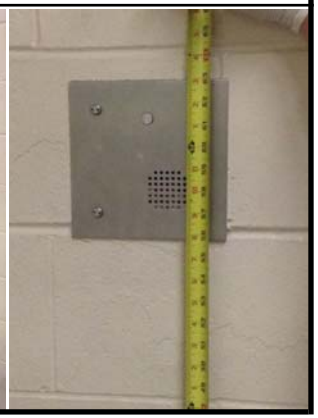
ADA Reference:	
308.2.1	
CBC Reference:	
11B-308.2.1	
Floor:	1st
Room:	Pre-release - B
Location:	
Cost:	See *6
Duration:	See *6

245	Main Annex Jail	**Priority:**	1
Category	Walks

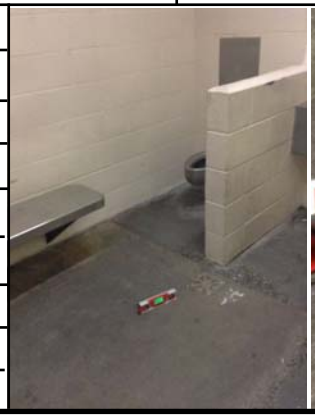
Issue	**Recommendation**
Cross slope of walk over 2.083% (1:48)	Provide concrete walk with maximum 2.0% slope cross slope where cross slope exceeds 2.0%

ADA Reference:	
403.3	
CBC Reference:	
11B-403.3	
Floor:	1st
Room:	Pre-release - B
Location:	
Cost:	5000
Duration:	40 hrs

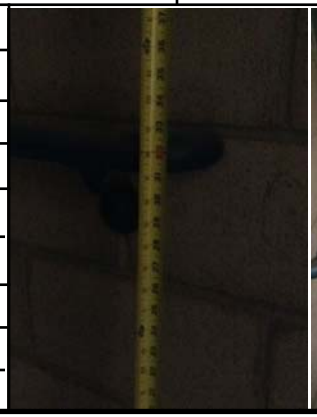
Issue	**Recommendation**
Height of handrail(s) less than 34" above nosing of threads	Provide handrails per current standards

ADA Reference:	
505.4	
CBC Reference:	
11B-505.4	
Floor:	1st
Room:	Stairwell
Location:	Center
Cost:	5000
Duration:	20 hrs

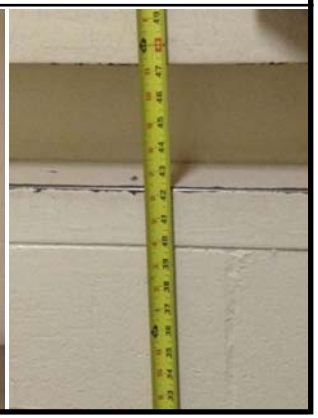
ADA Reference:	
N/A	
CBC Reference:	
11B-904.4.1	
Floor:	1st
Room:	Enroute
Location:	
Cost:	4000
Duration:	20 hrs

276	Main Annex Jail	**Priority:**	2
Category	Detention Facility Water Closets (GENERAL)

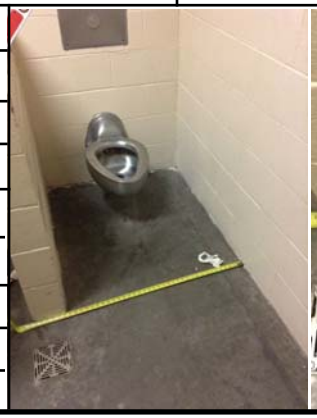
Issue	**Recommendation**
Water closet clearance not 60" wide measured perpendicular from the side wall	Provide required clearance or provide alternative accessible water closet

ADA Reference:	
604.3.1	
CBC Reference:	
11B-604.3.1	
Floor:	1st
Room:	Enroute
Location:	
Cost:	8000
Duration:	40 hrs

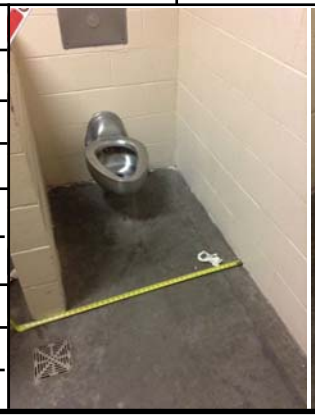
Issue	**Recommendation**
Seat height measured less than 17" AFF	Provide water closet per current standards

ADA Reference:	
604.4	
CBC Reference:	
11B-604.4	
Floor:	1st
Room:	Enroute
Location:	
Cost:	2000
Duration:	16 hrs

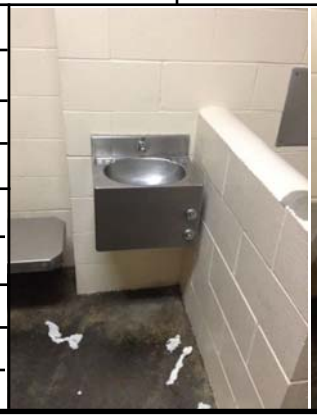
Issue	**Recommendation**
Minimum 29" clearance under lavatory apron not provided (measured at front edge)	Reset lavatory as required

ADA Reference:	
N/A	
CBC Reference:	
11B-606.2	
Floor:	1st
Room:	Enroute
Location:	
Cost:	3000
Duration:	16 hrs

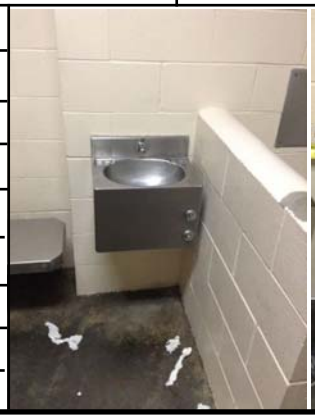
Issue	**Recommendation**
Lavatory not 18" minimum to centerline from side wall or partition	Relocate Lavatory as required; modification maybe required

ADA Reference:	
N/A	
CBC Reference:	
11B-606.6	
Floor:	1st
Room:	Enroute
Location:	
Cost:	See ID #278
Duration:	See ID #278

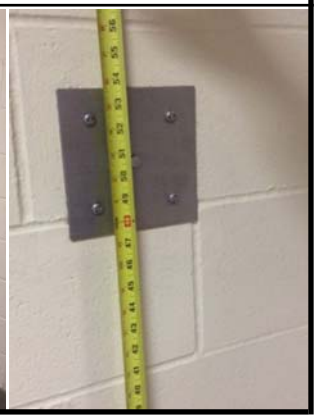
Issue	**Recommendation**
Maximum 48" AFF reach range exceeded /(forward unobstructed reach, 10" maximum reach depth)	Provide required reach range

ADA Reference:	
308.2.1	
CBC Reference:	
11B-308.2.1	
Floor:	1st
Room:	Enroute
Location:	
Cost:	See *6
Duration:	See *6

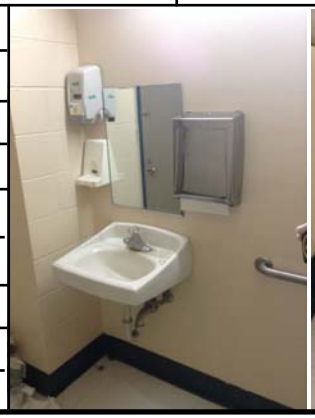
Issue	**Recommendation**
Drain and/or hot water piping not insulated (wrapped)	Insulate as required to protect against contact

ADA Reference:	
606.5	
CBC Reference:	
11B-606.5	
Floor:	1st
Room:	Staff Restroom
Location:	Women
Cost:	50
Duration:	.25 hrs

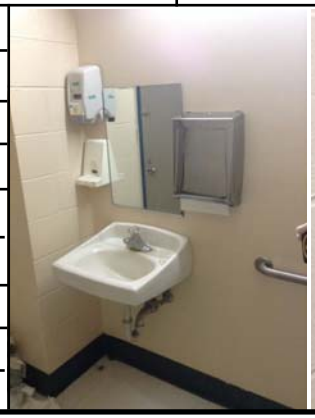
Issue	**Recommendation**
Mirror over lavatory or countertop measured over 40" AFF to the bottom edge of the reflecting surface	Reset mirror to maximum 40" AFF to reflecting surface

ADA Reference:	
603.3	
CBC Reference:	
11B-603.3	
Floor:	1st
Room:	Staff Restroom
Location:	Women
Cost:	100
Duration:	1 hr

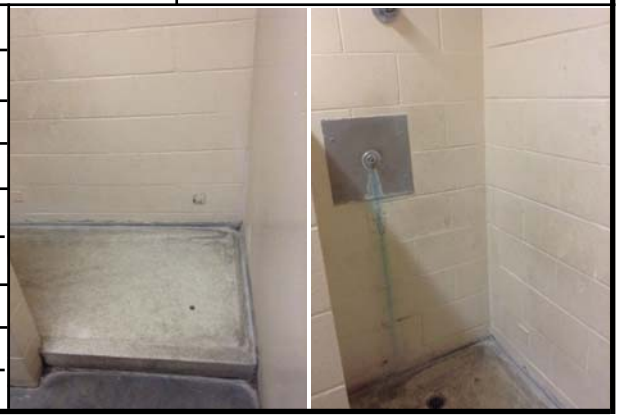
ADA Reference:	
608.7	
CBC Reference:	
11B-608.7	
Floor:	1st
Room:	male dress-in
Location:	Shower
Cost:	2000
Duration:	20 hrs

314	Main Annex Jail	**Priority:**	2
Category	Detention Facility Showers

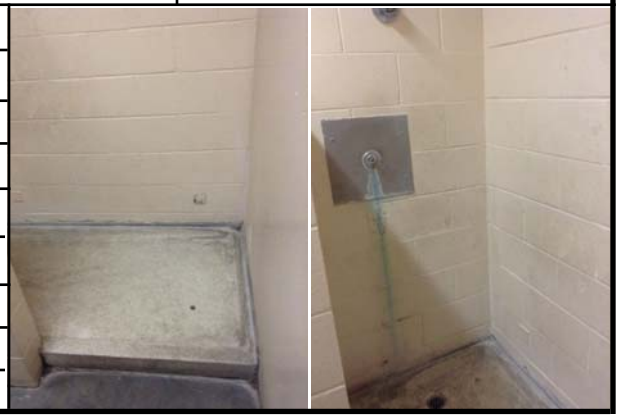
ADA Reference:	
N/A	
CBC Reference:	
11B-610.5	
Floor:	1st
Room:	male dress-in
Location:	Shower
Cost:	800
Duration:	1 hr

315	Main Annex Jail	**Priority:**	2
Category	Detention Facility Showers

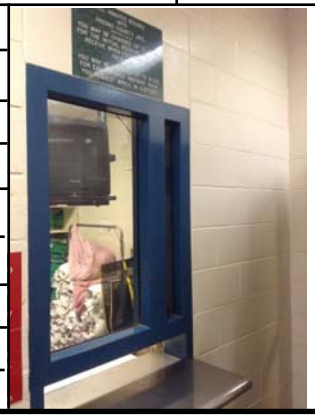
Issue	**Recommendation**
Lettering height on sign between 70" - 120" AFF (to bottom) not 2" minimum	Remove and replace sign per current standards

ADA Reference:	
703.5.5	
CBC Reference:	
11B-703.5.5	
Floor:	1st
Room:	male dress-in
Location:	
Cost:	See *1
Duration:	See *1

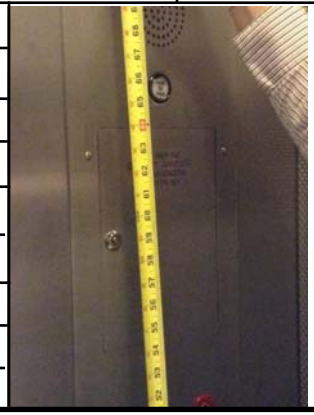
Issue	**Recommendation**
Emergency communication device (telephone) not provided or over 48" AFF	Adjust as required

ADA Reference:	
407.4.9	
CBC Reference:	
11B-407.4.9	
Floor:	1st
Room:	Elevator 4
Location:	
Cost:	5000
Duration:	20 hrs

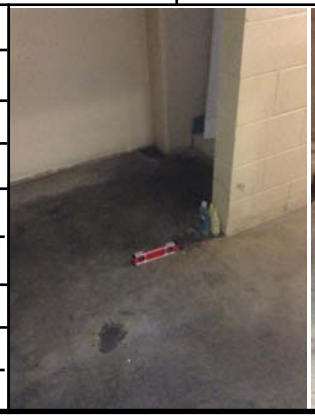
Issue	**Recommendation**
Cross slope of walk over 2.083% (1:48)	Provide concrete walk with maximum 2.0% slope cross slope where cross slope exceeds 2.0%

ADA Reference:	
403.3	
CBC Reference:	
11B-403.3	
Floor:	2nd
Room:	Cell - B4
Location:	
Cost:	See *13
Duration:	See *13

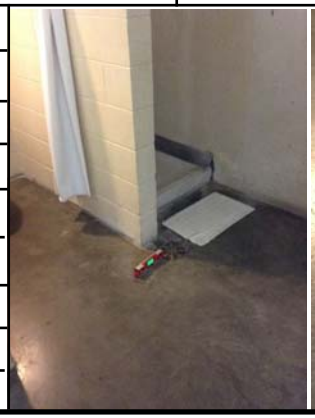
Issue	**Recommendation**
Cross slope of walk over 2.083% (1:48)	Provide concrete walk with maximum 2.0% slope cross slope where cross slope exceeds 2.0%

ADA Reference:	
403.3	
CBC Reference:	
11B-403.3	
Floor:	2nd
Room:	Cell - B3
Location:	
Cost:	See *13
Duration:	See *13

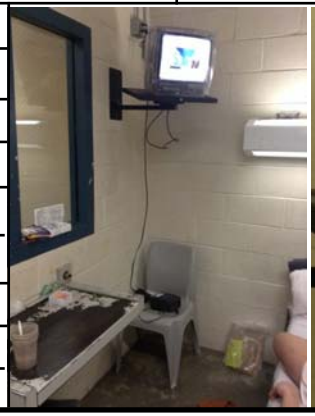
Issue	**Recommendation**
Maximum 48" AFF reach range exceeded /(forward unobstructed reach, 10" maximum reach depth)	Provide required reach range

ADA Reference:	
308.2.1	
CBC Reference:	
11B-308.2.1	
Floor:	2nd
Room:	Cell - B3
Location:	
Cost:	See *13
Duration:	See *13

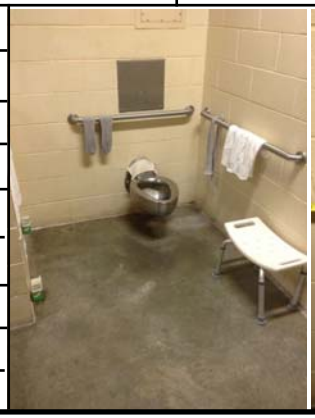
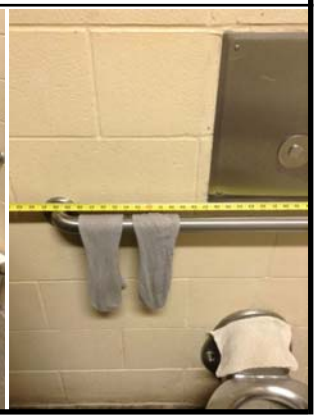
Issue	**Recommendation**
Rear wall grab bar not 24" minimum length from C/L of toilet towards open side	Adjust as required and/or provide new bar per current standards

ADA Reference:	
604.5.2	
CBC Reference:	
11B-604.5.2	
Floor:	2nd
Room:	Cell - B2
Location:	
Cost:	See *13
Duration:	See *13

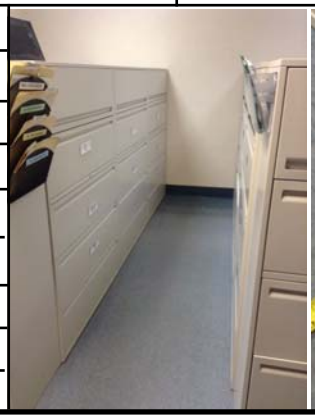
Issue	**Recommendation**
Minimum clear aisle width of 44" (serving two sides) not provided	Provide 44" width clearance

ADA Reference:	
N/A	
CBC Reference:	
11B-403.5.1	
Floor:	2nd
Room:	Medical
Location:	
Cost:	500
Duration:	5 hrs

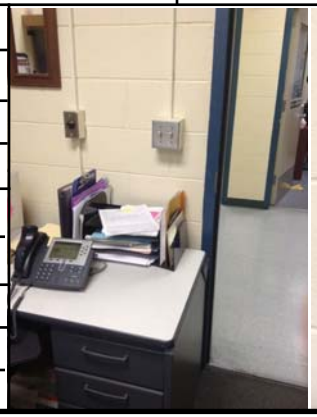
Issue	**Recommendation**
Switch measured over 48" AFF / measure to top of switch box	Provide occupancy room sensor or lower switch

ADA Reference:	
308.2.1	
CBC Reference:	
11B-308.2.1	
Floor:	2nd
Room:	Support staff
Location:	
Cost:	See *6
Duration:	See *6

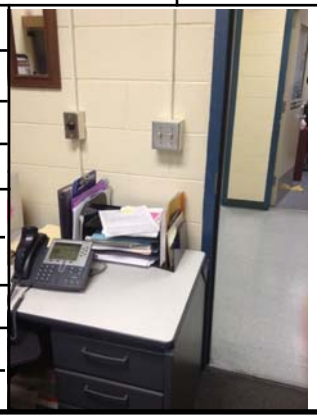
Issue	**Recommendation**
Minimum 18" maneuvering clearance on latch side (pull side, front approach) of interior door not provided	Provide minimum 18" maneuvering clearance

ADA Reference:	
404.2.4.1	
CBC Reference:	
11B-404.2.4.1	
Floor:	2nd
Room:	Support staff
Location:	
Cost:	200
Duration:	2 hrs

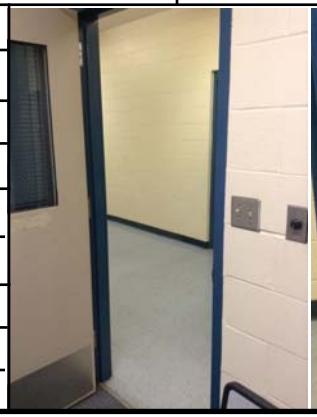
Issue	**Recommendation**
Switch measured over 48" AFF / measure to top of switch box	Provide occupancy room sensor or lower switch

ADA Reference:	
308.2.1	
CBC Reference:	
11B-308.2.1	
Floor:	2nd
Room:	Secretary
Location:	
Cost:	See *6
Duration:	See *6

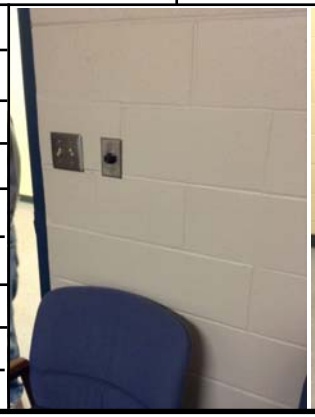
Issue	**Recommendation**
Switch measured over 48" AFF / measure to top of switch box	Provide occupancy room sensor or lower switch

ADA Reference:	
308.2.1	
CBC Reference:	
11B-308.2.1	
Floor:	2nd
Room:	Secretary
Location:	
Cost:	See *6
Duration:	See *6

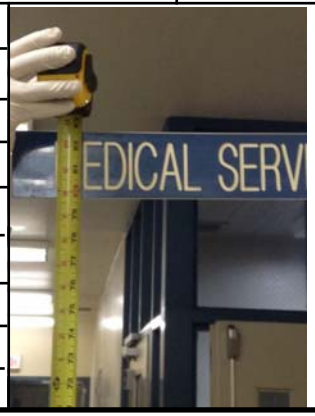
Issue	**Recommendation**
Lettering height on sign between 70" - 120" AFF (to bottom) not 2" minimum	Remove and replace sign per current standards

ADA Reference:	
703.5.5	
CBC Reference:	
11B-703.5.5	
Floor:	2nd
Room:	Corridor
Location:	
Cost:	See *1
Duration:	See *1

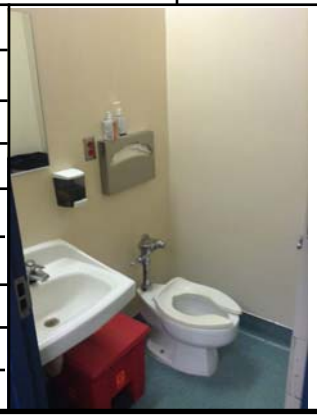
Issue	**Recommendation**
Required 60" diameter circle or 'T'-shaped clear floor space not provided within room	Provide required clearance

ADA Reference:	
304.3	
CBC Reference:	
11B-304.3	
Floor:	2nd
Room:	Nurse Room
Location:	Restroom
Cost:	10000
Duration:	50 hrs

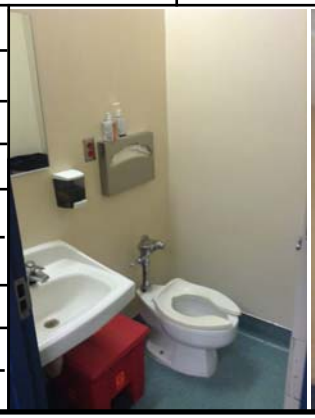
427	Main Annex Jail	**Priority:**	3
Category	Lavatories (GENERAL)

Issue	**Recommendation**
Drain and/or hot water piping not insulated (wrapped)	Insulate as required to protect against contact

ADA Reference:	
606.5	
CBC Reference:	
11B-606.5	
Floor:	2nd
Room:	Nurse Room
Location:	Restroom
Cost:	50
Duration:	.25 hrs

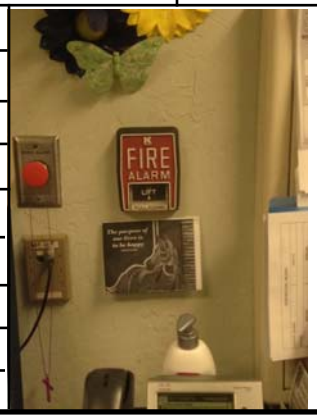
Issue	**Recommendation**
Maximum 48" AFF reach range exceeded /(forward unobstructed reach, 10" maximum reach depth)	Provide required reach range

ADA Reference:	
308.2.1	
CBC Reference:	
11B-308.2.1	
Floor:	2nd
Room:	Nurse Room
Location:	
Cost:	See *6
Duration:	See *6

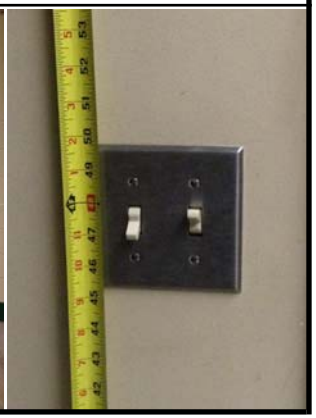
Issue	**Recommendation**
Switch measured over 48" AFF / measure to top of switch box	Provide occupancy room sensor or lower switch

ADA Reference:	
308.2.1	
CBC Reference:	
11B-308.2.1	
Floor:	2nd
Room:	Pharmacy
Location:	
Cost:	See *6
Duration:	See *6

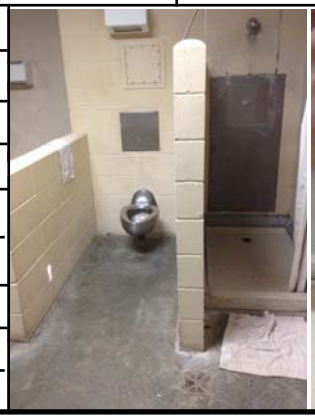
Issue	**Recommendation**
Maximum 48" AFF reach range exceeded /(forward unobstructed reach, 10" maximum reach depth)	Provide required reach range

ADA Reference:	
308.2.1	
CBC Reference:	
11B-308.2.1	
Floor:	2nd
Room:	Cell - B1
Location:	
Cost:	See *13
Duration:	See *13

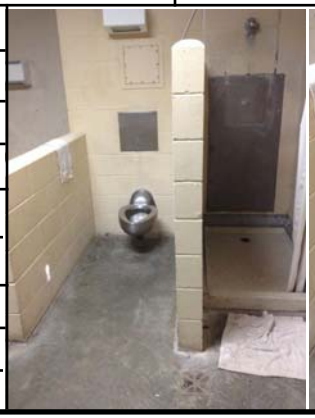
Issue	**Recommendation**
Grab bars not provided on rear wall	Provide required grab bar

ADA Reference:	
604.5	
CBC Reference:	
11B-604.5	
Floor:	2nd
Room:	Cell - B1
Location:	
Cost:	See *13
Duration:	See *13

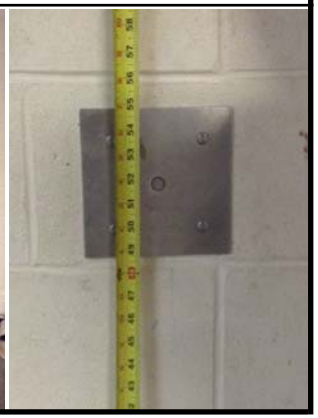
ADA Reference:	
308.2.1	
CBC Reference:	
11B-308.2.1	
Floor:	2nd
Room:	Cell - B1
Location:	
Cost:	See *13
Duration:	See *13

468	Main Annex Jail	**Priority:**	2
Category	Reach Range

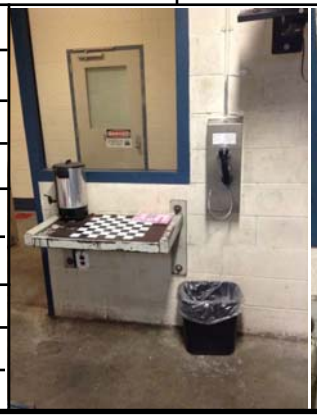
Issue	**Recommendation**
Clear floor space not provided for wheelchair accessible telephone	Reconfigure telephone location to provide required clear floor space

ADA Reference:	
704.2.1	
CBC Reference:	
11B-704.2.1	
Floor:	2nd
Room:	Cell - B1
Location:	
Cost:	See *13
Duration:	See *13

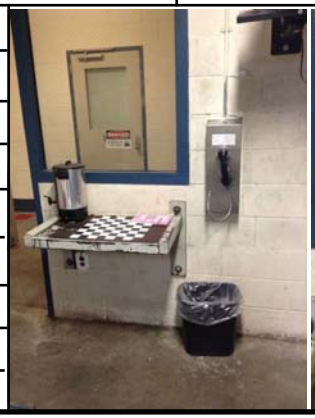
471	Main Annex Jail	**Priority:**	4
Category	Telephones

Issue	**Recommendation**
At least one TTY not provided in a secured area of a correctional facility if a public phone for detainees is provided	Provide accessible TTY per current standards

ADA Reference:	
217.4.8	
CBC Reference:	
11B-217.4.8	
Floor:	2nd
Room:	Cell - B1
Location:	
Cost:	See *5
Duration:	See *5

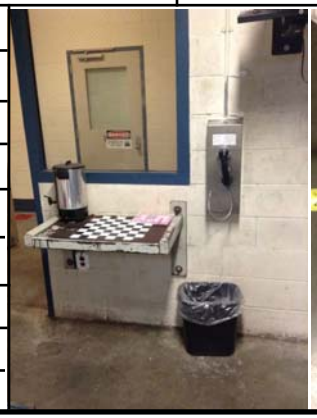
472	Main Annex Jail	**Priority:**	2
Category	Dining/Bar Facilities

Issue	**Recommendation**
Required 30" by 48" clear floor space not provided at accessible seating spaces	Provide required clear floor space at accessible seating

ADA Reference:	
902.2	
CBC Reference:	
11B-902.2	
Floor:	2nd
Room:	Cell - B1
Location:	
Cost:	See *13
Duration:	See *13

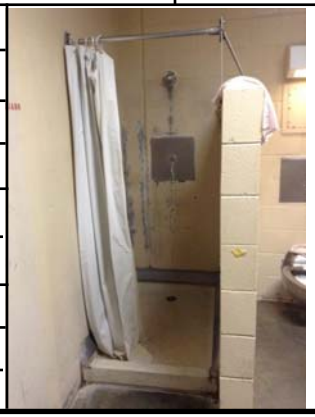
Issue	**Recommendation**
Grab bar not provided on back wall for standard or alternate shower	Provide new bar per current standards

ADA Reference:	
608.3.2	
CBC Reference:	
11B-608.3.2	
Floor:	2nd
Room:	Cell - A10
Location:	Shower
Cost:	See *13
Duration:	See *13

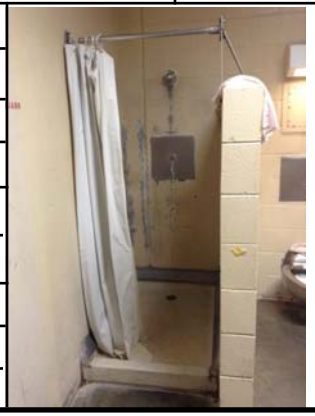
Issue	**Recommendation**
Grab bar not provided on side wall opposite of seat in standard shower	Provide new bar per current standards

ADA Reference:	
608.3.2	
CBC Reference:	
11B-608.3.2	
Floor:	2nd
Room:	Cell - A10
Location:	Shower
Cost:	See *13
Duration:	See *13

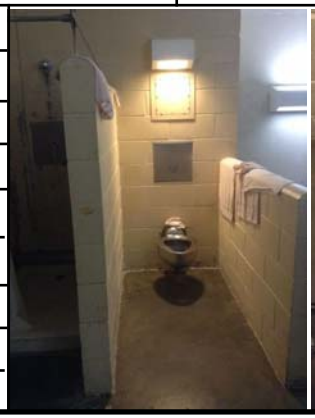
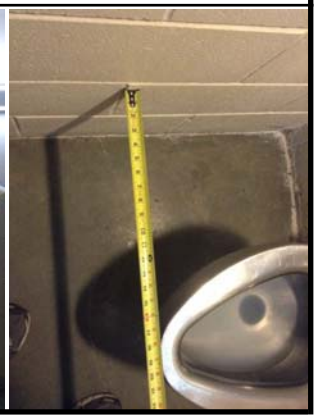
Issue	**Recommendation**
Centerline of toilet not 17"-18" from sidewall or partition in wheel chair accessible toilet compartment	Relocate/adjust as required

ADA Reference:	
N/A	
CBC Reference:	
11B-604.2	
Floor:	2nd
Room:	Cell - A10
Location:	
Cost:	See *13
Duration:	See *13

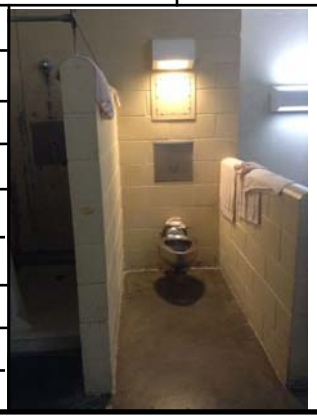
484	Main Annex Jail	**Priority:**	2
Category	Detention Facility Water Closets (GENERAL)

Issue	**Recommendation**
Grab bars not provided on rear wall	Provide required grab bar

ADA Reference:	
604.5	
CBC Reference:	
11B-604.5	
Floor:	2nd
Room:	Cell - A10
Location:	
Cost:	See *13
Duration:	See *13

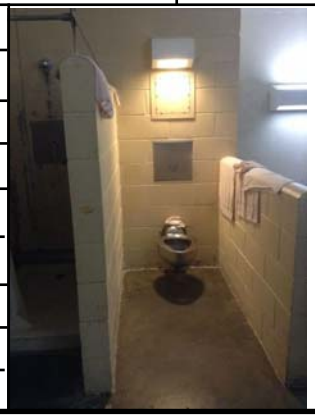
485	Main Annex Jail	**Priority:**	2
Category	Detention Facility Water Closets (GENERAL)

Issue	**Recommendation**
Grab bars not provided on sidewall	Provide required grab bar

ADA Reference:	
604.5	
CBC Reference:	
11B-604.5	
Floor:	2nd
Room:	Cell - A10
Location:	
Cost:	See *13
Duration:	See *13

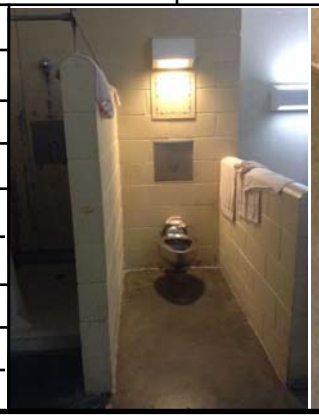
ADA Reference:	
604.3.1	
CBC Reference:	
11B-604.3.1	
Floor:	2nd
Room:	Cell - A10
Location:	
Cost:	See *13
Duration:	See *13

487	Main Annex Jail	**Priority:**	2
Category	Reach Range

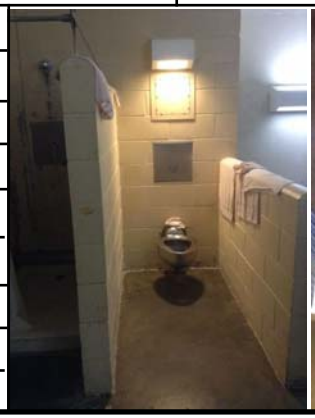
Issue	**Recommendation**
Maximum 48" AFF reach range exceeded /(forward unobstructed reach, 10" maximum reach depth)	Provide required reach range

ADA Reference:	
308.2.1	
CBC Reference:	
11B-308.2.1	
Floor:	2nd
Room:	Cell - A10
Location:	
Cost:	See *13
Duration:	See *13

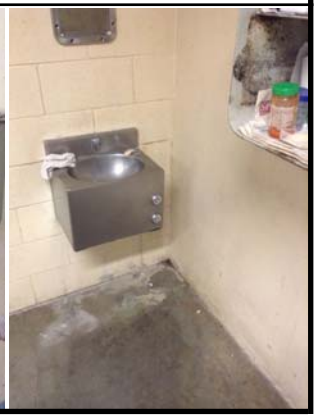
ADA Reference:	
606.2	
CBC Reference:	
11B-606.2	
Floor:	2nd
Room:	Cell - A10
Location:	
Cost:	See *13
Duration:	See *13

494	Main Annex Jail	**Priority:**	2
Category	Reach Range

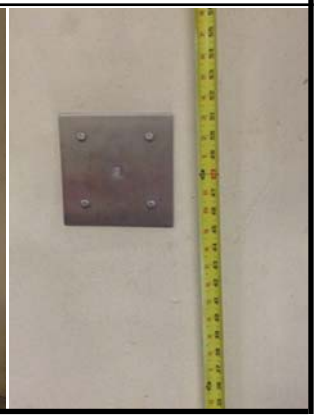
ADA Reference:	
308.2.1	
CBC Reference:	
11B-308.2.1	
Floor:	2nd
Room:	Cell - A10
Location:	
Cost:	See *13
Duration:	See *13

495	Main Annex Jail	**Priority:**	2
Category	Reach Range

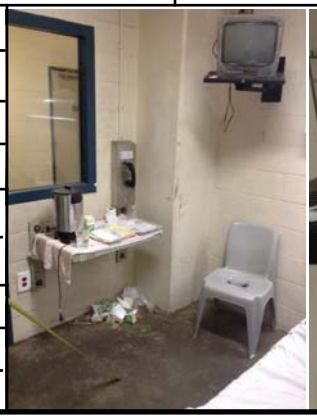
Issue	**Recommendation**
Maximum 48" AFF reach range exceeded /(forward unobstructed reach, 10" maximum reach depth)	Provide required reach range

ADA Reference:	
308.2.1	
CBC Reference:	
11B-308.2.1	
Floor:	2nd
Room:	Cell - A9
Location:	
Cost:	See *13
Duration:	See *13

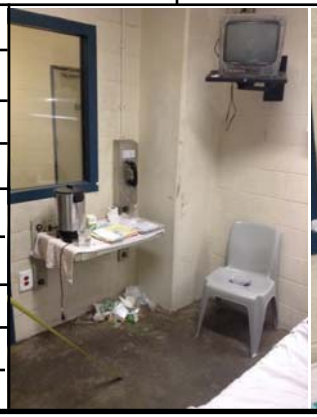
Issue	**Recommendation**
At least one TTY not provided in a secured area of a correctional facility if a public phone for detainees is provided	Provide accessible TTY per current standards

ADA Reference:	
217.4.8	
CBC Reference:	
11B-217.4.8	
Floor:	2nd
Room:	Cell - A9
Location:	
Cost:	See *5
Duration:	See *5

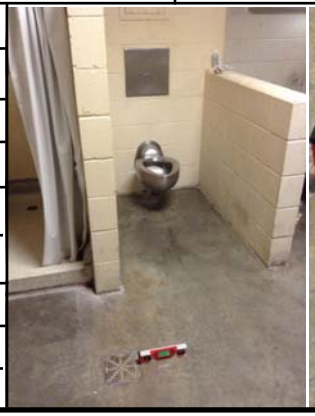
Issue	**Recommendation**
Cross slope of walk over 2.083% (1:48)	Provide concrete walk with maximum 2.0% slope cross slope where cross slope exceeds 2.0%

ADA Reference:	
403.3	
CBC Reference:	
11B-403.3	
Floor:	2nd
Room:	Cell - A8
Location:	
Cost:	See *13
Duration:	See *13

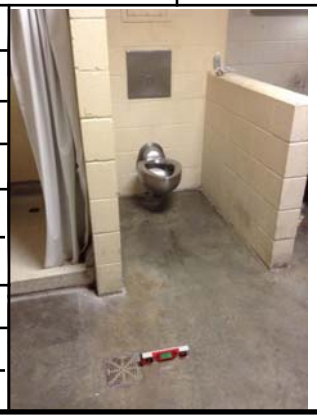
Issue	**Recommendation**
Grab bars not provided on sidewall	Provide required grab bar

ADA Reference:	
604.5	
CBC Reference:	
11B-604.5	
Floor:	2nd
Room:	Cell - A8
Location:	
Cost:	See *13
Duration:	See *13

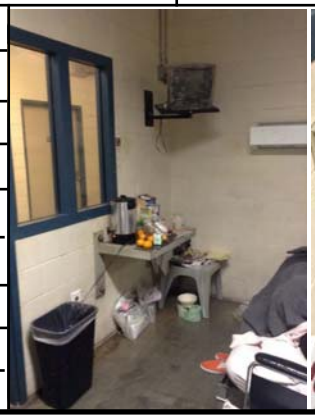
Issue	**Recommendation**
Minimum 36" clear width not provided/where serving occupant load less than 10	Provide 36" clear width

ADA Reference:	
403.5.1	
CBC Reference:	
11B-403.5.1	
Floor:	2nd
Room:	Cell - A8
Location:	
Cost:	See *13
Duration:	See *13

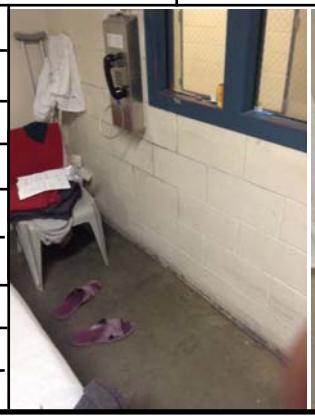
Issue	**Recommendation**
Clear floor space not provided for wheelchair accessible telephone	Reconfigure telephone location to provide required clear floor space

ADA Reference:	
704.2.1	
CBC Reference:	
11B-704.2.1	
Floor:	2nd
Room:	Cell - A8
Location:	
Cost:	See *13
Duration:	See *13

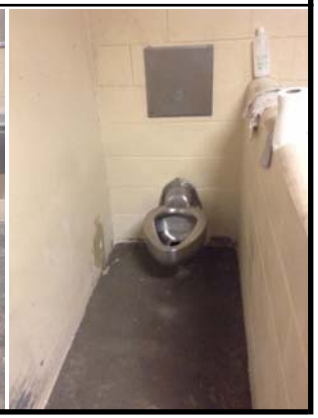
ADA Reference:	
604.5	
CBC Reference:	
11B-604.5	
Floor:	2nd
Room:	Cell - A7
Location:	
Cost:	See *13
Duration:	See *13

568	Main Annex Jail	**Priority:**	3
Category	Lavatories (ADULT)

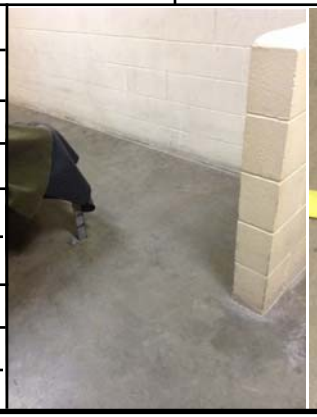
Issue	**Recommendation**
Minimum 36" clear width not provided/where serving occupant load less than 10	Provide 36" clear width

ADA Reference:	
403.5.1	
CBC Reference:	
11B-403.5.1	
Floor:	2nd
Room:	Cell - A5
Location:	
Cost:	See *13
Duration:	See *13

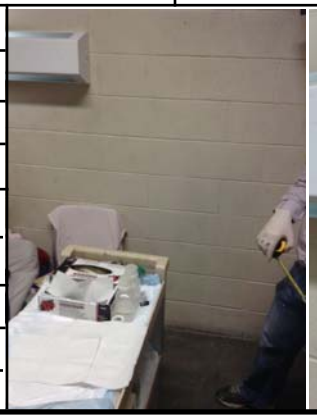
Issue	**Recommendation**
Maximum 48" AFF reach range exceeded /(forward unobstructed reach, 10" maximum reach depth)	Provide required reach range

ADA Reference:	
308.2.1	
CBC Reference:	
11B-308.2.1	
Floor:	2nd
Room:	Cell - A5
Location:	
Cost:	See *13
Duration:	See *13

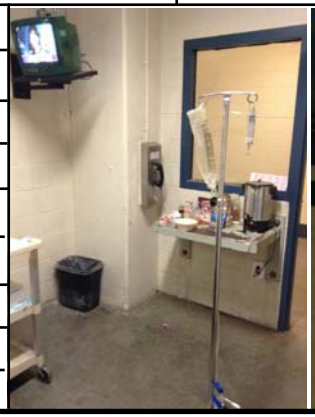
Issue	**Recommendation**
Maximum 48" AFF reach range exceeded /(forward unobstructed reach, 10" maximum reach depth)	Provide required reach range

ADA Reference:	
308.2.1	
CBC Reference:	
11B-308.2.1	
Floor:	2nd
Room:	Cell - A5
Location:	
Cost:	See *13
Duration:	See *13

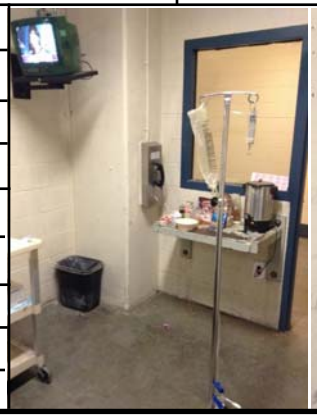
Issue	**Recommendation**
Clear floor space not provided for wheelchair accessible telephone	Reconfigure telephone location to provide required clear floor space

ADA Reference:	
704.2.1	
CBC Reference:	
11B-704.2.1	
Floor:	2nd
Room:	Cell - A5
Location:	
Cost:	See *13
Duration:	See *13
