County of Fresno

Main Annex Jail
ADA Transition Plan

LARS ANDERSEN & ASSOCIATES, INC.

JUNE 30, 2014

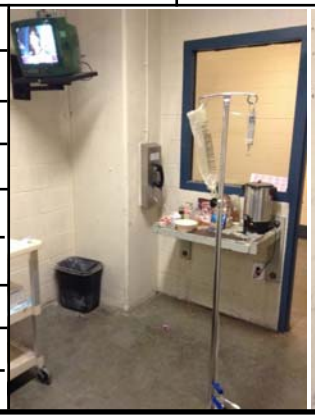
Issue	**Recommendation**
At least one TTY not provided in a secured area of a correctional facility if a public phone for detainees is provided	Provide accessible TTY per current standards

ADA Reference:	
217.4.8	
CBC Reference:	
11B-217.4.8	
Floor:	2nd
Room:	Cell - A5
Location:	
Cost:	See *5
Duration:	See *5

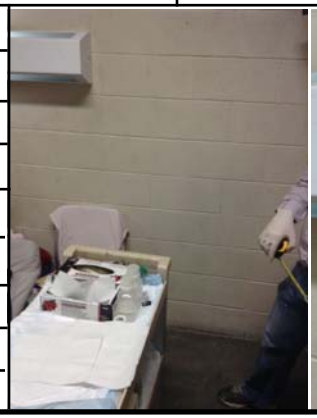
Issue	**Recommendation**
Objects with leading edges more than 27" and no more than 80" AFF shall protrude 4" maximum horizontally into the circulation path	Provide required clearance/adjust as required

ADA Reference:	
307.2	
CBC Reference:	
11B-307.2	
Floor:	2nd
Room:	Cell - A5
Location:	
Cost:	See *13
Duration:	See *13

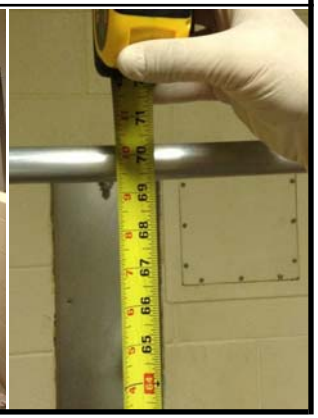
ADA Reference:	
307.4	
CBC Reference:	
11B-307.4	
Floor:	2nd
Room:	Cell - A4
Location:	Shower
Cost:	See *13
Duration:	See *13

637	Main Annex Jail	**Priority:**	2
Category	Detention Facility Showers

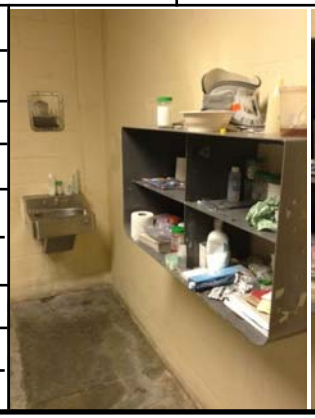
Issue	**Recommendation**
Objects with leading edges more than 27" and no more than 80" AFF shall protrude 4" maximum horizontally into the circulation path	Provide required clearance/adjust as required

ADA Reference:	
307.2	
CBC Reference:	
11B-307.2	
Floor:	2nd
Room:	Cell - A4
Location:	
Cost:	See *13
Duration:	See *13

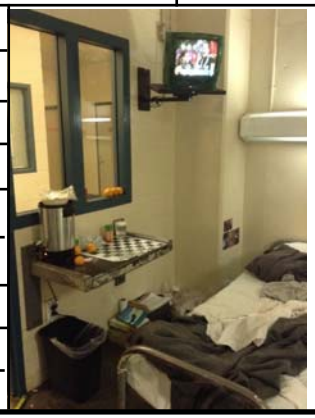
Issue	**Recommendation**
Required 30" by 48" clear floor space not provided at accessible seating spaces	Provide required clear floor space at accessible seating

ADA Reference:	
902.2	
CBC Reference:	
11B-902.2	
Floor:	2nd
Room:	Cell - A4
Location:	
Cost:	See *13
Duration:	See *13

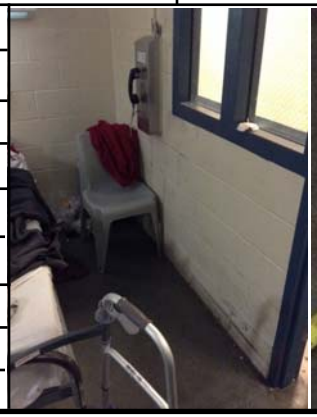
Issue	**Recommendation**
Minimum 36" clear width not provided/where serving occupant load less than 10	Provide 36" clear width

ADA Reference:	
403.5.1	
CBC Reference:	
11B-403.5.1	
Floor:	2nd
Room:	Cell - A4
Location:	
Cost:	See *13
Duration:	See *13

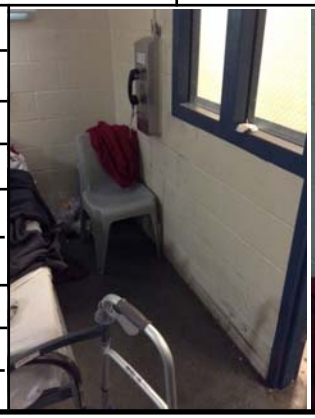
Issue	**Recommendation**
Clear floor space not provided for wheelchair accessible telephone	Reconfigure telephone location to provide required clear floor space

ADA Reference:	
704.2.1	
CBC Reference:	
11B-704.2.1	
Floor:	2nd
Room:	Cell - A4
Location:	
Cost:	See *13
Duration:	See *13

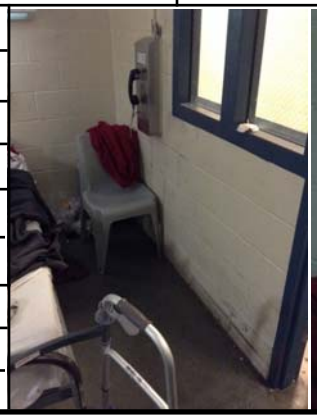
Issue	**Recommendation**
At least one TTY not provided in a secured area of a correctional facility if a public phone for detainees is provided	Provide accessible TTY per current standards

ADA Reference:	
217.4.8	
CBC Reference:	
11B-217.4.8	
Floor:	2nd
Room:	Cell - A4
Location:	
Cost:	See *5
Duration:	See *5

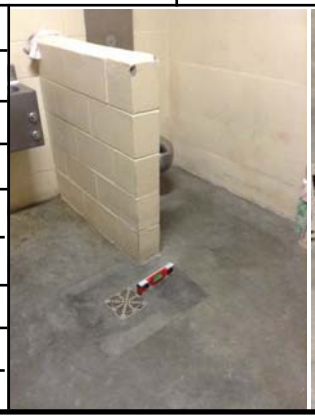
Issue	**Recommendation**
Cross slope of walk over 2.083% (1:48)	Provide concrete walk with maximum 2.0% slope cross slope where cross slope exceeds 2.0%

ADA Reference:	
403.3	
CBC Reference:	
11B-403.3	
Floor:	2nd
Room:	Cell - A3
Location:	
Cost:	See *13
Duration:	See *13

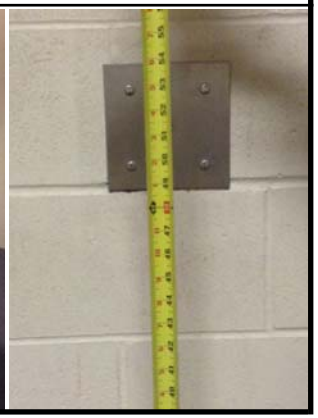
Issue	**Recommendation**
Maximum 48" AFF reach range exceeded /(forward unobstructed reach, 10" maximum reach depth)	Provide required reach range

ADA Reference:	
308.2.1	
CBC Reference:	
11B-308.2.1	
Floor:	2nd
Room:	Cell - A3
Location:	
Cost:	See *13
Duration:	See *13

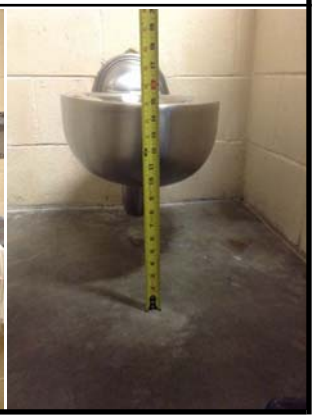
Issue	**Recommendation**
Seat height measured less than 17" AFF	Provide water closet per current standards

ADA Reference:	
604.4	
CBC Reference:	
11B-604.4	
Floor:	2nd
Room:	Cell - A2
Location:	
Cost:	2000
Duration:	16 hrs

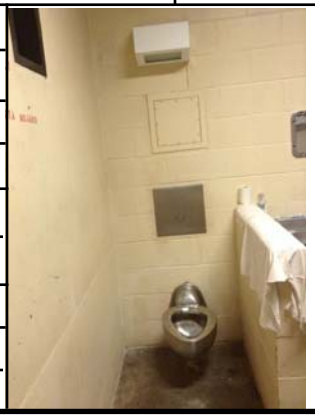
Issue	**Recommendation**
Grab bars not provided on rear wall	Provide required grab bar

ADA Reference:	
604.5	
CBC Reference:	
11B-604.5	
Floor:	2nd
Room:	Cell - A2
Location:	
Cost:	See *13
Duration:	See *13

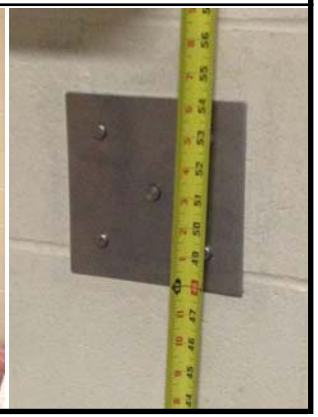
Issue	**Recommendation**
Maximum 48" AFF reach range exceeded /(forward unobstructed reach, 10" maximum reach depth)	Provide required reach range

ADA Reference:	
308.2.1	
CBC Reference:	
11B-308.2.1	
Floor:	2nd
Room:	Cell - A2
Location:	
Cost:	See *13
Duration:	See *13

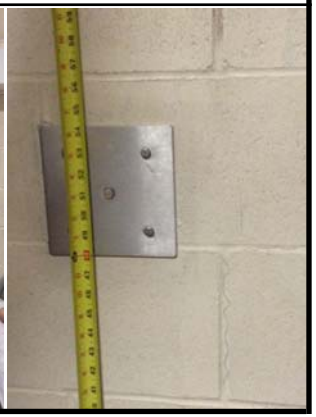
Issue	**Recommendation**
Maximum 48" AFF reach range exceeded /(forward unobstructed reach, 10" maximum reach depth)	Provide required reach range

ADA Reference:	
308.2.1	
CBC Reference:	
11B-308.2.1	
Floor:	2nd
Room:	Cell - A1
Location:	
Cost:	See *13
Duration:	See *13

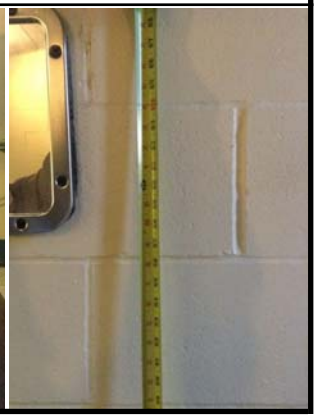
Issue	**Recommendation**
Mirror over lavatory or countertop measured over 40" AFF to the bottom edge of the reflecting surface	Reset mirror to maximum 40" AFF to reflecting surface

ADA Reference:	
603.3	
CBC Reference:	
11B-603.3	
Floor:	2nd
Room:	Cell - C2
Location:	
Cost:	See *13
Duration:	See *13

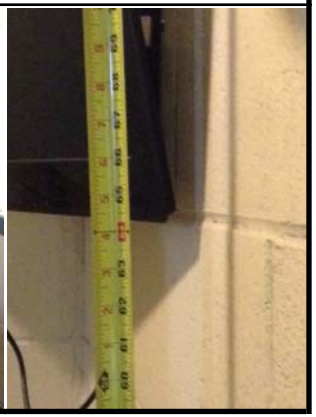
Issue	**Recommendation**
Maximum 48" AFF reach range exceeded /(forward unobstructed reach, 10" maximum reach depth)	Provide required reach range

ADA Reference:	
308.2.1	
CBC Reference:	
11B-308.2.1	
Floor:	2nd
Room:	Cell - C2
Location:	
Cost:	See *13
Duration:	See *13

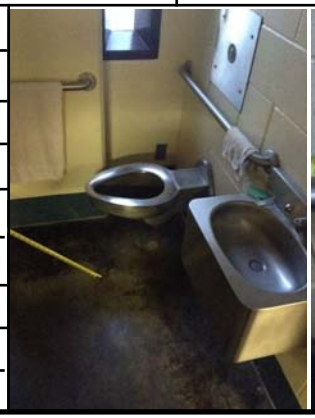
Issue	**Recommendation**
Rear wall grab bar not 24" minimum length from C/L of toilet towards open side	Adjust as required and/or provide new bar per current standards

ADA Reference:	
604.5.2	
CBC Reference:	
11B-604.5.2	
Floor:	2nd
Room:	Cell - C1
Location:	
Cost:	See *13
Duration:	See *13

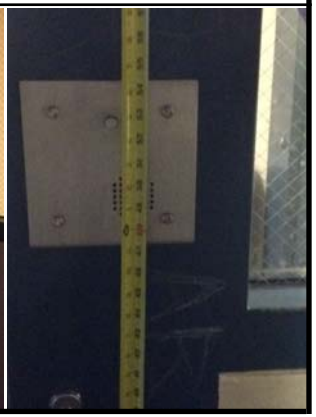
Issue	**Recommendation**
Maximum 48" AFF reach range exceeded /(forward unobstructed reach, 10" maximum reach depth)	Provide required reach range

ADA Reference:	
308.2.1	
CBC Reference:	
11B-308.2.1	
Floor:	2nd
Room:	Cell - C1
Location:	
Cost:	See *13
Duration:	See *13

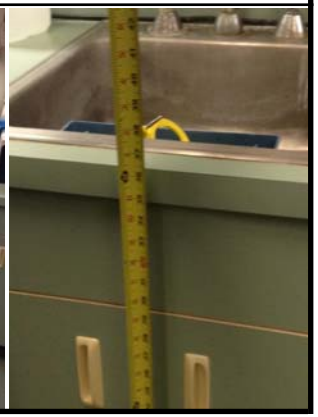
Issue	Recommendation
Height of rim or counter measured over 34" AFF	Reset sink/or provide maximum 34" AFF counter

ADA Reference:	
606.3	
CBC Reference:	
11B-606.3	
Floor:	2nd
Room:	X-Ray
Location:	
Cost:	1000
Duration:	8 hrs

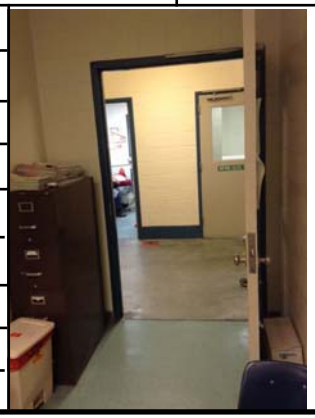
Issue	Recommendation
Minimum 18" maneuvering clearance on latch side (pull side, front approach) of interior door not provided	Provide minimum 18" maneuvering clearance

ADA Reference:	
404.2.4.1	
CBC Reference:	
11B-404.2.4.1	
Floor:	2nd
Room:	X-Ray
Location:	
Cost:	200
Duration:	2 hrs

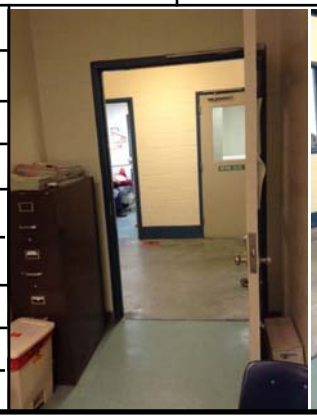
Issue	Recommendation
Lever-type hardware not provided	Remove and replace with lever-type hardware

ADA Reference:	
404.2.7	
CBC Reference:	
11B-404.2.7	
Floor:	2nd
Room:	X-Ray
Location:	
Cost:	500
Duration:	1 hr

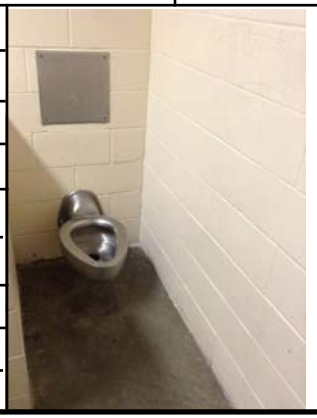
Issue	**Recommendation**
Grab bars not provided on rear wall	Provide required grab bar

ADA Reference:	
604.5	
CBC Reference:	
11B-604.5	
Floor:	2nd
Room:	Holding Cell
Location:	
Cost:	300
Duration:	1.5

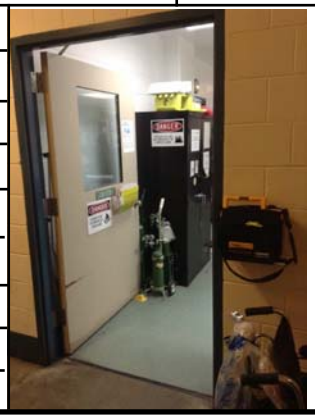
Issue	**Recommendation**
Room identification sign not provided in Braille	Provide sign per current standards

ADA Reference:	
703.3	
CBC Reference:	
11B-703.3	
Floor:	2nd
Room:	Exam room
Location:	
Cost:	See *1
Duration:	See *1

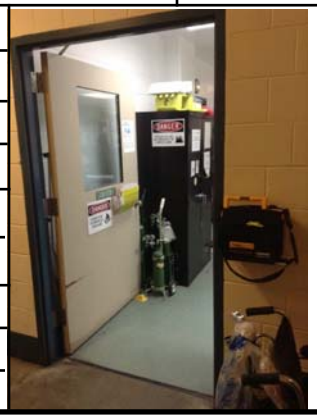
Issue	**Recommendation**
Lever-type hardware not provided	Remove and replace with lever-type hardware

ADA Reference:	
404.2.7	
CBC Reference:	
11B-404.2.7	
Floor:	2nd
Room:	Exam room
Location:	
Cost:	500
Duration:	1 hr

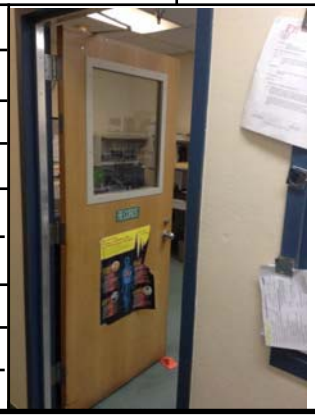
Issue	**Recommendation**
Lever-type hardware not provided	Remove and replace with lever-type hardware

ADA Reference:	
404.2.7	
CBC Reference:	
11B-404.2.7	
Floor:	2nd
Room:	Records
Location:	
Cost:	500
Duration:	1 hr

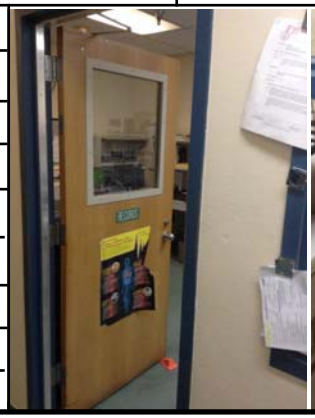
Issue	**Recommendation**
Minimum 18" maneuvering clearance on latch side (pull side, front approach) of interior door not provided	Provide minimum 18" maneuvering clearance

ADA Reference:	
404.2.4.1	
CBC Reference:	
11B-404.2.4.1	
Floor:	2nd
Room:	Records
Location:	
Cost:	200
Duration:	2 hrs

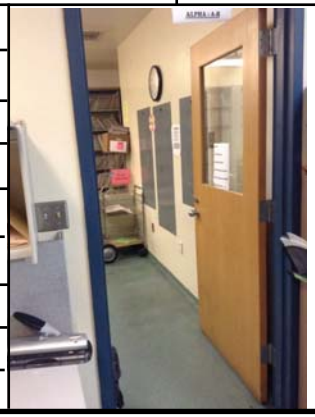
Issue	**Recommendation**
Lever-type hardware not provided	Remove and replace with lever-type hardware

ADA Reference:	
404.2.7	
CBC Reference:	
11B-404.2.7	
Floor:	2nd
Room:	Records
Location:	
Cost:	500
Duration:	1 hr

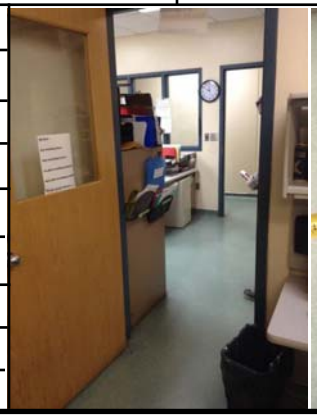
Issue	**Recommendation**
Minimum 18" maneuvering clearance on latch side (pull side, front approach) of interior door not provided	Provide minimum 18" maneuvering clearance

ADA Reference:	
404.2.4.1	
CBC Reference:	
11B-404.2.4.1	
Floor:	2nd
Room:	Records
Location:	
Cost:	200
Duration:	2 hrs

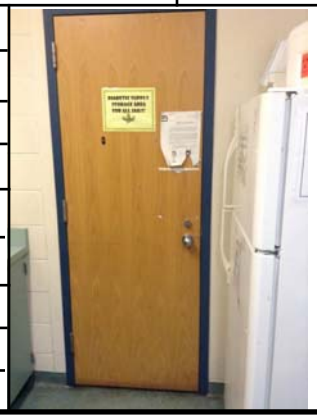
Issue	**Recommendation**
Minimum 18" maneuvering clearance on latch side (pull side, front approach) of interior door not provided	Provide minimum 18" maneuvering clearance

ADA Reference:	
404.2.4.1	
CBC Reference:	
11B-404.2.4.1	
Floor:	2nd
Room:	Laboratory
Location:	
Cost:	200
Duration:	2 hrs

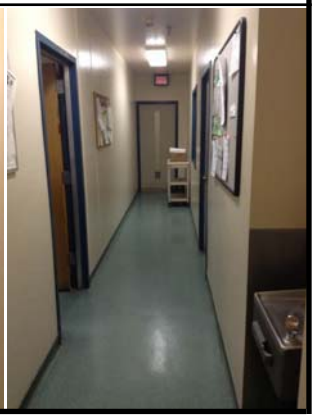
Issue	**Recommendation**
Audible Fire Alarm not provided in public or common use areas	Provide audible and visual fire alarm per current standards

ADA Reference:	
215.2	
CBC Reference:	
11B-215.2	
Floor:	2nd
Room:	Corridor
Location:	
Cost:	See *4
Duration:	See *4

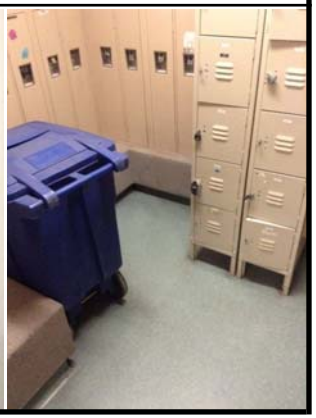
Issue	**Recommendation**
Door swings into room/turning space not provided	Provide turning space

ADA Reference:	
803.3	
CBC Reference:	
11B-803.3	
Floor:	2nd
Room:	Break room
Location:	Men -
Cost:	6000
Duration:	18 hrs

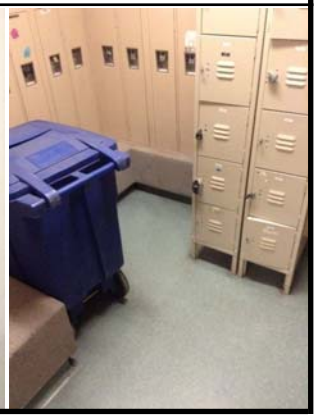
ADA Reference:	
803.2	
CBC Reference:	
11B-803.2	
Floor:	2nd
Room:	Break room
Location:	Men -
Cost:	4000
Duration:	20 hrs

806	Main Annex Jail	**Priority:**	1
Category	Landings/Thresholds

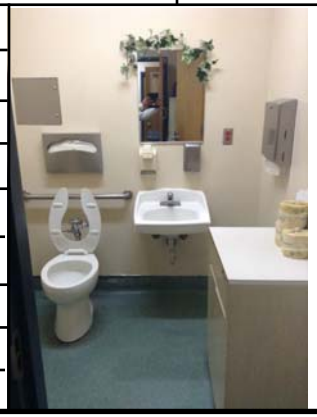
Issue	**Recommendation**
Water closet clearance not 60" wide measured perpendicular from the side wall	Provide required clearance or provide alternative accessible water closet

ADA Reference:	
604.3.1	
CBC Reference:	
11B-604.3.1	
Floor:	2nd
Room:	Break room
Location:	Men -
Cost:	2000
Duration:	10 hrs

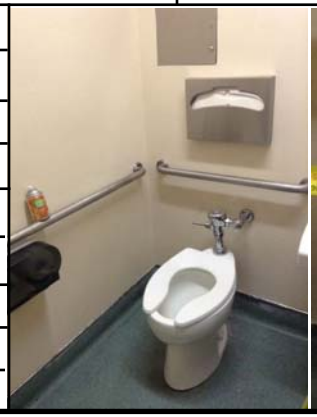
Issue	**Recommendation**
Water closet clearance not 60" wide measured perpendicular from the side wall	Provide required clearance or provide alternative accessible water closet

ADA Reference:	
604.3.1	
CBC Reference:	
11B-604.3.1	
Floor:	2nd
Room:	Break room
Location:	Men -
Cost:	2000
Duration:	10 hrs

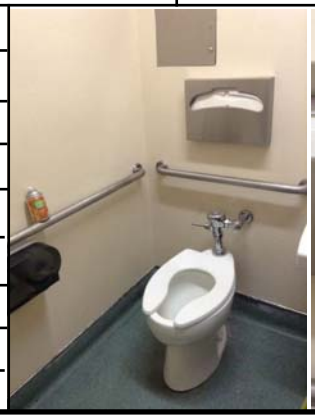
Issue	**Recommendation**
Toilet seat dispenser measured over 40" AFF to operable part	Reset accessories to maximum 40" AFF to operating controls

ADA Reference:	
N/A	
CBC Reference:	
11B-603.5	
Floor:	2nd
Room:	Break room
Location:	Men -
Cost:	50
Duration:	.5 hrs

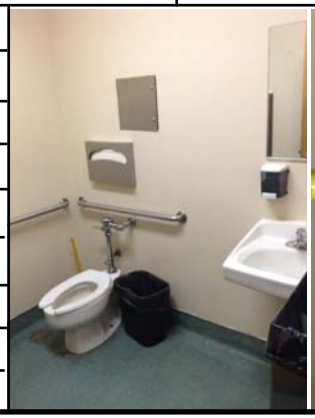
Issue	**Recommendation**
Water closet clearance not 60" wide measured perpendicular from the side wall	Provide required clearance or provide alternative accessible water closet

ADA Reference:	
604.3.1	
CBC Reference:	
11B-604.3.1	
Floor:	2nd
Room:	Break room
Location:	Women-
Cost:	2000
Duration:	10 hrs

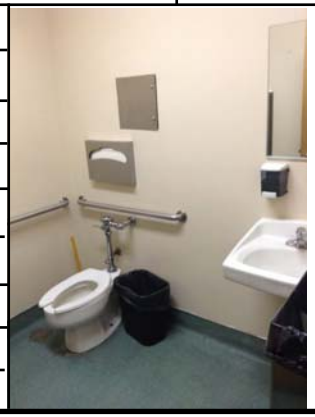
Issue	**Recommendation**
Flush controls not on open side of fixture (non-ambulatory accessible compartments)	Remove and replace water closet per current standards

ADA Reference:	
604.6	
CBC Reference:	
11B-604.6	
Floor:	2nd
Room:	Break room
Location:	Women-
Cost:	2000
Duration:	16 hrs

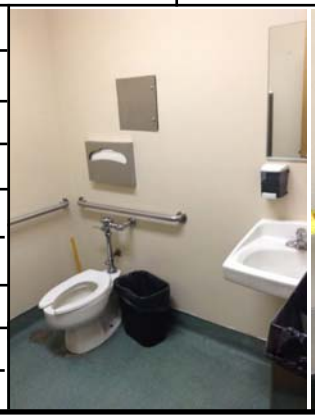
Issue	**Recommendation**
Sidewall grab bar minimum extension 54" from rear wall	Adjust as required and/or provide new bar per current standards

ADA Reference:	
604.5.1	
CBC Reference:	
11B-604.5.1	
Floor:	2nd
Room:	Break room
Location:	Women-
Cost:	300
Duration:	1.5

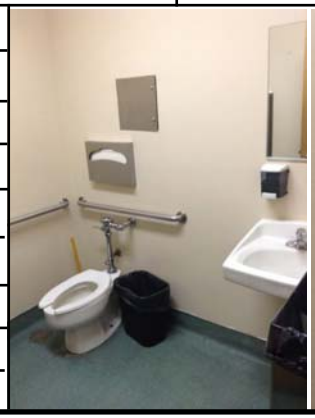
Issue	**Recommendation**
Soap dispenser measured over 40" AFF to operable part	Reset accessories to maximum 40" AFF to operating controls

ADA Reference:	
N/A	
CBC Reference:	
11B-603.5	
Floor:	2nd
Room:	Break room
Location:	Women-
Cost:	50
Duration:	.5 hrs

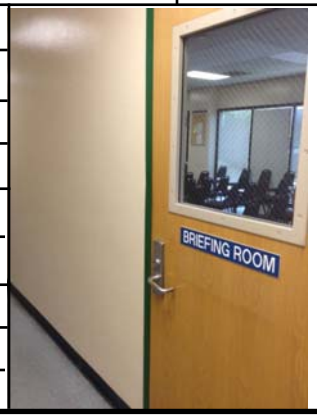
Issue	**Recommendation**
Room identification sign not provided in Braille	Provide sign per current standards

ADA Reference:	
703.3	
CBC Reference:	
11B-703.3	
Floor:	2nd
Room:	Briefing room
Location:	
Cost:	See *1
Duration:	See *1

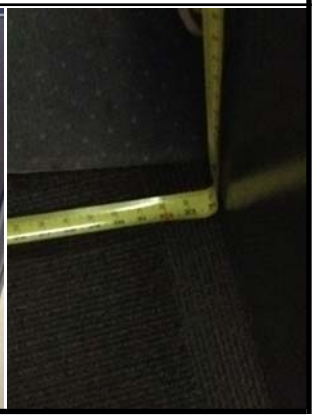
Issue	**Recommendation**
Minimum 36" clear width not provided/where serving occupant load less than 10	Provide 36" clear width

ADA Reference:	
403.5.1	
CBC Reference:	
11B-403.5.1	
Floor:	2nd
Room:	Lieutenant
Location:	
Cost:	200
Duration:	2 hrs

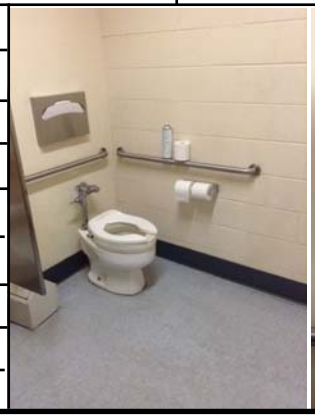
Issue	**Recommendation**
Toilet seat dispenser measured over 40" AFF to operable part	Reset accessories to maximum 40" AFF to operating controls

ADA Reference:	
N/A	
CBC Reference:	
11B-603.5	
Floor:	2nd
Room:	Staff Restroom
Location:	Unisex
Cost:	50
Duration:	.5 hrs

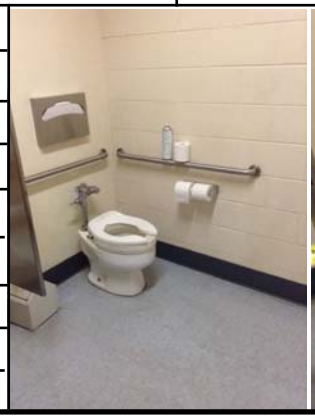
Issue	**Recommendation**
Water closet clearance not 60" wide measured perpendicular from the side wall	Provide required clearance or provide alternative accessible water closet

ADA Reference:	
604.3.1	
CBC Reference:	
11B-604.3.1	
Floor:	2nd
Room:	Staff Restroom
Location:	Unisex
Cost:	2000
Duration:	10 hrs

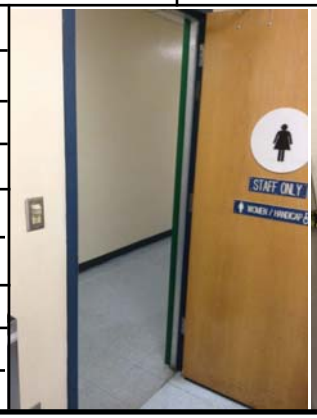
Issue	**Recommendation**
Minimum 18" maneuvering clearance on latch side (pull side, front approach) of interior door not provided	Provide minimum 18" maneuvering clearance

ADA Reference:	
404.2.4.1	
CBC Reference:	
11B-404.2.4.1	
Floor:	2nd
Room:	Staff Restroom
Location:	Women
Cost:	200
Duration:	2 hrs

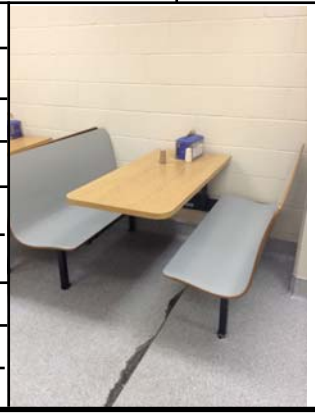
Issue	**Recommendation**
At least 5% of total seating is not accessible 16 Seats	Provide accessible seating spaces as required

ADA Reference:	
226.1	
CBC Reference:	
11B-226.1	
Floor:	2nd
Room:	Break room
Location:	
Cost:	2000
Duration:	10 hrs

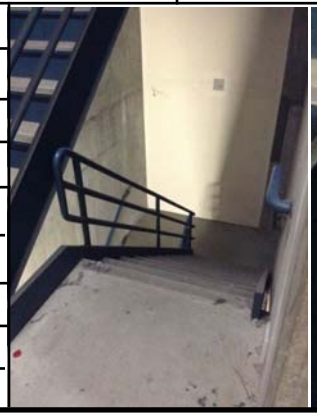
Issue	**Recommendation**
Height of handrail(s) less than 34" above nosing of threads	Provide handrails per current standards

ADA Reference:	
505.4	
CBC Reference:	
11B-505.4	
Floor:	2nd
Room:	Stairwell
Location:	Northwest
Cost:	5000
Duration:	20 hrs

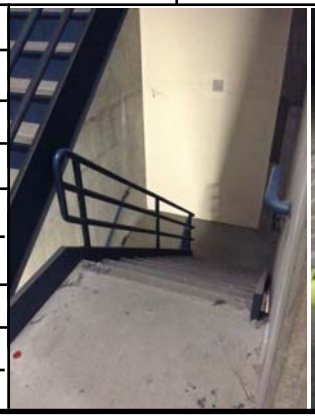
Issue	**Recommendation**
Width of stairs not 44" minimum	Provide stairs with minimum 44" width

ADA Reference:	
N/A	
CBC Reference:	
1009.4	
Floor:	2nd
Room:	Stairwell
Location:	Northwest
Cost:	N/A
Duration:	N/A

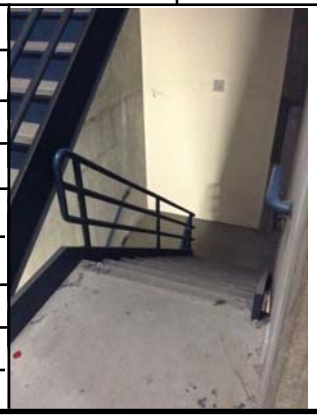
Issue	**Recommendation**
Extension of handrail at top stairs not 12" minimum of level distance (parallel with floor) beyond top nosing	Modify handrail(s) to provide required 12" extensions or replace per current standards

ADA Reference:	
505.10.2	
CBC Reference:	
11B-505.10.2	
Floor:	2nd
Room:	Stairwell
Location:	Northwest
Cost:	1500
Duration:	2 hrs

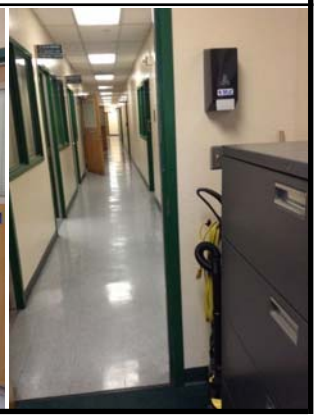
Issue	**Recommendation**
Minimum 18" maneuvering clearance on latch side (pull side, front approach) of interior door not provided	Provide minimum 18" maneuvering clearance

ADA Reference:	
404.2.4.1	
CBC Reference:	
11B-404.2.4.1	
Floor:	2nd
Room:	Conference
Location:	
Cost:	200
Duration:	2 hrs

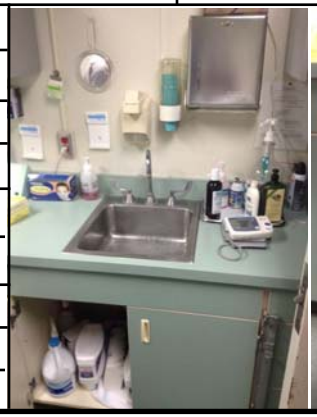
Issue	**Recommendation**
Height of rim or counter measured over 34" AFF	Reset sink/or provide maximum 34" AFF counter

ADA Reference:	
606.3	
CBC Reference:	
11B-606.3	
Floor:	2nd
Room:	Dental
Location:	
Cost:	1000
Duration:	8 hrs

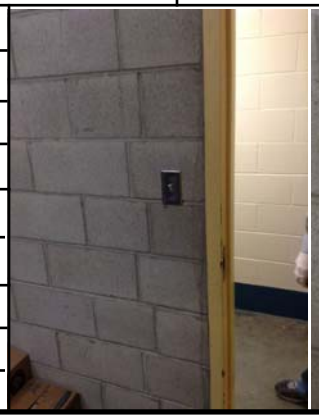
Issue	**Recommendation**
Switch measured over 48" AFF / measure to top of switch box	Provide occupancy room sensor or lower switch

ADA Reference:	
308.2.1	
CBC Reference:	
11B-308.2.1	
Floor:	3rd
Room:	Storage
Location:	North
Cost:	See *6
Duration:	See *6

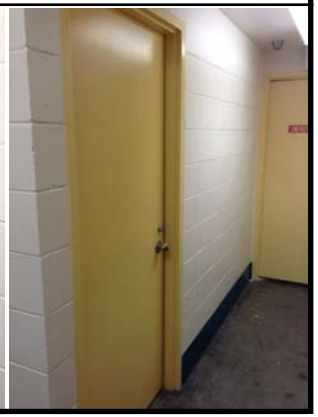
Issue	**Recommendation**
Lever-type hardware not provided	Remove and replace with lever-type hardware

ADA Reference:	
404.2.7	
CBC Reference:	
11B-404.2.7	
Floor:	3rd
Room:	Storage
Location:	
Cost:	500
Duration:	1 hr

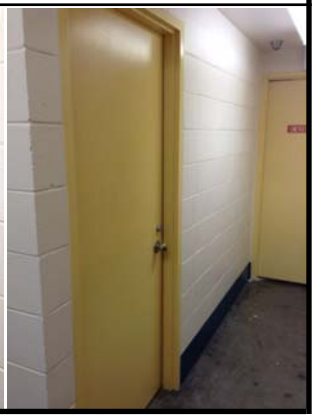
Issue	**Recommendation**
Room identification sign not provided in Braille	Provide sign per current standards

ADA Reference:	
703.3	
CBC Reference:	
11B-703.3	
Floor:	3rd
Room:	Storage
Location:	
Cost:	See *1
Duration:	See *1

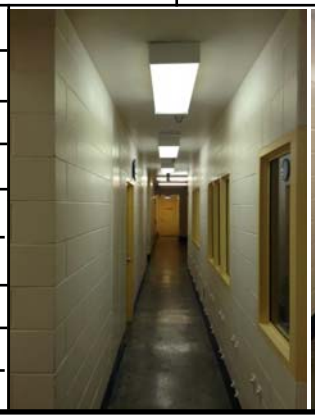
Issue	**Recommendation**
Audible Fire Alarm not provided in public or common use areas	Provide audible and visual fire alarm per current standards

ADA Reference:	
215.2	
CBC Reference:	
11B-215.2	
Floor:	3rd
Room:	Corridor
Location:	
Cost:	See *4
Duration:	See *4

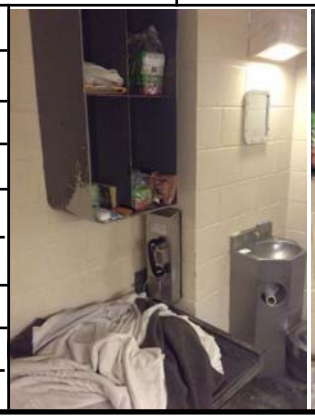
Issue	**Recommendation**
Maximum 48" AFF reach range exceeded /(forward unobstructed reach, 10" maximum reach depth)	Provide required reach range

ADA Reference:	
308.2.1	
CBC Reference:	
11B-308.2.1	
Floor:	3rd
Room:	Cell FF
Location:	Rear Cell
Cost:	See *10
Duration:	See *10

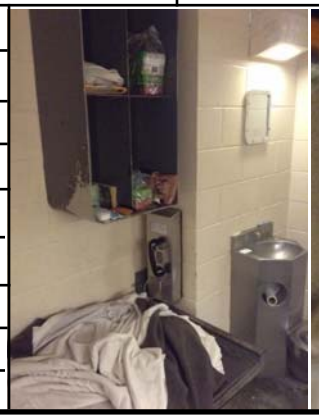
Issue	**Recommendation**
Clear floor space not provided for wheelchair accessible telephone	Reconfigure telephone location to provide required clear floor space

ADA Reference:	
704.2.1	
CBC Reference:	
11B-704.2.1	
Floor:	3rd
Room:	Cell FF
Location:	Rear Cell
Cost:	See *10
Duration:	See *10

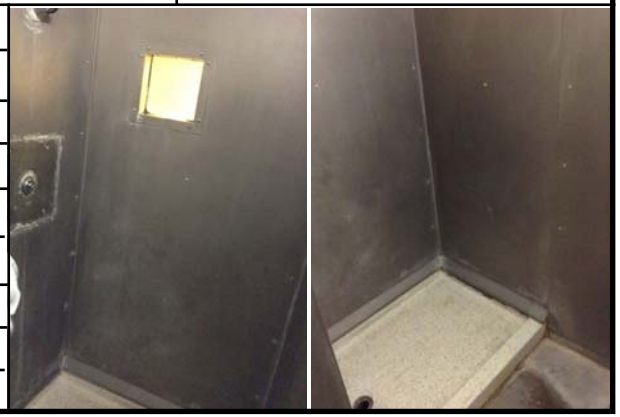
ADA Reference:	
N/A	
CBC Reference:	
11B-610.5	
Floor:	3rd
Room:	Shower
Location:	Rear Cell
Cost:	See *11
Duration:	See *11

994	Main Annex Jail	**Priority:**	2
Category	Detention Facility Showers

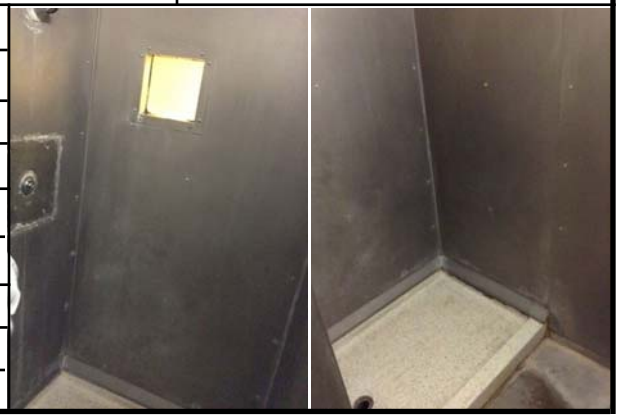
ADA Reference:	
608.3.2	
CBC Reference:	
11B-608.3.2	
Floor:	3rd
Room:	Shower
Location:	Rear Cell
Cost:	See *11
Duration:	See *11

995	Main Annex Jail	**Priority:**	2
Category	Detention Facility Showers

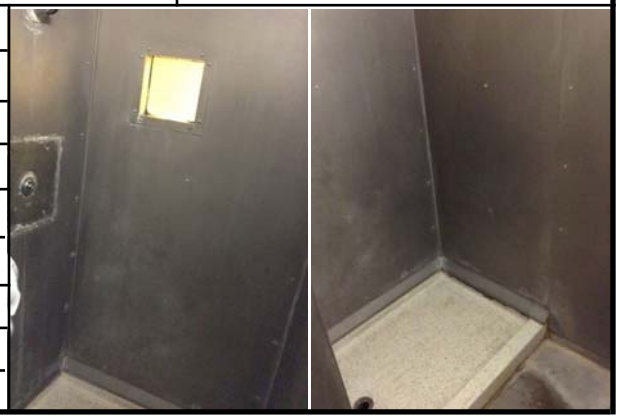
ADA Reference:	
608.3.2	
CBC Reference:	
11B-608.3.2	
Floor:	3rd
Room:	Shower
Location:	Rear Cell
Cost:	See *11
Duration:	See *11

997	Main Annex Jail	**Priority:**	2
Category	Detention Facility Accessories

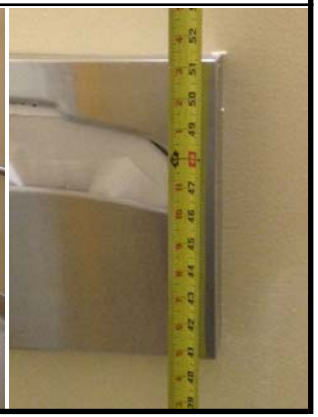
Issue	**Recommendation**
Toilet seat dispenser measured over 40" AFF to operable part	Reset accessories to maximum 40" AFF to operating controls

ADA Reference:	
N/A	
CBC Reference:	
11B-603.5	
Floor:	3rd
Room:	Staff Restroom
Location:	
Cost:	50
Duration:	.5 hrs

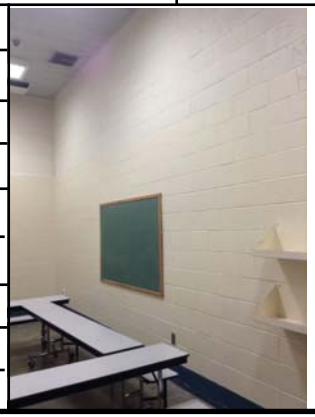
Issue	**Recommendation**
Audible Fire Alarm not provided in public or common use areas	Provide audible and visual fire alarm per current standards

ADA Reference:	
215.2	
CBC Reference:	
11B-215.2	
Floor:	3rd
Room:	Classroom
Location:	
Cost:	See *4
Duration:	See *4

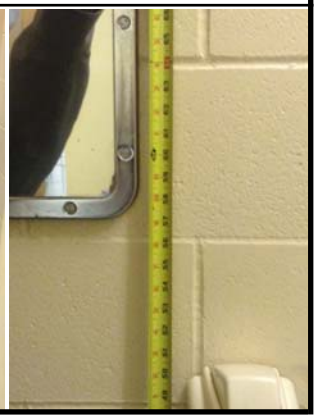
Issue	**Recommendation**
Mirror (not over lavatory) measured over 35" AFF to the bottom edge of the reflecting surface	Reset mirror to maximum 35" AFF to reflecting surface

ADA Reference:	
603.3	
CBC Reference:	
11B-603.3	
Floor:	3rd
Room:	Infirmary
Location:	Restroom
Cost:	100
Duration:	1 hr

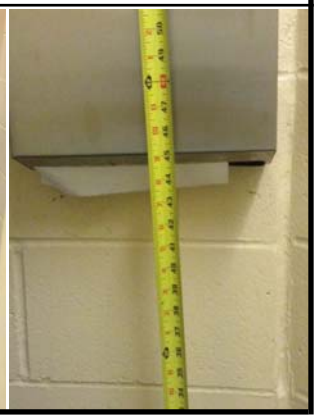
Issue	**Recommendation**
Towel dispenser measured over 40" AFF to operable part	Reset accessories to maximum 40" AFF to operating controls

ADA Reference:	
N/A	
CBC Reference:	
11B-603.5	
Floor:	3rd
Room:	Infirmary
Location:	Restroom
Cost:	50
Duration:	.5 hrs

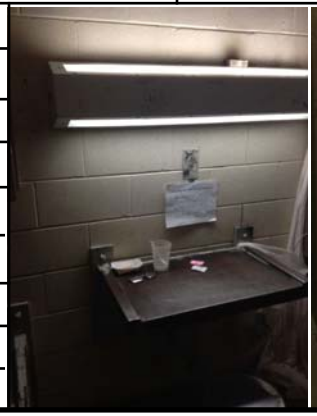
Issue	**Recommendation**
Maximum 48" AFF reach range exceeded /(forward unobstructed reach, 10" maximum reach depth)	Provide required reach range

ADA Reference:	
308.2.1	
CBC Reference:	
11B-308.2.1	
Floor:	3rd
Room:	Pod - A
Location:	Cell
Cost:	See *9
Duration:	See *9

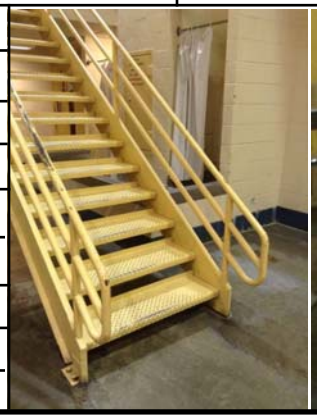
Issue	**Recommendation**
Height of handrail(s) less than 34" above nosing of threads	Provide handrails per current standards

ADA Reference:	
505.4	
CBC Reference:	
11B-505.4	
Floor:	3rd
Room:	Pod - A
Location:	
Cost:	5000
Duration:	20 hrs

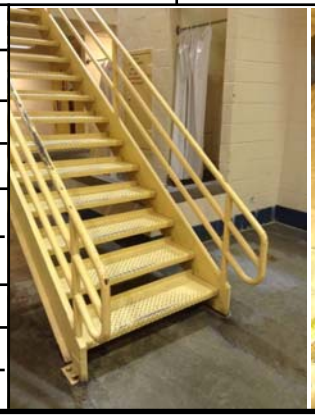
Issue	**Recommendation**
Width of stairs not 44" minimum	Provide stairs with minimum 44" width

ADA Reference:	
N/A	
CBC Reference:	
1009.4	
Floor:	3rd
Room:	Pod - A
Location:	
Cost:	N/A
Duration:	N/A

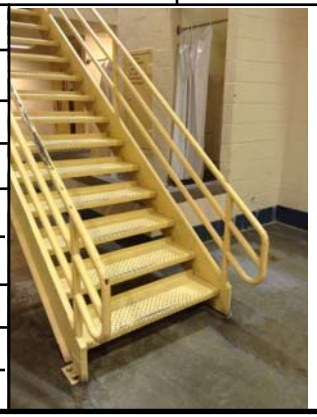
Issue	**Recommendation**
Open risers provided interior stairways only	Install closer strip at open risers or remove and replace stairs for compliance

ADA Reference:	
504.3	
CBC Reference:	
11B-504.3	
Floor:	3rd
Room:	Pod - A
Location:	
Cost:	6000
Duration:	30 hrs

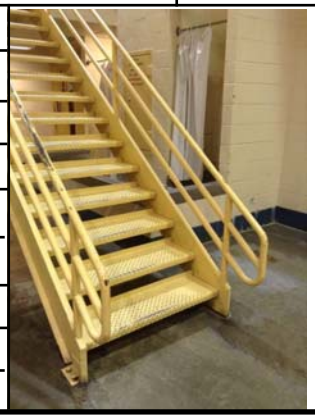
Issue	**Recommendation**
Extension of handrail at bottom of stairs not a minimum of tread width; plus 12" beyond bottom nosing horizontal with ground or floor surface	Modify handrail(s) to provide required extensions or replace per current standards

ADA Reference:	
505.10.3	
CBC Reference:	
11B-505.10.3	
Floor:	3rd
Room:	Pod - A
Location:	
Cost:	1500
Duration:	2 hrs

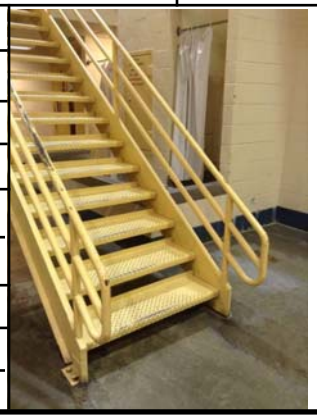
Issue	**Recommendation**
Vertical clearance not 80" high minimum	Provide required vertical clearance

ADA Reference:	
307.4	
CBC Reference:	
11B-307.4	
Floor:	3rd
Room:	Pod - A
Location:	
Cost:	10000
Duration:	50 hrs

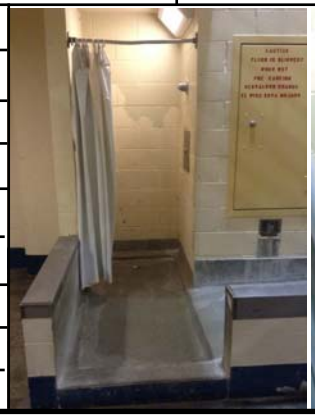
Issue	**Recommendation**
Folding seat not provided	Provide folding seat

ADA Reference:	
N/A	
CBC Reference:	
11B-610.5	
Floor:	3rd
Room:	Pod - A
Location:	Shower
Cost:	See *7
Duration:	See *7

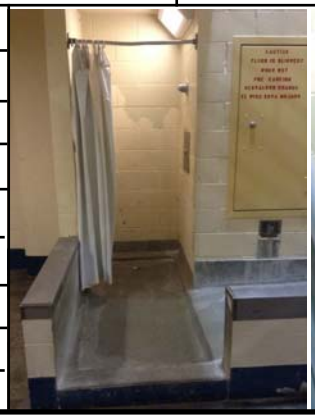
Issue	**Recommendation**
Grab bar not provided on side wall opposite of entry in alternate shower	Adjust as required and/or provide new bar per current standards

ADA Reference:	
608.3.3	
CBC Reference:	
11B-608.3.3	
Floor:	3rd
Room:	Pod - A
Location:	Shower
Cost:	See *7
Duration:	See *7

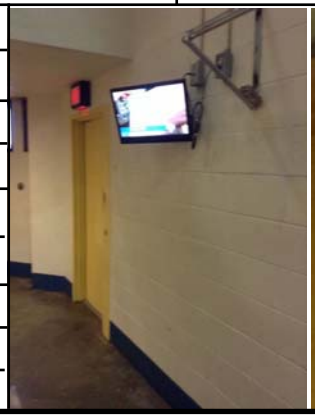
Issue	**Recommendation**
Objects with leading edges more than 27" and no more than 80" AFF shall protrude 4" maximum horizontally into the circulation path	Provide required clearance/adjust as required

ADA Reference:	
307.2	
CBC Reference:	
11B-307.2	
Floor:	3rd
Room:	Pod - B
Location:	
Cost:	500
Duration:	5 hrs

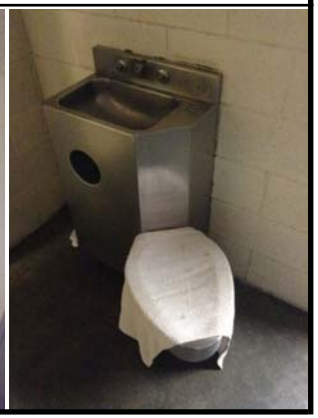
Issue	**Recommendation**
Grab bars not provided on rear wall	Provide required grab bar

ADA Reference:	
604.5	
CBC Reference:	
11B-604.5	
Floor:	3rd
Room:	Pod - B
Location:	Cell
Cost:	See *9
Duration:	See *9

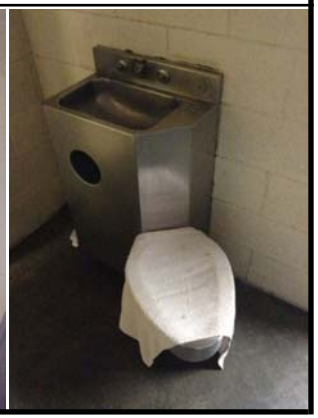
Issue	**Recommendation**
Grab bars not provided on sidewall	Provide required grab bar

ADA Reference:	
604.5	
CBC Reference:	
11B-604.5	
Floor:	3rd
Room:	Pod - B
Location:	Cell
Cost:	See *9
Duration:	See *9

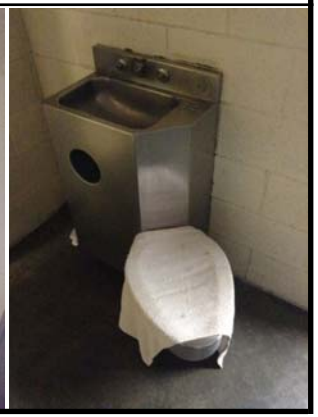
Issue	**Recommendation**
Centerline of toilet not 17"-18" from sidewall or partition in wheel chair accessible toilet compartment	Relocate/adjust as required

ADA Reference:	
N/A	
CBC Reference:	
11B-604.2	
Floor:	3rd
Room:	Pod - B
Location:	Cell
Cost:	See *9
Duration:	See *9

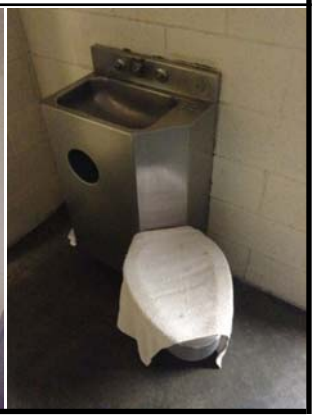
Issue	**Recommendation**
Minimum 29" clearance under lavatory apron not provided (measured at front edge)	Reset lavatory as required

ADA Reference:	
N/A	
CBC Reference:	
11B-606.2	
Floor:	3rd
Room:	Pod - B
Location:	Cell
Cost:	See *9
Duration:	See *9

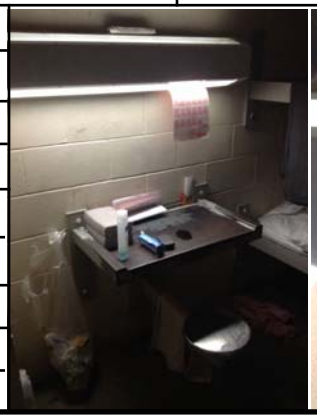
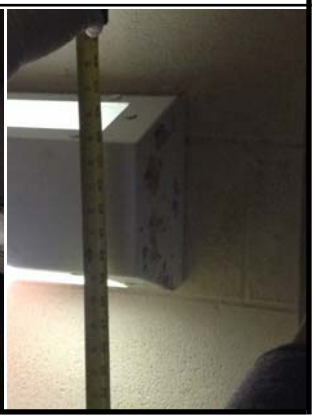
Issue	**Recommendation**
Maximum 48" AFF reach range exceeded /(forward unobstructed reach, 10" maximum reach depth)	Provide required reach range

ADA Reference:	
308.2.1	
CBC Reference:	
11B-308.2.1	
Floor:	3rd
Room:	Pod - B
Location:	Cell
Cost:	See *9
Duration:	See *9

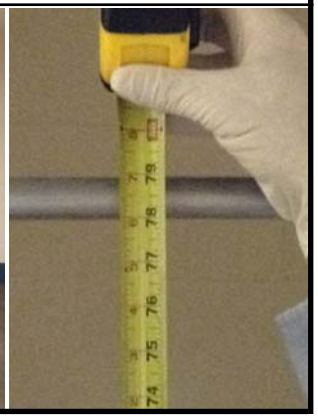
Issue	**Recommendation**
Vertical clearance not 80" high minimum	Provide required vertical clearance

ADA Reference:	
307.4	
CBC Reference:	
11B-307.4	
Floor:	3rd
Room:	Pod - B
Location:	Shower
Cost:	See *7
Duration:	See *7

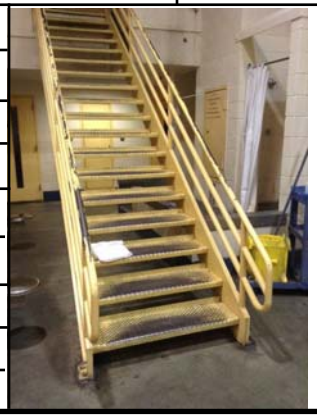
Issue	**Recommendation**
Open risers provided interior stairways only	Install closer strip at open risers or remove and replace stairs for compliance

ADA Reference:	
504.3	
CBC Reference:	
11B-504.3	
Floor:	3rd
Room:	Pod - C
Location:	
Cost:	6000
Duration:	30 hrs

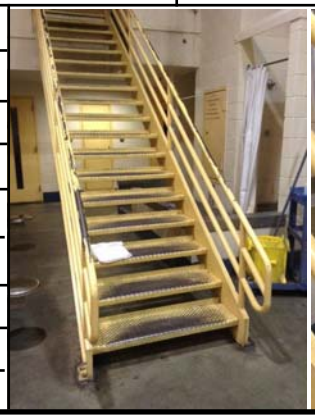
Issue	**Recommendation**
Height of handrail(s) less than 34" above nosing of threads	Provide handrails per current standards

ADA Reference:	
505.4	
CBC Reference:	
11B-505.4	
Floor:	3rd
Room:	Pod - C
Location:	
Cost:	5000
Duration:	20 hrs

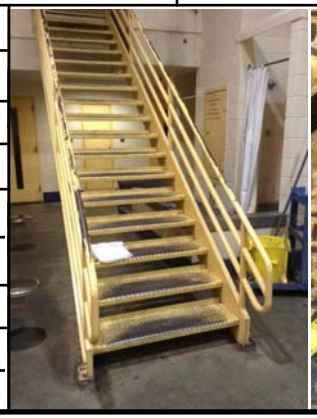
Issue	**Recommendation**
Width of stairs not 44" minimum	Provide stairs with minimum 44" width

ADA Reference:	
N/A	
CBC Reference:	
1009.4	
Floor:	3rd
Room:	Pod - C
Location:	
Cost:	N/A
Duration:	N/A

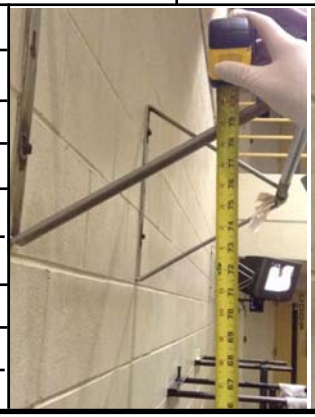
Issue	**Recommendation**
Objects with leading edges more than 27" and no more than 80" AFF shall protrude 4" maximum horizontally into the circulation path	Provide required clearance/adjust as required

ADA Reference:	
307.2	
CBC Reference:	
11B-307.2	
Floor:	3rd
Room:	Pod - C
Location:	
Cost:	500
Duration:	5 hrs

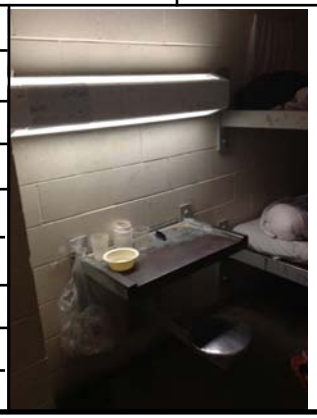
Issue	**Recommendation**
Required 30" by 48" clear floor space not provided at accessible seating spaces	Provide required clear floor space at accessible seating

ADA Reference:	
902.2	
CBC Reference:	
11B-902.2	
Floor:	3rd
Room:	Pod - C
Location:	Cell
Cost:	See *9
Duration:	See *9

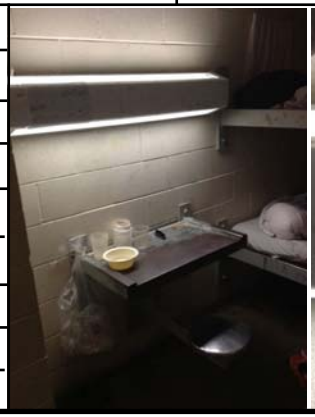
Issue	**Recommendation**
Maximum 48" AFF reach range exceeded /(forward unobstructed reach, 10" maximum reach depth)	Provide required reach range

ADA Reference:	
308.2.1	
CBC Reference:	
11B-308.2.1	
Floor:	3rd
Room:	Pod - C
Location:	Cell
Cost:	See *9
Duration:	See *9

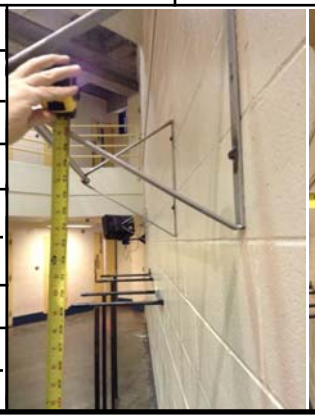
Issue	**Recommendation**
Objects with leading edges more than 27" and no more than 80" AFF shall protrude 4" maximum horizontally into the circulation path	Provide required clearance/adjust as required

ADA Reference:	
307.2	
CBC Reference:	
11B-307.2	
Floor:	3rd
Room:	Pod - D
Location:	
Cost:	500
Duration:	5 hrs

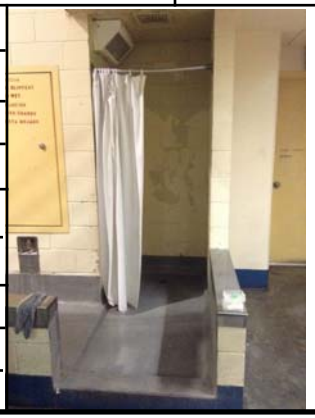
Issue	**Recommendation**
Threshold into shower greater than 1/2" height	Provide transition into shower

ADA Reference:	
608.7	
CBC Reference:	
11B-608.7	
Floor:	3rd
Room:	Pod - D
Location:	Shower
Cost:	See *7
Duration:	See *7

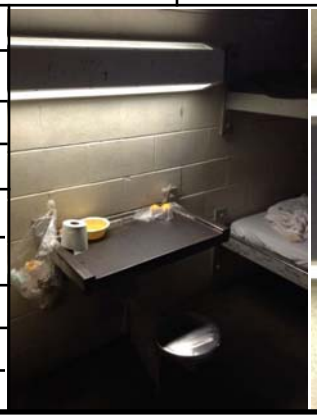
Issue	**Recommendation**
Maximum 48" AFF reach range exceeded /(forward unobstructed reach, 10" maximum reach depth)	Provide required reach range

ADA Reference:	
308.2.1	
CBC Reference:	
11B-308.2.1	
Floor:	3rd
Room:	Pod - D
Location:	Cell
Cost:	See *9
Duration:	See *9

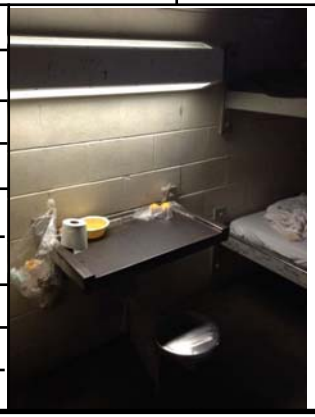
Issue	**Recommendation**
Required 30" by 48" clear floor space not provided at accessible seating spaces	Provide required clear floor space at accessible seating

ADA Reference:	
902.2	
CBC Reference:	
11B-902.2	
Floor:	3rd
Room:	Pod - D
Location:	Cell
Cost:	See *9
Duration:	See *9

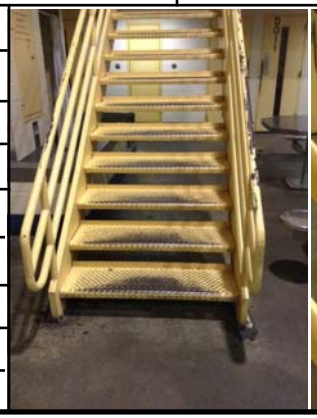
Issue	**Recommendation**
Height of handrail(s) less than 34" above nosing of threads	Provide handrails per current standards

ADA Reference:	
505.4	
CBC Reference:	
11B-505.4	
Floor:	3rd
Room:	Pod - D
Location:	
Cost:	5000
Duration:	20 hrs

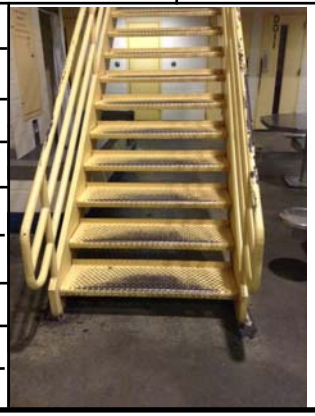
Issue	**Recommendation**
Vertical clearance not 80" high minimum	Provide required vertical clearance

ADA Reference:	
307.4	
CBC Reference:	
11B-307.4	
Floor:	3rd
Room:	Pod - D
Location:	
Cost:	10000
Duration:	50 hrs

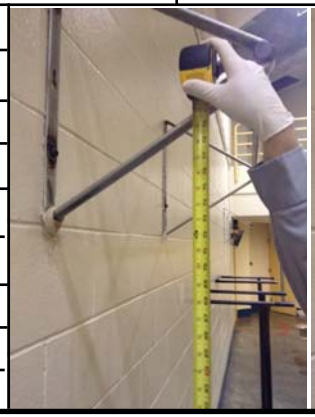
Issue	**Recommendation**
Objects with leading edges more than 27" and no more than 80" AFF shall protrude 4" maximum horizontally into the circulation path	Provide required clearance/adjust as required

ADA Reference:	
307.2	
CBC Reference:	
11B-307.2	
Floor:	3rd
Room:	Pod - E
Location:	
Cost:	500
Duration:	5 hrs

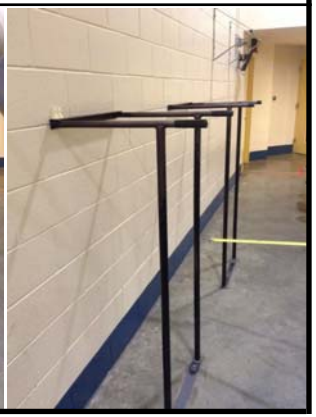
Issue	**Recommendation**
Objects with leading edges more than 27" and no more than 80" AFF shall protrude 4" maximum horizontally into the circulation path	Provide required clearance/adjust as required

ADA Reference:	
307.2	
CBC Reference:	
11B-307.2	
Floor:	3rd
Room:	Pod - E
Location:	
Cost:	500
Duration:	5 hrs

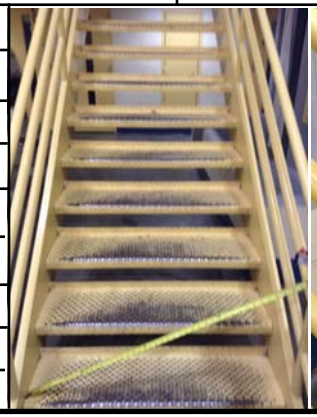
Issue	**Recommendation**
Height of handrail(s) less than 34" above nosing of threads	Provide handrails per current standards

ADA Reference:	
505.4	
CBC Reference:	
11B-505.4	
Floor:	3rd
Room:	Pod - E
Location:	
Cost:	5000
Duration:	20 hrs

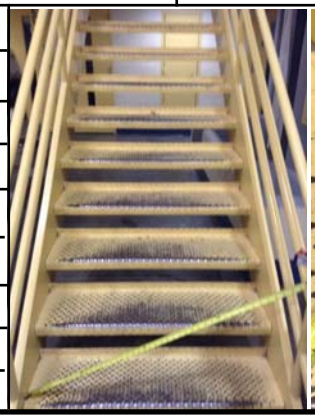
Issue	**Recommendation**
Width of stairs not 44" minimum	Provide stairs with minimum 44" width

ADA Reference:	
N/A	
CBC Reference:	
1009.4	
Floor:	3rd
Room:	Pod - E
Location:	
Cost:	N/A
Duration:	N/A

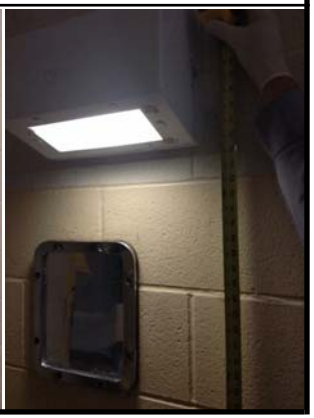
Issue	**Recommendation**
Mirror over lavatory or countertop measured over 40" AFF to the bottom edge of the reflecting surface	Reset mirror to maximum 40" AFF to reflecting surface

ADA Reference:	
603.3	
CBC Reference:	
11B-603.3	
Floor:	3rd
Room:	Pod - E
Location:	Cell
Cost:	See *9
Duration:	See *9

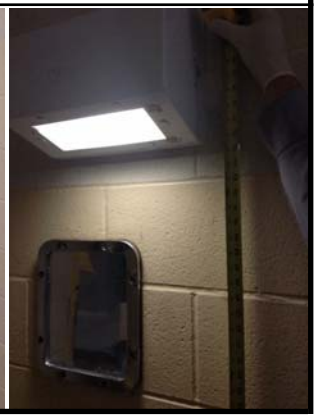
Issue	**Recommendation**
Maximum 48" AFF reach range exceeded /(forward unobstructed reach, 10" maximum reach depth)	Provide required reach range

ADA Reference:	
308.2.1	
CBC Reference:	
11B-308.2.1	
Floor:	3rd
Room:	Pod - E
Location:	Cell
Cost:	See *9
Duration:	See *9

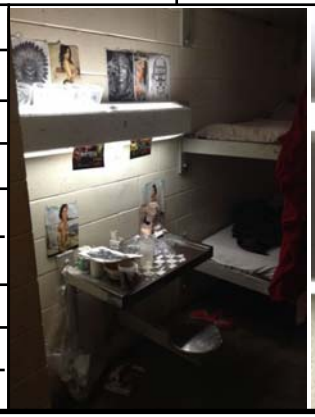
Issue	**Recommendation**
Maximum 48" AFF reach range exceeded /(forward unobstructed reach, 10" maximum reach depth)	Provide required reach range

ADA Reference:	
308.2.1	
CBC Reference:	
11B-308.2.1	
Floor:	3rd
Room:	Pod - E
Location:	Cell
Cost:	See *9
Duration:	See *9

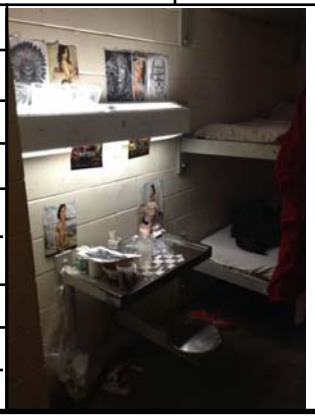
Issue	**Recommendation**
Required 30" by 48" clear floor space not provided at accessible seating spaces	Provide required clear floor space at accessible seating

ADA Reference:	
902.2	
CBC Reference:	
11B-902.2	
Floor:	3rd
Room:	Pod - E
Location:	Cell
Cost:	See *9
Duration:	See *9

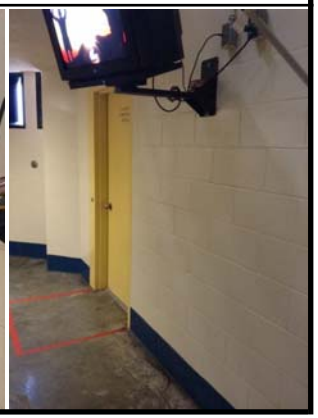
Issue	**Recommendation**
Objects with leading edges more than 27" and no more than 80" AFF shall protrude 4" maximum horizontally into the circulation path	Provide required clearance/adjust as required

ADA Reference:	
307.2	
CBC Reference:	
11B-307.2	
Floor:	3rd
Room:	Pod - F
Location:	
Cost:	500
Duration:	5 hrs

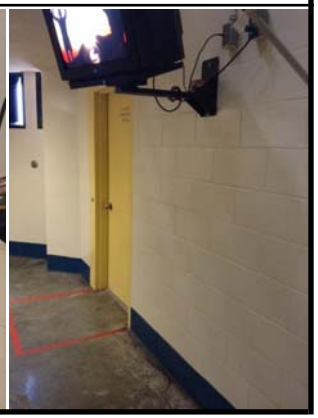
ADA Reference:	
308.2.1	
CBC Reference:	
11B-308.2.1	
Floor:	3rd
Room:	Pod - F
Location:	
Cost:	1000
Duration:	5 hrs

1237	Main Annex Jail	**Priority:**	1
Category	Accessible Path of Travel

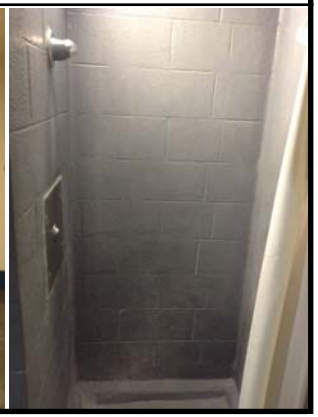
Issue	**Recommendation**
Folding seat not provided	Provide folding seat

ADA Reference:	
N/A	
CBC Reference:	
11B-610.5	
Floor:	3rd
Room:	Pod - F
Location:	Shower
Cost:	See *7
Duration:	See *7

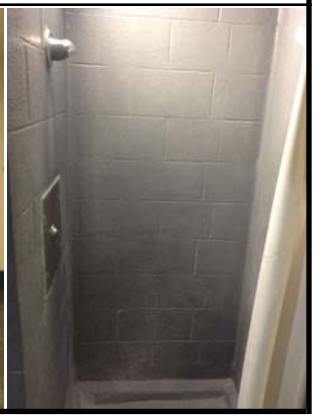
Issue	**Recommendation**
Grab bar not provided on back wall for standard or alternate shower	Provide new bar per current standards

ADA Reference:	
608.3.2	
CBC Reference:	
11B-608.3.2	
Floor:	3rd
Room:	Pod - F
Location:	Shower
Cost:	See *7
Duration:	See *7

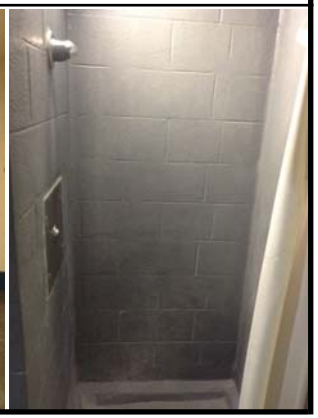
Issue	**Recommendation**
Grab bar not provided on side wall opposite of entry in alternate shower	Adjust as required and/or provide new bar per current standards

ADA Reference:	
608.3.3	
CBC Reference:	
11B-608.3.3	
Floor:	3rd
Room:	Pod - F
Location:	Shower
Cost:	See *7
Duration:	See *7

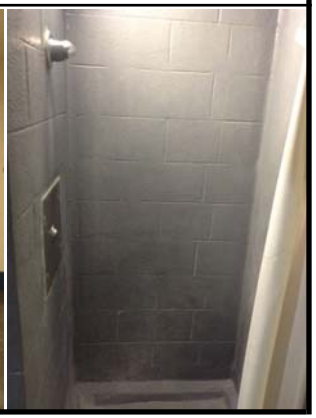
Issue	**Recommendation**
Grab bar not provided on side wall opposite of seat in standard shower	Provide new bar per current standards

ADA Reference:	
608.3.2	
CBC Reference:	
11B-608.3.2	
Floor:	3rd
Room:	Pod - F
Location:	Shower
Cost:	See *7
Duration:	See *7

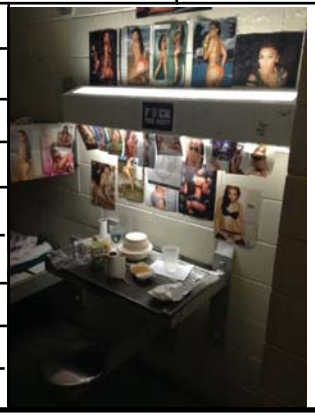
Issue	**Recommendation**
Required 30" by 48" clear floor space not provided at accessible seating spaces	Provide required clear floor space at accessible seating

ADA Reference:	
902.2	
CBC Reference:	
11B-902.2	
Floor:	3rd
Room:	Pod - F
Location:	Cell
Cost:	See *9
Duration:	See *9

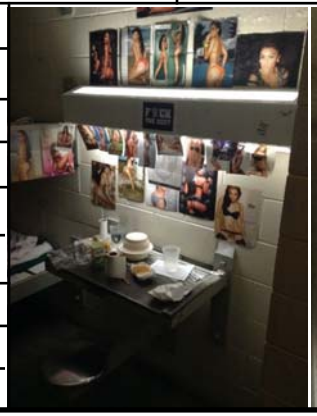
Issue	**Recommendation**
Maximum 48" AFF reach range exceeded /(forward unobstructed reach, 10" maximum reach depth)	Provide required reach range

ADA Reference:	
308.2.1	
CBC Reference:	
11B-308.2.1	
Floor:	3rd
Room:	Pod - F
Location:	Cell
Cost:	See *9
Duration:	See *9

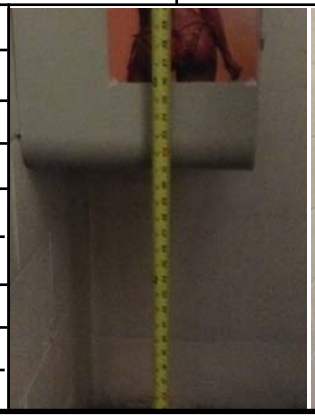
Issue	**Recommendation**
Objects with leading edges more than 27" and no more than 80" AFF shall protrude 4" maximum horizontally into the circulation path	Provide required clearance/adjust as required

ADA Reference:	
307.2	
CBC Reference:	
11B-307.2	
Floor:	3rd
Room:	Pod - F
Location:	Cell
Cost:	See *9
Duration:	See *9
