County of Fresno

Main Annex Jail
ADA Transition Plan

LARS ANDERSEN & ASSOCIATES, INC.

JUNE 30, 2014

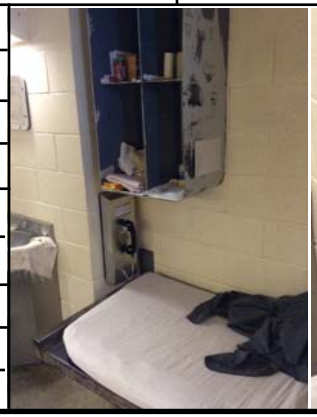
Issue	**Recommendation**
At least one TTY not provided in a secured area of a correctional facility if a public phone for detainees is provided	Provide accessible TTY per current standards

ADA Reference:	
217.4.8	
CBC Reference:	
11B-217.4.8	
Floor:	4th
Room:	Cell FF
Location:	Rear Cell
Cost:	See *5
Duration:	See *5

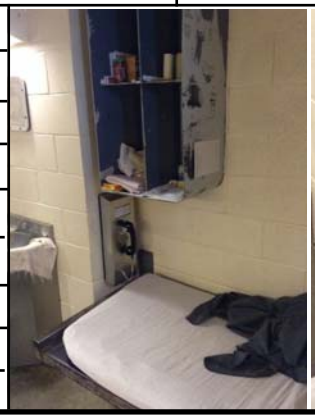
Issue	**Recommendation**
Clear floor space not provided for wheelchair accessible telephone	Reconfigure telephone location to provide required clear floor space

ADA Reference:	
704.2.1	
CBC Reference:	
11B-704.2.1	
Floor:	4th
Room:	Cell FF
Location:	Rear Cell
Cost:	See *10
Duration:	See *10

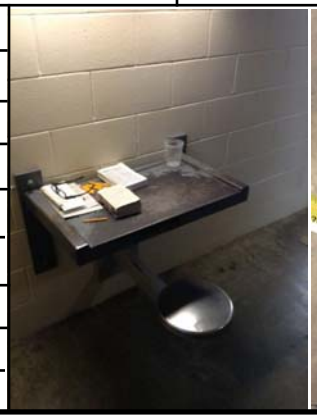
Issue	**Recommendation**
Required 30" by 48" clear floor space not provided at accessible seating spaces	Provide required clear floor space at accessible seating

ADA Reference:	
902.2	
CBC Reference:	
11B-902.2	
Floor:	4th
Room:	Cell FF
Location:	Rear Cell
Cost:	See *10
Duration:	See *10

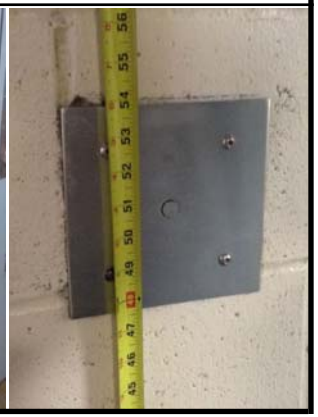
Issue	**Recommendation**
Maximum 48" AFF reach range exceeded /(forward unobstructed reach, 10" maximum reach depth)	Provide required reach range

ADA Reference:	
308.2.1	
CBC Reference:	
11B-308.2.1	
Floor:	4th
Room:	Cell FF
Location:	Rear Cell
Cost:	See *10
Duration:	See *10

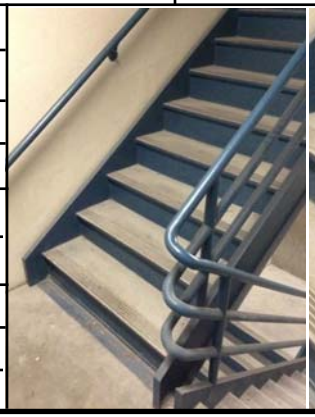
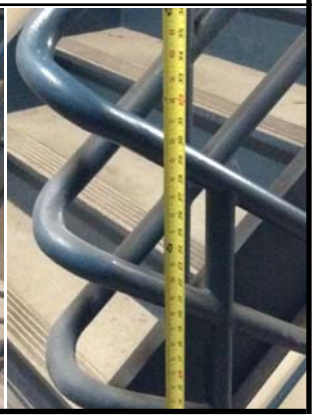
Issue	**Recommendation**
Height of handrail(s) less than 34" above nosing of threads	Provide handrails per current standards

ADA Reference:	
505.4	
CBC Reference:	
11B-505.4	
Floor:	4th
Room:	Stairwell
Location:	Southwest
Cost:	5000
Duration:	20 hrs

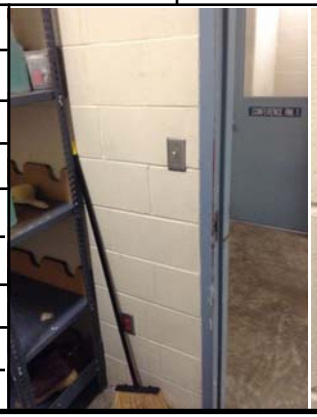
Issue	**Recommendation**
Switch measured over 48" AFF / measure to top of switch box	Provide occupancy room sensor or lower switch

ADA Reference:	
308.2.1	
CBC Reference:	
11B-308.2.1	
Floor:	4th
Room:	Janitor
Location:	
Cost:	See *6
Duration:	See *6

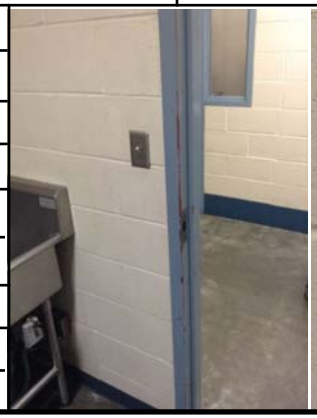
Issue	**Recommendation**
Switch measured over 48" AFF / measure to top of switch box	Provide occupancy room sensor or lower switch

ADA Reference:	
308.2.1	
CBC Reference:	
11B-308.2.1	
Floor:	4th
Room:	Scullery
Location:	
Cost:	See *6
Duration:	See *6

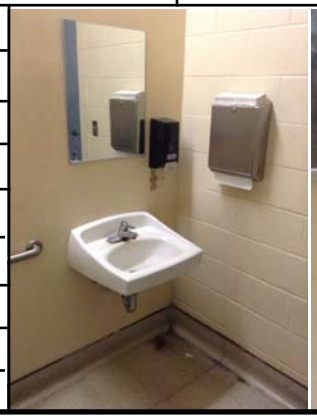
Issue	**Recommendation**
Soap dispenser measured over 40" AFF to operable part	Reset accessories to maximum 40" AFF to operating controls

ADA Reference:	
N/A	
CBC Reference:	
11B-603.5	
Floor:	4th
Room:	Staff Restroom
Location:	
Cost:	50
Duration:	.5 hrs

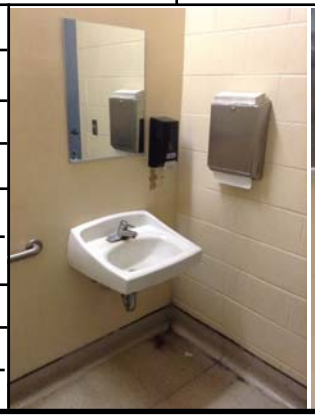
Issue	**Recommendation**
Mirror over lavatory or countertop measured over 40" AFF to the bottom edge of the reflecting surface	Reset mirror to maximum 40" AFF to reflecting surface

ADA Reference:	
603.3	
CBC Reference:	
11B-603.3	
Floor:	4th
Room:	Staff Restroom
Location:	
Cost:	100
Duration:	1 hr

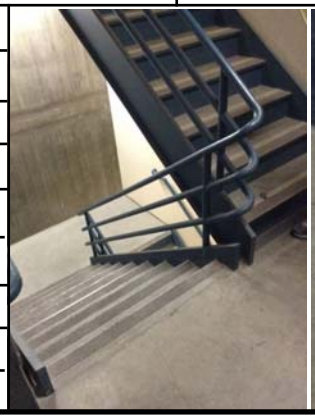
Issue	**Recommendation**
Width of stairs not 44" minimum	Provide stairs with minimum 44" width

ADA Reference:	
N/A	
CBC Reference:	
1009.4	
Floor:	4th
Room:	Stairwell
Location:	North
Cost:	N/A
Duration:	N/A

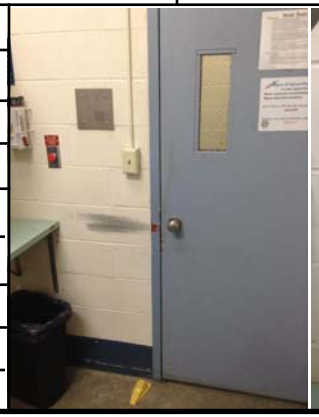
Issue	**Recommendation**
Switch measured over 48" AFF / measure to top of switch box	Provide occupancy room sensor or lower switch

ADA Reference:	
308.2.1	
CBC Reference:	
11B-308.2.1	
Floor:	4th
Room:	Infirmary
Location:	
Cost:	See *6
Duration:	See *6

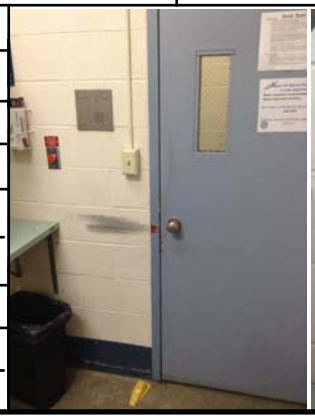
Issue	**Recommendation**
Maximum 48" AFF reach range exceeded /(forward unobstructed reach, 10" maximum reach depth)	Provide required reach range

ADA Reference:	
308.2.1	
CBC Reference:	
11B-308.2.1	
Floor:	4th
Room:	Infirmary
Location:	
Cost:	See *6
Duration:	See *6

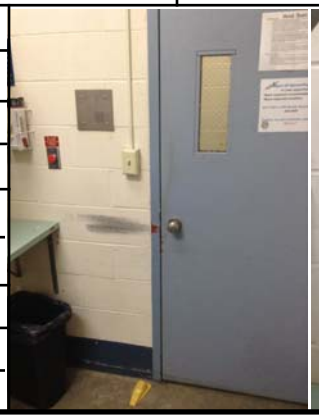
Issue	**Recommendation**
Maximum 48" AFF reach range exceeded /(forward unobstructed reach, 10" maximum reach depth)	Provide required reach range

ADA Reference:	
308.2.1	
CBC Reference:	
11B-308.2.1	
Floor:	4th
Room:	Infirmary
Location:	
Cost:	See *6
Duration:	See *6

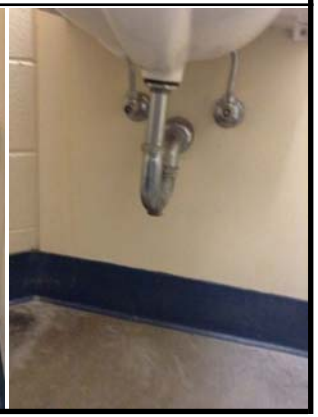
Issue	**Recommendation**
Drain and/or hot water piping not insulated (wrapped)	Insulate as required to protect against contact

ADA Reference:	
606.5	
CBC Reference:	
11B-606.5	
Floor:	4th
Room:	Infirmary
Location:	Restroom
Cost:	50
Duration:	.25 hrs

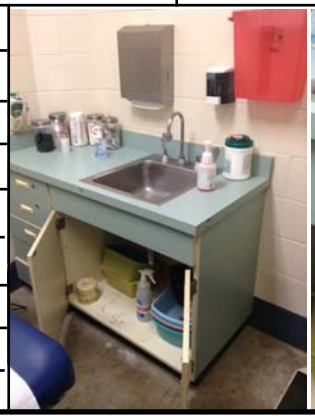
Issue	**Recommendation**
Height of rim or counter measured over 34" AFF	Reset sink/or provide maximum 34" AFF counter

ADA Reference:	
606.3	
CBC Reference:	
11B-606.3	
Floor:	4th
Room:	Infirmary
Location:	
Cost:	1000
Duration:	8 hrs

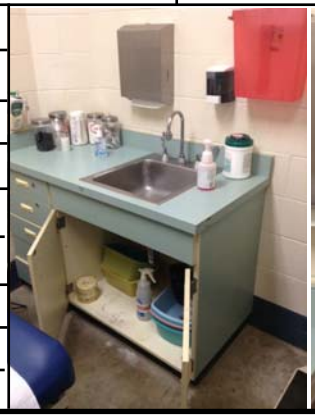
Issue	**Recommendation**
Maximum 44" AFF front obstructed reach range exceeded when obstruction depth is between 20"-25"	Provide required reach range

ADA Reference:	
308.2.2	
CBC Reference:	
11B-308.2.2	
Floor:	4th
Room:	Infirmary
Location:	
Cost:	50
Duration:	.5 hrs

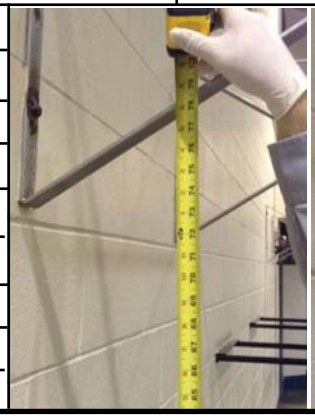
Issue	**Recommendation**
Objects with leading edges more than 27" and no more than 80" AFF shall protrude 4" maximum horizontally into the circulation path	Provide required clearance/adjust as required

ADA Reference:	
307.2	
CBC Reference:	
11B-307.2	
Floor:	4th
Room:	Pod - A
Location:	
Cost:	500
Duration:	5 hrs

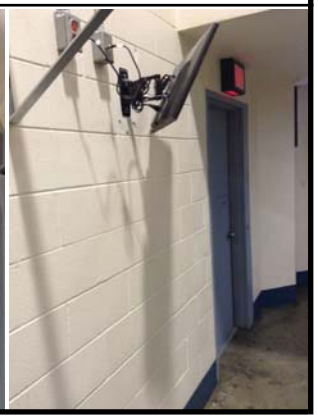
Issue	**Recommendation**
Objects with leading edges more than 27" and no more than 80" AFF shall protrude 4" maximum horizontally into the circulation path	Provide required clearance/adjust as required

ADA Reference:	
307.2	
CBC Reference:	
11B-307.2	
Floor:	4th
Room:	Pod - A
Location:	
Cost:	500
Duration:	5 hrs

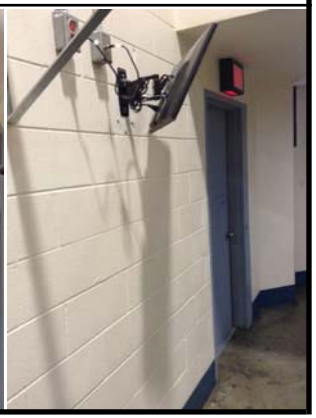
Issue	**Recommendation**
Maximum 48" AFF reach range exceeded /(forward unobstructed reach, 10" maximum reach depth)	Provide required reach range

ADA Reference:	
308.2.1	
CBC Reference:	
11B-308.2.1	
Floor:	4th
Room:	Pod - A
Location:	
Cost:	1000
Duration:	5 hrs

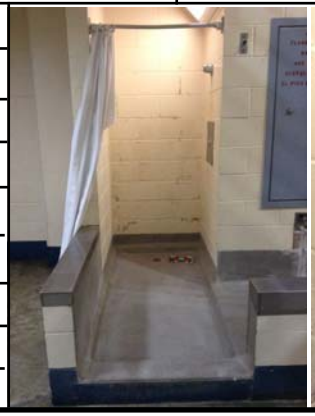
Issue	**Recommendation**
Centerline of water control not 39"-41" above shower floor and top of unit not greater than 48"	Adjust as required

ADA Reference:
N/A
CBC Reference:
11B-608.5.2

Floor:	4th
Room:	Pod - A
Location:	Shower
Cost:	See *7
Duration:	See *7

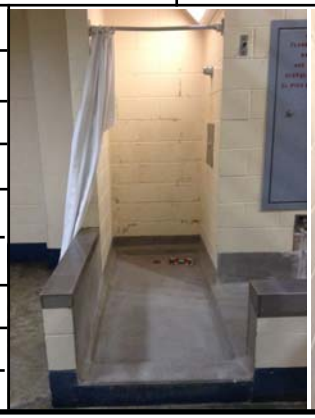
Issue	**Recommendation**
Grab bar not provided on back wall for standard or alternate shower	Provide new bar per current standards

ADA Reference:	
608.3.2	
CBC Reference:	
11B-608.3.2	
Floor:	4th
Room:	Pod - A
Location:	Shower
Cost:	See *7
Duration:	See *7

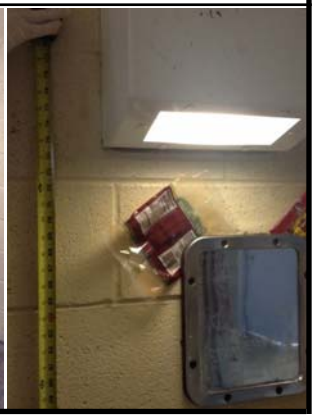
Issue	**Recommendation**
Mirror over lavatory or countertop measured over 40" AFF to the bottom edge of the reflecting surface	Reset mirror to maximum 40" AFF to reflecting surface

ADA Reference:	
603.3	
CBC Reference:	
11B-603.3	
Floor:	4th
Room:	Pod - A
Location:	Cell
Cost:	See *9
Duration:	See *9

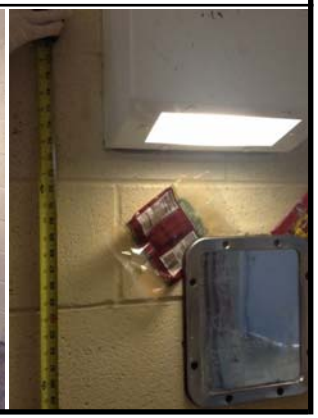
Issue	**Recommendation**
Maximum 48" AFF reach range exceeded /(forward unobstructed reach, 10" maximum reach depth)	Provide required reach range

ADA Reference:	
308.2.1	
CBC Reference:	
11B-308.2.1	
Floor:	4th
Room:	Pod - A
Location:	Cell
Cost:	See *9
Duration:	See *9

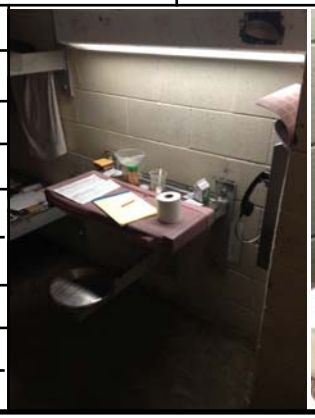
Issue	**Recommendation**
Clear floor space not provided for wheelchair accessible telephone	Reconfigure telephone location to provide required clear floor space

ADA Reference:	
704.2.1	
CBC Reference:	
11B-704.2.1	
Floor:	4th
Room:	Pod - A
Location:	Cell
Cost:	See *9
Duration:	See *9

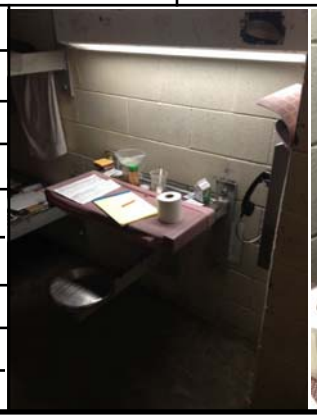
Issue	**Recommendation**
At least one TTY not provided in a secured area of a correctional facility if a public phone for detainees is provided	Provide accessible TTY per current standards

ADA Reference:	
217.4.8	
CBC Reference:	
11B-217.4.8	
Floor:	4th
Room:	Pod - A
Location:	Cell
Cost:	See *5
Duration:	See *5

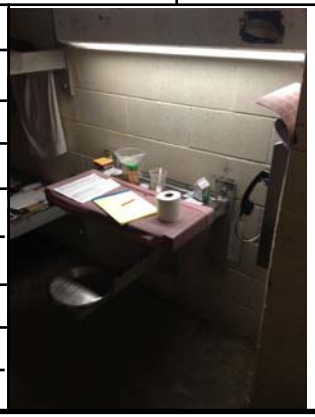
Issue	**Recommendation**
Required 30" by 48" clear floor space not provided at accessible seating spaces	Provide required clear floor space at accessible seating

ADA Reference:	
902.2	
CBC Reference:	
11B-902.2	
Floor:	4th
Room:	Pod - A
Location:	Cell
Cost:	See *9
Duration:	See *9

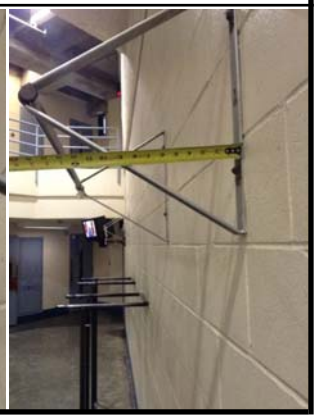
Issue	**Recommendation**
Objects with leading edges more than 27" and no more than 80" AFF shall protrude 4" maximum horizontally into the circulation path	Provide required clearance/adjust as required

ADA Reference:	
307.2	
CBC Reference:	
11B-307.2	
Floor:	4th
Room:	Pod - B
Location:	
Cost:	500
Duration:	5 hrs

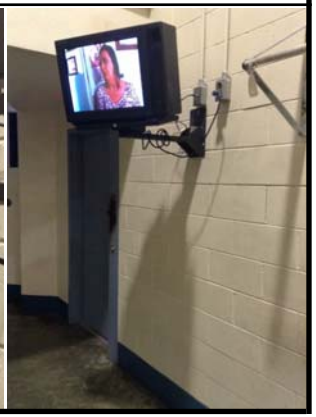
Issue	**Recommendation**
Objects with leading edges more than 27" and no more than 80" AFF shall protrude 4" maximum horizontally into the circulation path	Provide required clearance/adjust as required

ADA Reference:	
307.2	
CBC Reference:	
11B-307.2	
Floor:	4th
Room:	Pod - B
Location:	
Cost:	500
Duration:	5 hrs

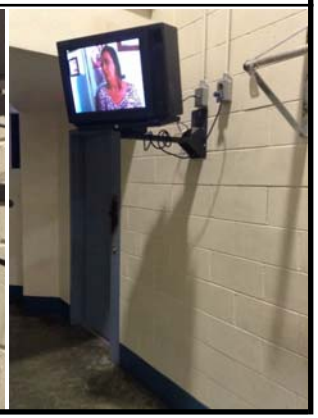
Issue	**Recommendation**
Maximum 48" AFF reach range exceeded /(forward unobstructed reach, 10" maximum reach depth)	Provide required reach range

ADA Reference:	
308.2.1	
CBC Reference:	
11B-308.2.1	
Floor:	4th
Room:	Pod - B
Location:	
Cost:	1000
Duration:	5 hrs

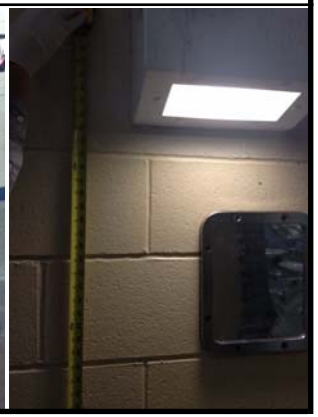
Issue	**Recommendation**
Mirror over lavatory or countertop measured over 40" AFF to the bottom edge of the reflecting surface	Reset mirror to maximum 40" AFF to reflecting surface

ADA Reference:	
603.3	
CBC Reference:	
11B-603.3	
Floor:	4th
Room:	Pod - B
Location:	Cell
Cost:	See *9
Duration:	See *9

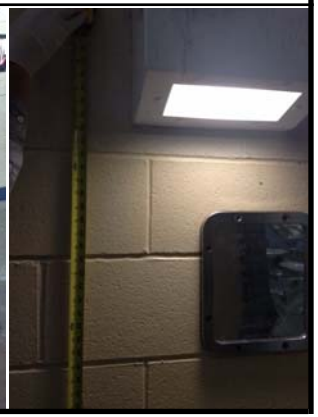
Issue	**Recommendation**
Maximum 48" AFF reach range exceeded /(forward unobstructed reach, 10" maximum reach depth)	Provide required reach range

ADA Reference:	
308.2.1	
CBC Reference:	
11B-308.2.1	
Floor:	4th
Room:	Pod - B
Location:	Cell
Cost:	See *9
Duration:	See *9

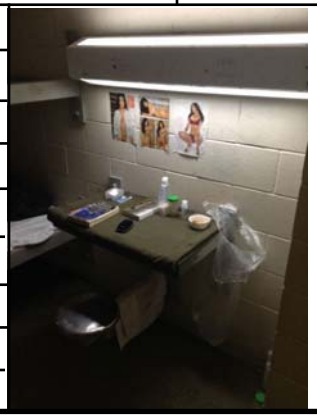
Issue	**Recommendation**
Required 30" by 48" clear floor space not provided at accessible seating spaces	Provide required clear floor space at accessible seating

ADA Reference:	
902.2	
CBC Reference:	
11B-902.2	
Floor:	4th
Room:	Pod - B
Location:	Cell
Cost:	See *9
Duration:	See *9

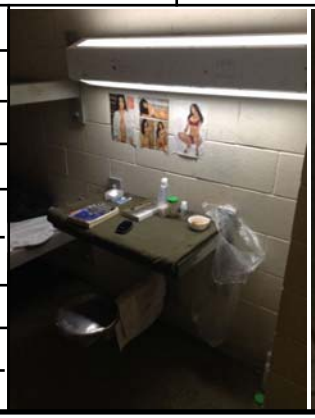
Issue	**Recommendation**
Maximum 48" AFF reach range exceeded /(forward unobstructed reach, 10" maximum reach depth)	Provide required reach range

ADA Reference:	
308.2.1	
CBC Reference:	
11B-308.2.1	
Floor:	4th
Room:	Pod - B
Location:	Cell
Cost:	See *9
Duration:	See *9

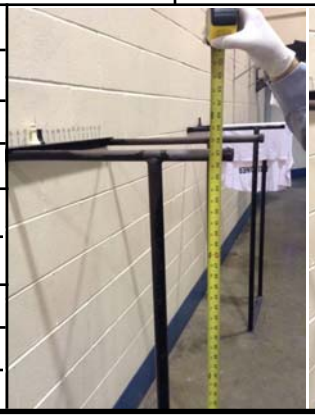
Issue	**Recommendation**
Objects with leading edges more than 27" and no more than 80" AFF shall protrude 4" maximum horizontally into the circulation path	Provide required clearance/adjust as required

ADA Reference:	
307.2	
CBC Reference:	
11B-307.2	
Floor:	4th
Room:	Pod - C
Location:	
Cost:	500
Duration:	5 hrs

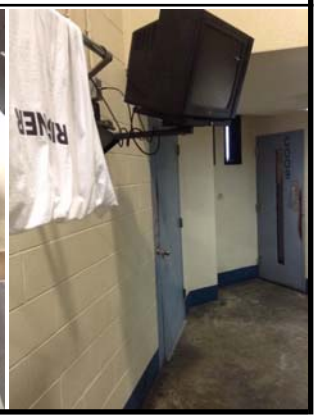
Issue	**Recommendation**
Objects with leading edges more than 27" and no more than 80" AFF shall protrude 4" maximum horizontally into the circulation path	Provide required clearance/adjust as required

ADA Reference:	
307.2	
CBC Reference:	
11B-307.2	
Floor:	4th
Room:	Pod - C
Location:	
Cost:	500
Duration:	5 hrs

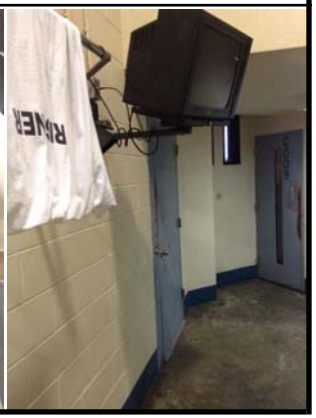
Issue	**Recommendation**
Maximum 48" AFF reach range exceeded /(forward unobstructed reach, 10" maximum reach depth)	Provide required reach range

ADA Reference:	
308.2.1	
CBC Reference:	
11B-308.2.1	
Floor:	4th
Room:	Pod - C
Location:	
Cost:	1000
Duration:	5 hrs

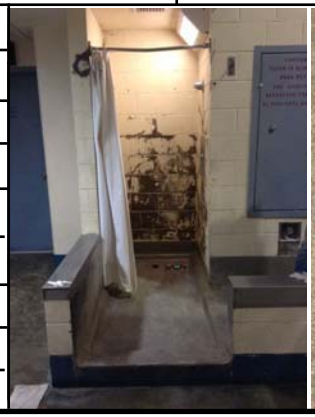
Issue	**Recommendation**
Shower floor slope greater that 2.083 percent	Provide accessible shower

ADA Reference:
N/A
CBC Reference:
11B-608.9

Floor:	4th
Room:	Pod - C
Location:	Shower
Cost:	See *7
Duration:	See *7

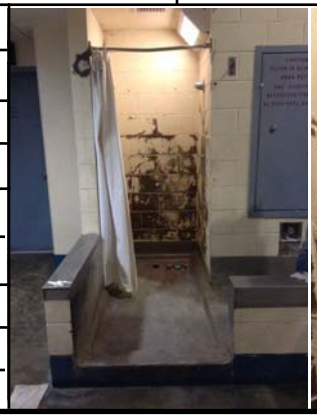
Issue	**Recommendation**
Centerline of water control not 39"-41" above shower floor and top of unit not greater than 48"	Adjust as required

ADA Reference:
N/A
CBC Reference:
11B-608.5.2

Floor:	4th
Room:	Pod - C
Location:	Shower
Cost:	See *7
Duration:	See *7

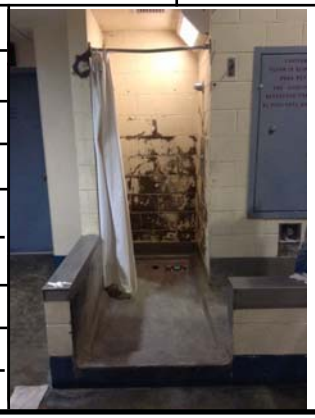
Issue	**Recommendation**
Threshold into shower greater than 1/2" height	Provide transition into shower

ADA Reference:
608.7
CBC Reference:
11B-608.7

Floor:	4th
Room:	Pod - C
Location:	Shower
Cost:	See *7
Duration:	See *7

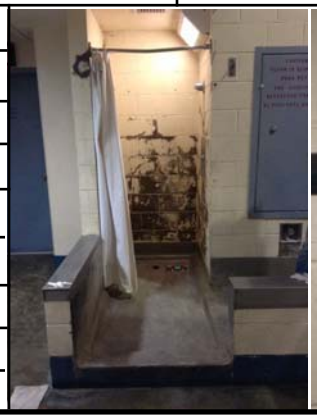
Issue	**Recommendation**
Vertical clearance not 80" high minimum	Provide required vertical clearance

ADA Reference:
307.4
CBC Reference:
11B-307.4

Floor:	4th
Room:	Pod - C
Location:	Shower
Cost:	See *7
Duration:	See *7

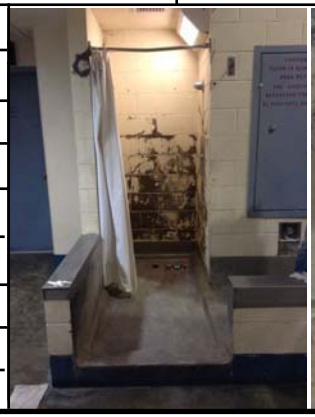
Issue	**Recommendation**
Coat hook measured over 48" AFF	Reset hook to maximum 48" AFF

ADA Reference:	
603.4	
CBC Reference:	
11B-603.4	
Floor:	4th
Room:	Pod - C
Location:	Shower
Cost:	See *7
Duration:	See *7

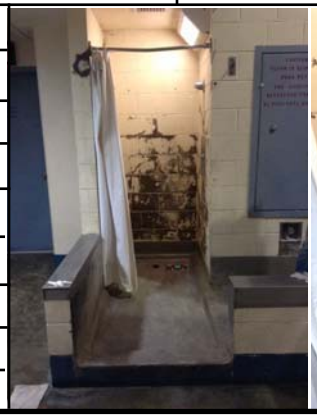
Issue	**Recommendation**
Folding seat not provided	Provide folding seat

ADA Reference:	
N/A	
CBC Reference:	
11B-610.5	
Floor:	4th
Room:	Pod - C
Location:	Shower
Cost:	See *7
Duration:	See *7

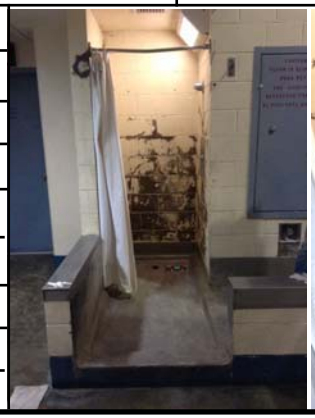
Issue	**Recommendation**
Grab bar not provided on back wall for standard or alternate shower	Provide new bar per current standards

ADA Reference:	
608.3.2	
CBC Reference:	
11B-608.3.2	
Floor:	4th
Room:	Pod - C
Location:	Shower
Cost:	See *7
Duration:	See *7

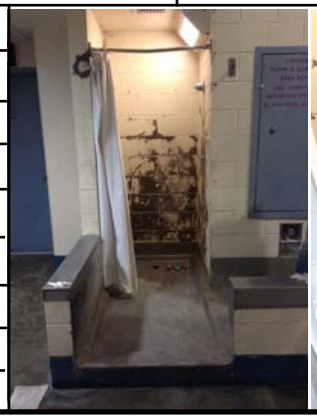
Issue	**Recommendation**
Grab bar not provided on side wall opposite of entry in alternate shower	Adjust as required and/or provide new bar per current standards

ADA Reference:	
608.3.3	
CBC Reference:	
11B-608.3.3	
Floor:	4th
Room:	Pod - C
Location:	Shower
Cost:	See *7
Duration:	See *7

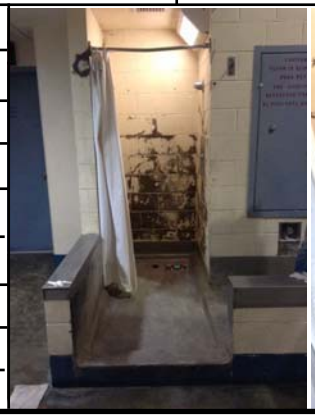
Issue	**Recommendation**
Grab bar not provided on side wall opposite of seat in standard shower	Provide new bar per current standards

ADA Reference:	
608.3.2	
CBC Reference:	
11B-608.3.2	
Floor:	4th
Room:	Pod - C
Location:	Shower
Cost:	See *7
Duration:	See *7

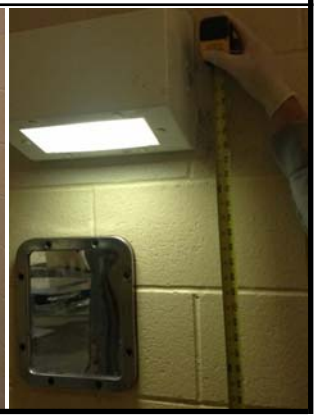
Issue	**Recommendation**
Mirror over lavatory or countertop measured over 40" AFF to the bottom edge of the reflecting surface	Reset mirror to maximum 40" AFF to reflecting surface

ADA Reference:	
603.3	
CBC Reference:	
11B-603.3	
Floor:	4th
Room:	Pod - C
Location:	Cell
Cost:	See *9
Duration:	See *9

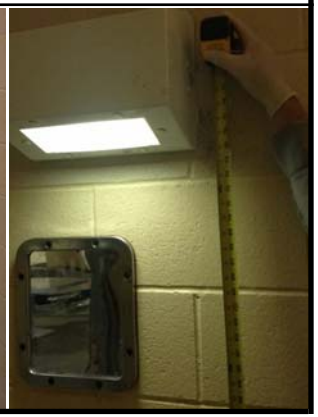
Issue	**Recommendation**
Maximum 48" AFF reach range exceeded /(forward unobstructed reach, 10" maximum reach depth)	Provide required reach range

ADA Reference:	
308.2.1	
CBC Reference:	
11B-308.2.1	
Floor:	4th
Room:	Pod - C
Location:	Cell
Cost:	See *9
Duration:	See *9

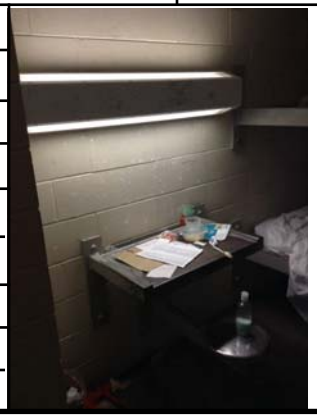
Issue	**Recommendation**
Required 30" by 48" clear floor space not provided at accessible seating spaces	Provide required clear floor space at accessible seating

ADA Reference:	
902.2	
CBC Reference:	
11B-902.2	
Floor:	4th
Room:	Pod - C
Location:	Cell
Cost:	See *9
Duration:	See *9

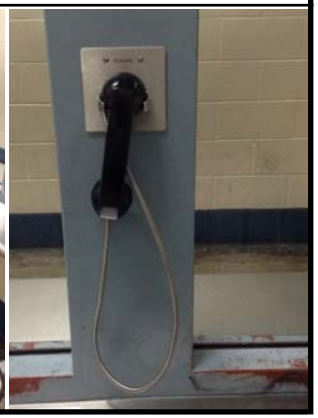
Issue	**Recommendation**
At least one TTY not provided in a secured area of a correctional facility if a public phone for detainees is provided	Provide accessible TTY per current standards

ADA Reference:	
217.4.8	
CBC Reference:	
11B-217.4.8	
Floor:	4th
Room:	Visitation
Location:	Inmate
Cost:	See *5
Duration:	See *5

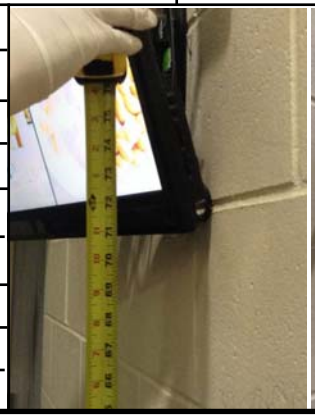
Issue	**Recommendation**
Objects with leading edges more than 27" and no more than 80" AFF shall protrude 4" maximum horizontally into the circulation path	Provide required clearance/adjust as required

ADA Reference:	
307.2	
CBC Reference:	
11B-307.2	
Floor:	4th
Room:	Pod - D
Location:	
Cost:	500
Duration:	5 hrs

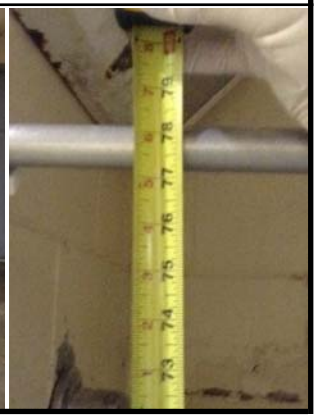
1474	Main Annex Jail	**Priority:**	2
Category	Detention Facility Accessories

Issue	**Recommendation**
Coat hook measured over 48" AFF	Reset hook to maximum 48" AFF

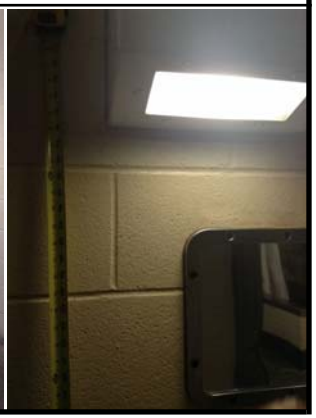
1489	Main Annex Jail	**Priority:**	2
Category	Reach Range

Issue	**Recommendation**
Maximum 48" AFF reach range exceeded /(forward unobstructed reach, 10" maximum reach depth)	Provide required reach range

ADA Reference:	
308.2.1	
CBC Reference:	
11B-308.2.1	
Floor:	4th
Room:	Pod - D
Location:	Cell
Cost:	See *9
Duration:	See *9

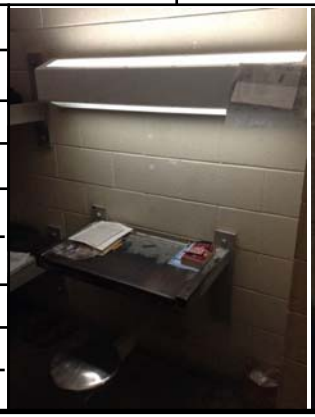
1494	Main Annex Jail	**Priority:**	2
Category	Dining/Bar Facilities

Issue	**Recommendation**
Required 30" by 48" clear floor space not provided at accessible seating spaces	Provide required clear floor space at accessible seating

ADA Reference:	
902.2	
CBC Reference:	
11B-902.2	
Floor:	4th
Room:	Pod - D
Location:	Cell
Cost:	See *9
Duration:	See *9

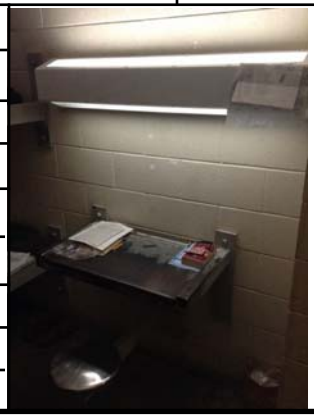
1495	Main Annex Jail	**Priority:**	1
Category	Protruding Objects

Issue	**Recommendation**
Objects with leading edges more than 27" and no more than 80" AFF shall protrude 4" maximum horizontally into the circulation path	Provide required clearance/adjust as required

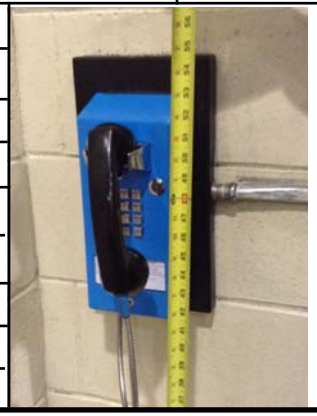
1501	Main Annex Jail	**Priority:**	2
Category	Reach Range

Issue	**Recommendation**
Maximum 48" AFF reach range exceeded /(forward unobstructed reach, 10" maximum reach depth)	Provide required reach range

ADA Reference:	
308.2.1	
CBC Reference:	
11B-308.2.1	
Floor:	4th
Room:	Pod - E
Location:	
Cost:	200
Duration:	2 hrs

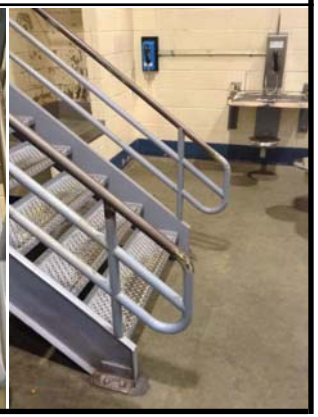
1507	Main Annex Jail	**Priority:**	1
Category	Accessible Path of Travel

Issue	**Recommendation**
Accessible path of travel not provided	Provide accessible path of travel

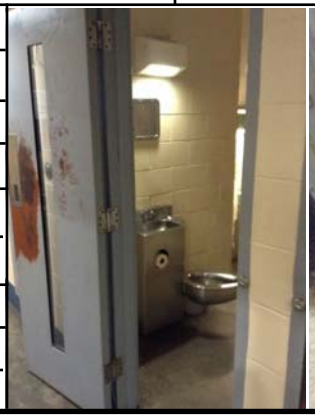
1523	Main Annex Jail	**Priority:**	2
Category	Detention Facility Water Closets (ADULT)

Issue	**Recommendation**
Seat height measured less than 17" AFF	Provide water closet per current standards

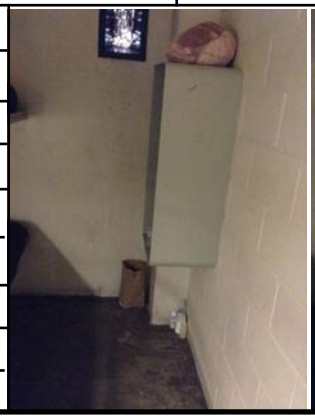
1532	Main Annex Jail	**Priority:**	2
Category	Reach Range

Issue	**Recommendation**
Maximum 48" AFF reach range exceeded /(forward unobstructed reach, 10" maximum reach depth)	Provide required reach range

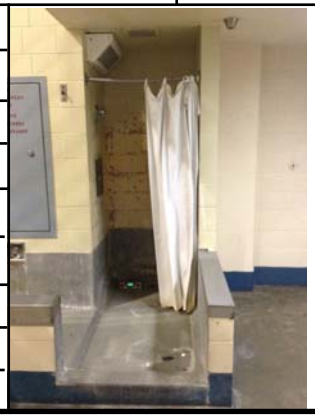
1546	Main Annex Jail	**Priority:**	2
Category	Detention Facility Showers

Issue	**Recommendation**
Shower floor slope greater that 2.083 percent	Provide accessible shower

ADA Reference:	
N/A	
CBC Reference:	
11B-608.9	
Floor:	4th
Room:	Pod - F
Location:	Shower
Cost:	See *7
Duration:	See *7

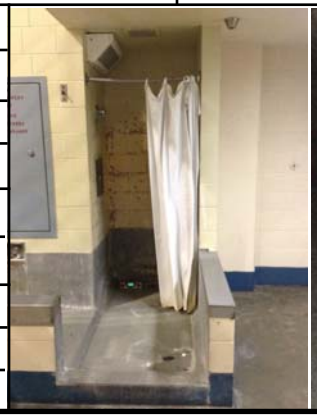
1547	Main Annex Jail	**Priority:**	2
Category	Detention Facility Showers

Issue	**Recommendation**
Centerline of water control not 39"-41" above shower floor and top of unit not greater than 48"	Adjust as required

ADA Reference:	
N/A	
CBC Reference:	
11B-608.5.2	
Floor:	4th
Room:	Pod - F
Location:	Shower
Cost:	See *7
Duration:	See *7

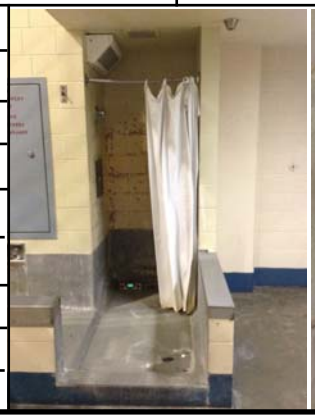
1548	Main Annex Jail	**Priority:**	2
Category	Detention Facility Accessories

Issue	**Recommendation**
Coat hook measured over 48" AFF	Reset hook to maximum 48" AFF

ADA Reference:	
603.4	
CBC Reference:	
11B-603.4	
Floor:	4th
Room:	Pod - F
Location:	Shower
Cost:	See *7
Duration:	See *7

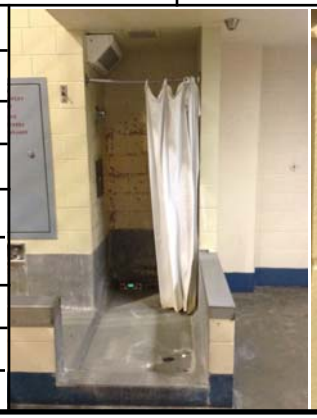
1549	Main Annex Jail	**Priority:**	1
Category	Protruding Objects

Issue	**Recommendation**
Vertical clearance not 80" high minimum	Provide required vertical clearance

ADA Reference:	
307.4	
CBC Reference:	
11B-307.4	
Floor:	4th
Room:	Pod - F
Location:	Shower
Cost:	See *7
Duration:	See *7

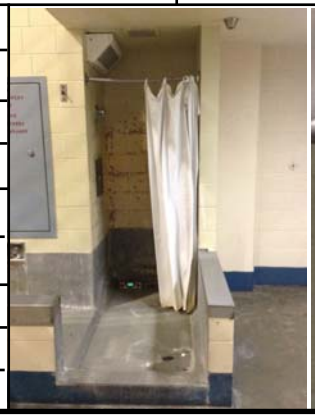
1550	Main Annex Jail	**Priority:**	2
Category	Detention Facility Showers

Issue	**Recommendation**
Folding seat not provided	Provide folding seat

ADA Reference:	
N/A	
CBC Reference:	
11B-610.5	
Floor:	4th
Room:	Pod - F
Location:	Shower
Cost:	See *7
Duration:	See *7

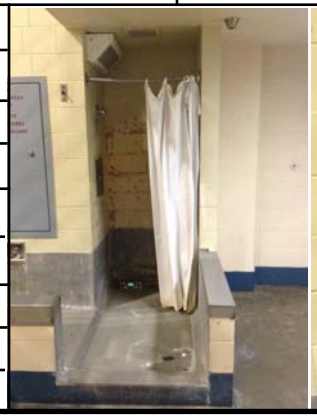
1551	Main Annex Jail	**Priority:**	2
Category	Detention Facility Showers

Issue	**Recommendation**
Grab bar not provided on back wall for standard or alternate shower	Provide new bar per current standards

ADA Reference:	
608.3.2	
CBC Reference:	
11B-608.3.2	
Floor:	4th
Room:	Pod - F
Location:	Shower
Cost:	See *7
Duration:	See *7

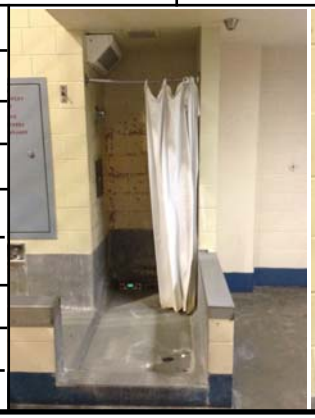
1552	Main Annex Jail	**Priority:**	2
Category	Detention Facility Showers

Issue	**Recommendation**
Grab bar not provided on side wall opposite of entry in alternate shower	Adjust as required and/or provide new bar per current standards

ADA Reference:	
608.3.3	
CBC Reference:	
11B-608.3.3	
Floor:	4th
Room:	Pod - F
Location:	Shower
Cost:	See *7
Duration:	See *7

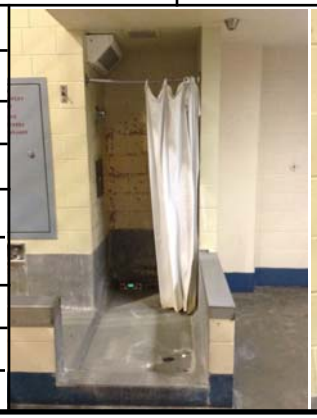
1553	Main Annex Jail	**Priority:**	2
Category	Detention Facility Showers

Issue	**Recommendation**
Grab bar not provided on side wall opposite of seat in standard shower	Provide new bar per current standards

ADA Reference:	
608.3.2	
CBC Reference:	
11B-608.3.2	
Floor:	4th
Room:	Pod - F
Location:	Shower
Cost:	See *7
Duration:	See *7

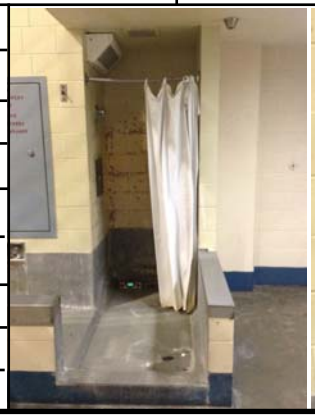
1554	Main Annex Jail	**Priority:**	2
Category	Detention Facility Showers

Issue	**Recommendation**
Minimum 59" long hose not provided	Provide required hose and/or adjust height per current standards

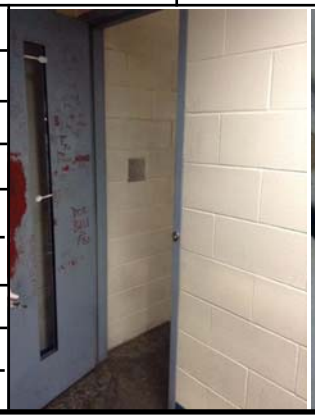
1556	Main Annex Jail	**Priority:**	2
Category	Detention Facility Water Closets (ADULT)

Issue	**Recommendation**
Seat height measured less than 17" AFF	Provide water closet per current standards

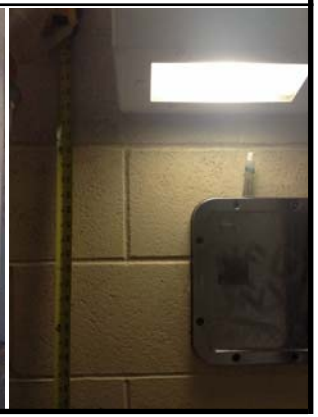
1558	Main Annex Jail	**Priority:**	2
Category	Reach Range

Issue	**Recommendation**
Maximum 48" AFF reach range exceeded /(forward unobstructed reach, 10" maximum reach depth)	Provide required reach range

ADA Reference:	
308.2.1	
CBC Reference:	
11B-308.2.1	
Floor:	4th
Room:	Pod - F
Location:	Cell
Cost:	See *9
Duration:	See *9

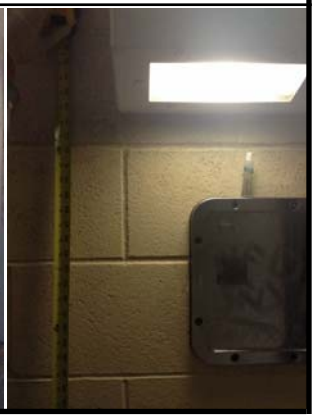
1559	Main Annex Jail	**Priority:**	2
Category	Detention Facility Water Closets (GENERAL)

Issue	**Recommendation**
Grab bars not provided on rear wall	Provide required grab bar

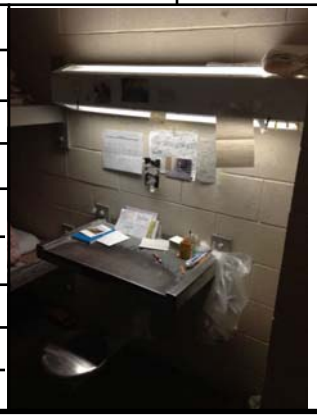
1563	Main Annex Jail	**Priority:**	2
Category	Reach Range

Issue	**Recommendation**
Maximum 48" AFF reach range exceeded /(forward unobstructed reach, 10" maximum reach depth)	Provide required reach range

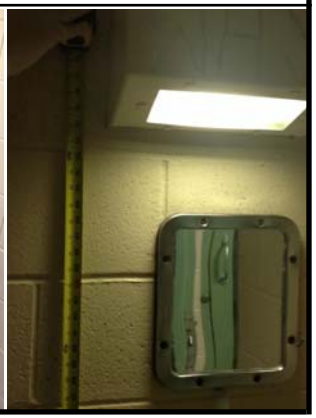
1581	Main Annex Jail	**Priority:**	2
Category	Reach Range

Issue	**Recommendation**
Maximum 48" AFF reach range exceeded /(forward unobstructed reach, 10" maximum reach depth)	Provide required reach range

ADA Reference:	
308.2.1	
CBC Reference:	
11B-308.2.1	
Floor:	5th
Room:	Cell FF
Location:	Cell
Cost:	See *10
Duration:	See *10

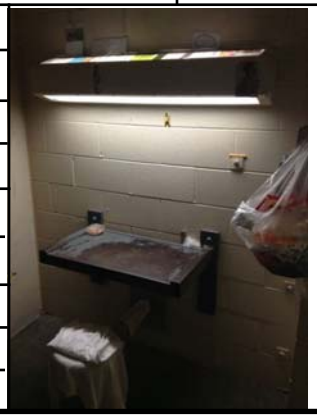
1583	Main Annex Jail	**Priority:**	2
Category	Reach Range

Issue	**Recommendation**
Maximum 48" AFF reach range exceeded /(forward unobstructed reach, 10" maximum reach depth)	Provide required reach range

ADA Reference:	
308.2.1	
CBC Reference:	
11B-308.2.1	
Floor:	5th
Room:	Cell FF
Location:	Cell
Cost:	See *10
Duration:	See *10

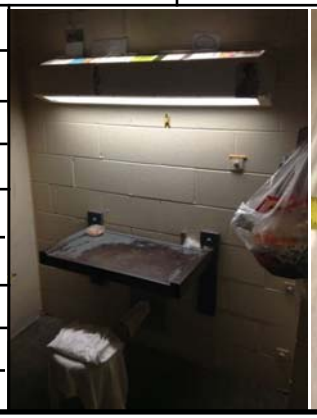
1585	Main Annex Jail	**Priority:**	2
Category	Reach Range

Issue	**Recommendation**
Maximum 48" AFF reach range exceeded /(forward unobstructed reach, 10" maximum reach depth)	Provide required reach range

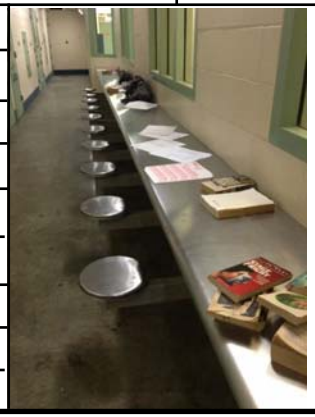
Issue	**Recommendation**
At least 5% of total seating is not accessible	Provide accessible seating spaces as required

ADA Reference:	
226.1	
CBC Reference:	
11B-226.1	
Floor:	5th
Room:	Cell FF
Location:	
Cost:	500
Duration:	5 hrs

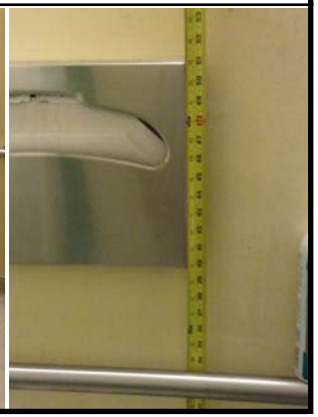
Issue	**Recommendation**
Toilet seat dispenser measured over 40" AFF to operable part	Reset accessories to maximum 40" AFF to operating controls

ADA Reference:	
N/A	
CBC Reference:	
11B-603.5	
Floor:	5th
Room:	Staff Restroom
Location:	
Cost:	50
Duration:	.5 hrs

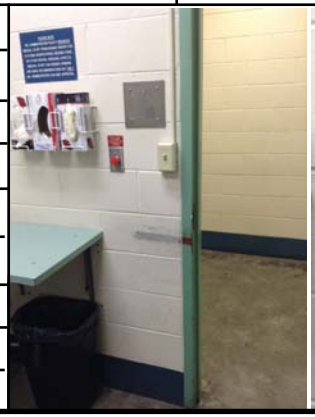
Issue	**Recommendation**
Maximum 48" AFF reach range exceeded /(forward unobstructed reach, 10" maximum reach depth)	Provide required reach range

ADA Reference:	
308.2.1	
CBC Reference:	
11B-308.2.1	
Floor:	5th
Room:	Infirmary
Location:	
Cost:	See *6
Duration:	See *6

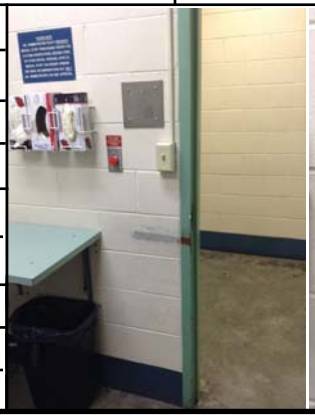
1634	Main Annex Jail	**Priority:**	2
Category	Reach Range

Issue	**Recommendation**
Switch measured over 48" AFF / measure to top of switch box	Provide occupancy room sensor or lower switch

ADA Reference:	
308.2.1	
CBC Reference:	
11B-308.2.1	
Floor:	5th
Room:	Infirmary
Location:	
Cost:	See *6
Duration:	See *6

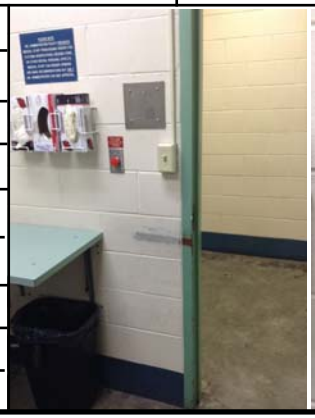
1635	Main Annex Jail	**Priority:**	2
Category	Reach Range

Issue	**Recommendation**
Maximum 48" AFF reach range exceeded /(forward unobstructed reach, 10" maximum reach depth)	Provide required reach range

ADA Reference:	
308.2.1	
CBC Reference:	
11B-308.2.1	
Floor:	5th
Room:	Infirmary
Location:	
Cost:	See *6
Duration:	See *6

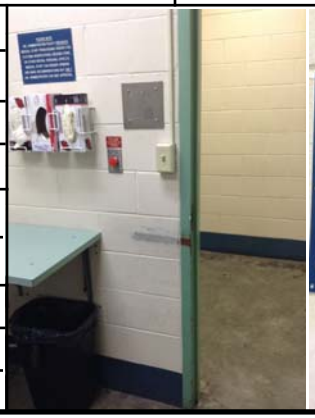
1636	Main Annex Jail	**Priority:**	1
Category	Interior Signage

Issue	**Recommendation**
Lettering height on sign over 40"-70" AFF (to bottom) not 5/8" minimum	Remove and replace sign per current standards

ADA Reference:	
703.5.5	
CBC Reference:	
11B-703.5.5	
Floor:	5th
Room:	Infirmary
Location:	
Cost:	See *1
Duration:	See *1

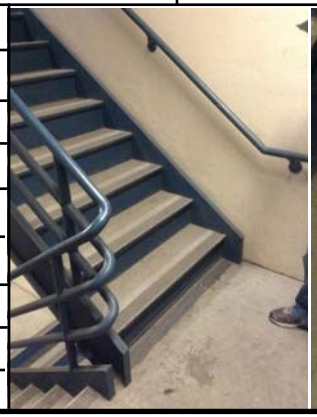
Issue	**Recommendation**
Width of stairs not 44" minimum	Provide stairs with minimum 44" width

ADA Reference:	
N/A	
CBC Reference:	
1009.4	
Floor:	5th
Room:	Stairwell
Location:	North
Cost:	N/A
Duration:	N/A

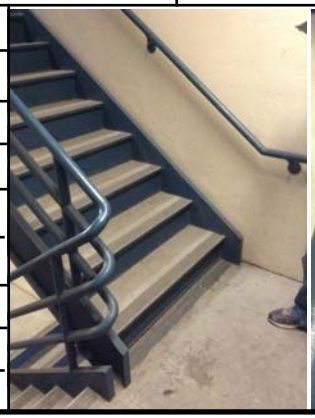
1659	Main Annex Jail	**Priority:**	1
Category	Stairs

Issue	**Recommendation**
Height of handrail(s) less than 34" above nosing of threads	Provide handrails per current standards

ADA Reference:	
505.4	
CBC Reference:	
11B-505.4	
Floor:	5th
Room:	Stairwell
Location:	North
Cost:	5000
Duration:	20 hrs

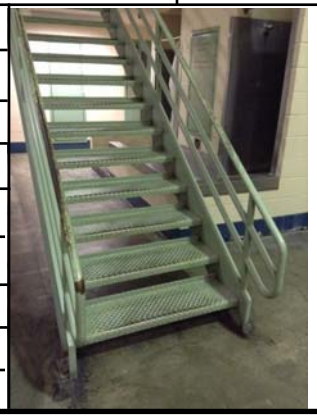
Issue	**Recommendation**
Open risers provided interior stairways only	Install closer strip at open risers or remove and replace stairs for compliance

ADA Reference:	
504.3	
CBC Reference:	
11B-504.3	
Floor:	5th
Room:	Pod - A
Location:	
Cost:	6000
Duration:	30 hrs

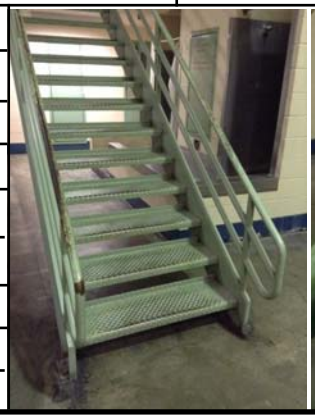
1683	Main Annex Jail	**Priority:**	1
Category	Stairs

Issue	**Recommendation**
Height of handrail(s) less than 34" above nosing of threads	Provide handrails per current standards

ADA Reference:	
505.4	
CBC Reference:	
11B-505.4	
Floor:	5th
Room:	Pod - A
Location:	
Cost:	5000
Duration:	20 hrs

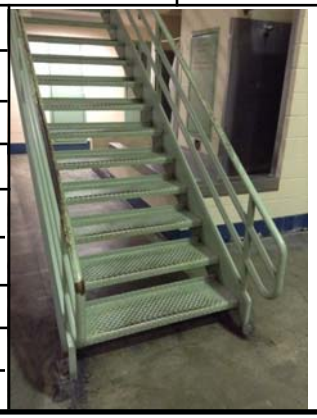
1684	Main Annex Jail	**Priority:**	1
Category	Stairs

Issue	**Recommendation**
Extension of handrail at bottom of stairs not a minimum of tread width; plus 12" beyond bottom nosing horizontal with ground or floor surface	Modify handrail(s) to provide required extensions or replace per current standards

ADA Reference:	
505.10.3	
CBC Reference:	
11B-505.10.3	
Floor:	5th
Room:	Pod - A
Location:	
Cost:	1500
Duration:	2 hrs

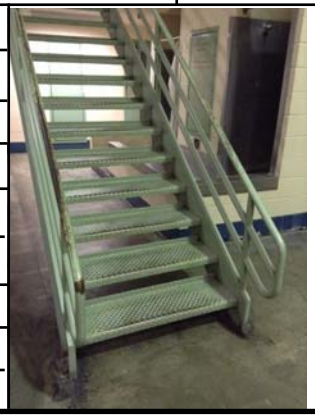
1685	Main Annex Jail	**Priority:**	1
Category	Protruding Objects

Issue	**Recommendation**
Vertical clearance not 80" high minimum	Provide required vertical clearance

ADA Reference:	
307.4	
CBC Reference:	
11B-307.4	
Floor:	5th
Room:	Pod - A
Location:	
Cost:	10000
Duration:	50 hrs

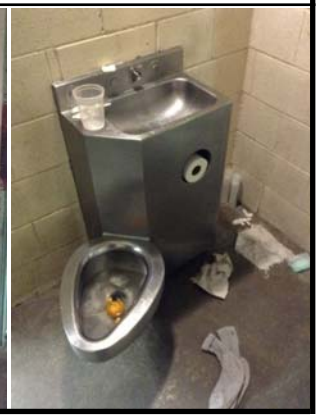
Issue	**Recommendation**
Grab bars not provided on rear wall	Provide required grab bar

ADA Reference:	
604.5	
CBC Reference:	
11B-604.5	
Floor:	5th
Room:	Pod - A
Location:	Cell
Cost:	See *9
Duration:	See *9

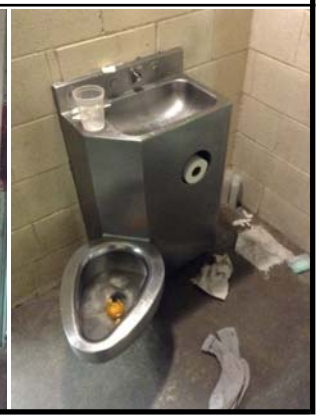
Issue	**Recommendation**
Minimum 29" clearance under lavatory apron not provided (measured at front edge)	Reset lavatory as required

ADA Reference:	
N/A	
CBC Reference:	
11B-606.2	
Floor:	5th
Room:	Pod - A
Location:	Cell
Cost:	See *9
Duration:	See *9

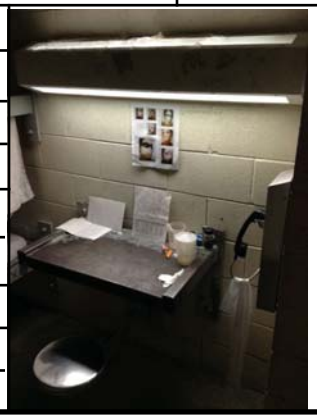
Issue	**Recommendation**
Required 30" by 48" clear floor space not provided at accessible seating spaces	Provide required clear floor space at accessible seating

ADA Reference:	
902.2	
CBC Reference:	
11B-902.2	
Floor:	5th
Room:	Pod - A
Location:	Cell
Cost:	See *9
Duration:	See *9

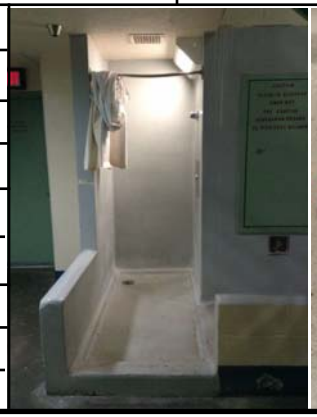
1742	Main Annex Jail	**Priority:**	2
Category	Detention Facility Showers

Issue	**Recommendation**
Shower floor slope greater that 2.083 percent	Provide accessible shower

ADA Reference:
N/A
CBC Reference:
11B-608.9

Floor:	5th
Room:	Pod - C
Location:	Shower
Cost:	See *7
Duration:	See *7

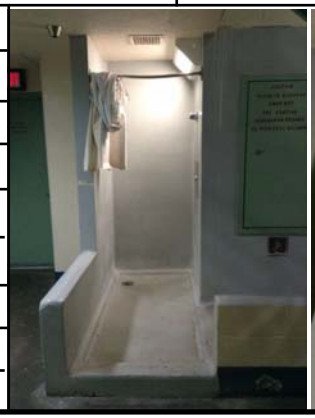
1743	Main Annex Jail	**Priority:**	1
Category	Protruding Objects

Issue	**Recommendation**
Vertical clearance not 80" high minimum	Provide required vertical clearance

ADA Reference:
307.4
CBC Reference:
11B-307.4

Floor:	5th
Room:	Pod - C
Location:	Shower
Cost:	See *7
Duration:	See *7

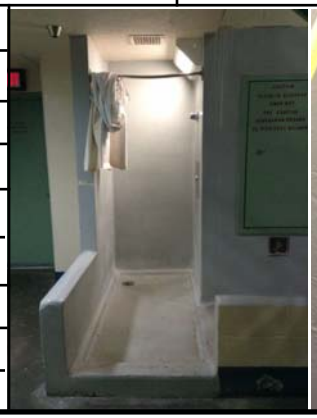
1744	Main Annex Jail	**Priority:**	2
Category	Detention Facility Showers

Issue	**Recommendation**
Centerline of water control not 39"-41" above shower floor and top of unit not greater than 48"	Adjust as required

ADA Reference:
N/A
CBC Reference:
11B-608.5.2

Floor:	5th
Room:	Pod - C
Location:	Shower
Cost:	See *7
Duration:	See *7

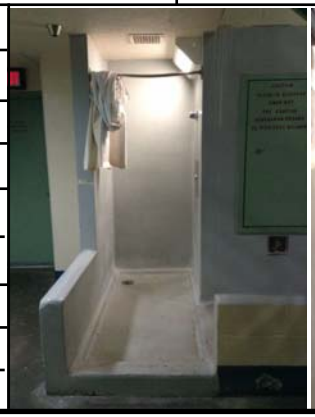
1745	Main Annex Jail	**Priority:**	2
Category	Detention Facility Showers

Issue	**Recommendation**
Folding seat not provided	Provide folding seat

ADA Reference:	
N/A	
CBC Reference:	
11B-610.5	
Floor:	5th
Room:	Pod - C
Location:	Shower
Cost:	See *7
Duration:	See *7

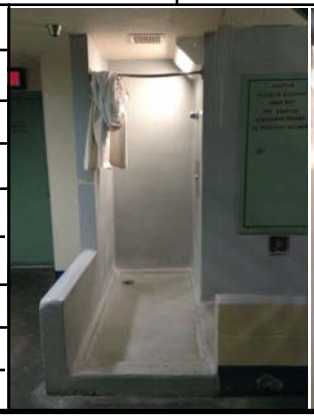
1746	Main Annex Jail	**Priority:**	2
Category	Detention Facility Showers

Issue	**Recommendation**
Grab bar not provided on back wall for standard or alternate shower	Provide new bar per current standards

ADA Reference:	
608.3.2	
CBC Reference:	
11B-608.3.2	
Floor:	5th
Room:	Pod - C
Location:	Shower
Cost:	See *7
Duration:	See *7

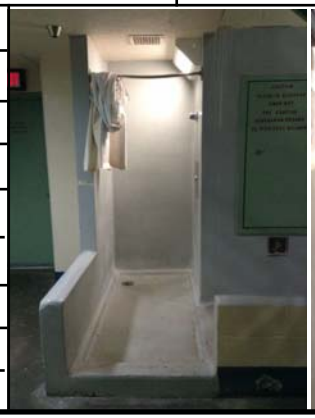
1747	Main Annex Jail	**Priority:**	2
Category	Detention Facility Showers

Issue	**Recommendation**
Grab bar not provided on side wall opposite of entry in alternate shower	Adjust as required and/or provide new bar per current standards

ADA Reference:	
608.3.3	
CBC Reference:	
11B-608.3.3	
Floor:	5th
Room:	Pod - C
Location:	Shower
Cost:	See *7
Duration:	See *7

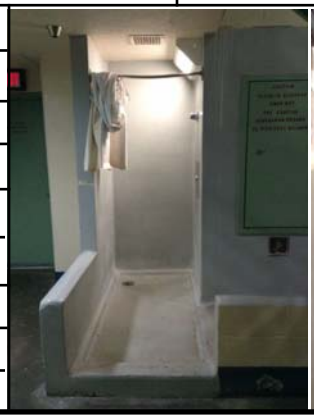
1748	Main Annex Jail	**Priority:**	2
Category	Detention Facility Showers

Issue	**Recommendation**
Grab bar not provided on side wall opposite of seat in standard shower	Provide new bar per current standards

ADA Reference:	
608.3.2	
CBC Reference:	
11B-608.3.2	
Floor:	5th
Room:	Pod - C
Location:	Shower
Cost:	See *7
Duration:	See *7

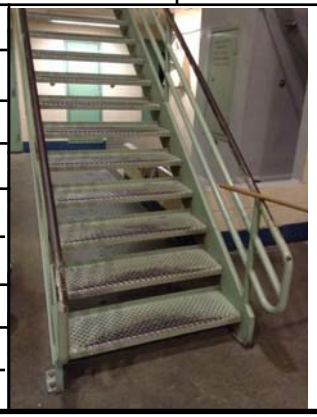
Issue	**Recommendation**
Extension of handrail at bottom of stairs not a minimum of tread width; plus 12" beyond bottom nosing horizontal with ground or floor surface	Modify handrail(s) to provide required extensions or replace per current standards

ADA Reference:	
505.10.3	
CBC Reference:	
11B-505.10.3	
Floor:	5th
Room:	Pod - C
Location:	
Cost:	1500
Duration:	2 hrs

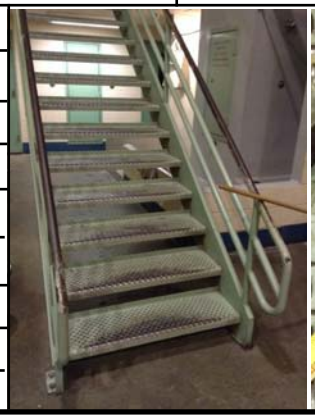
1751	Main Annex Jail	**Priority:**	1
Category	Stairs

Issue	**Recommendation**
Width of stairs not 44" minimum	Provide stairs with minimum 44" width

ADA Reference:	
N/A	
CBC Reference:	
1009.4	
Floor:	5th
Room:	Pod - C
Location:	
Cost:	N/A
Duration:	N/A

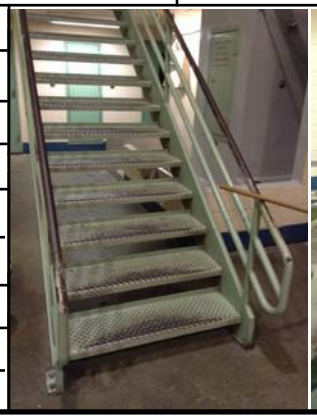
1752	Main Annex Jail	**Priority:**	1
Category	Stairs

Issue	**Recommendation**
Height of handrail(s) less than 34" above nosing of threads	Provide handrails per current standards

ADA Reference:	
505.4	
CBC Reference:	
11B-505.4	
Floor:	5th
Room:	Pod - C
Location:	
Cost:	5000
Duration:	20 hrs

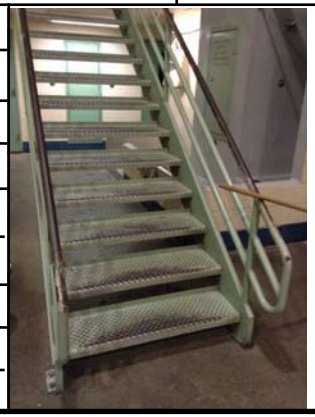
1753	Main Annex Jail	**Priority:**	1
Category	Stairs

Issue	**Recommendation**
Open risers provided interior stairways only	Install closer strip at open risers or remove and replace stairs for compliance

ADA Reference:	
504.3	
CBC Reference:	
11B-504.3	
Floor:	5th
Room:	Pod - C
Location:	
Cost:	6000
Duration:	30 hrs

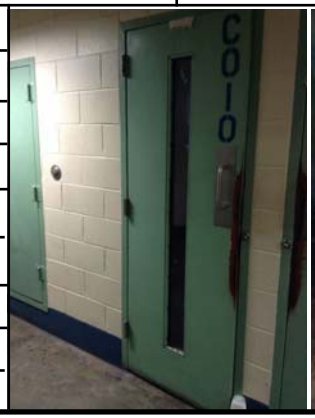
Issue	**Recommendation**
Minimum 32" wide clear width not provided	Provide 32" wide clear width

ADA Reference:	
404.2.3	
CBC Reference:	
11B-404.2.3	
Floor:	5th
Room:	Pod - C
Location:	Cell
Cost:	See *9
Duration:	See *9

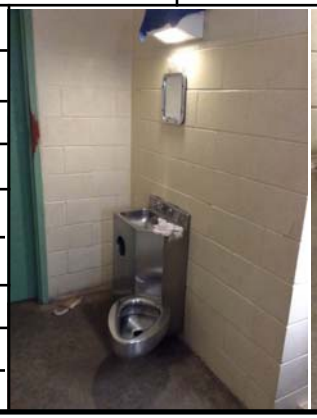
1756	Main Annex Jail	**Priority:**	2
Category	Detention Facility Water Closets (ADULT)

Issue	**Recommendation**
Seat height measured less than 17" AFF	Provide water closet per current standards

ADA Reference:	
604.4	
CBC Reference:	
11B-604.4	
Floor:	5th
Room:	Pod - C
Location:	Cell
Cost:	See *9
Duration:	See *9

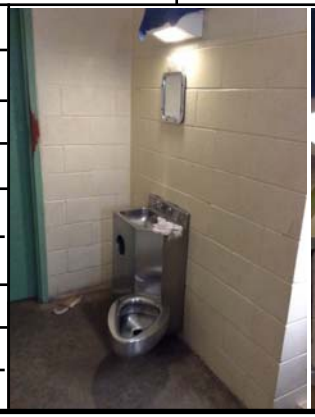
1757	Main Annex Jail	**Priority:**	2
Category	Detention Facility Accessories

Issue	**Recommendation**
Mirror over lavatory or countertop measured over 40" AFF to the bottom edge of the reflecting surface	Reset mirror to maximum 40" AFF to reflecting surface

ADA Reference:	
603.3	
CBC Reference:	
11B-603.3	
Floor:	5th
Room:	Pod - C
Location:	Cell
Cost:	See *9
Duration:	See *9

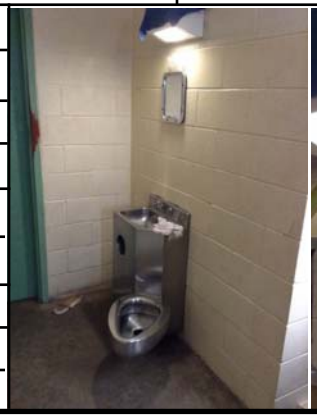
1758	Main Annex Jail	**Priority:**	2
Category	Reach Range

Issue	**Recommendation**
Maximum 48" AFF reach range exceeded /(forward unobstructed reach, 10" maximum reach depth)	Provide required reach range

ADA Reference:	
308.2.1	
CBC Reference:	
11B-308.2.1	
Floor:	5th
Room:	Pod - C
Location:	Cell
Cost:	See *9
Duration:	See *9

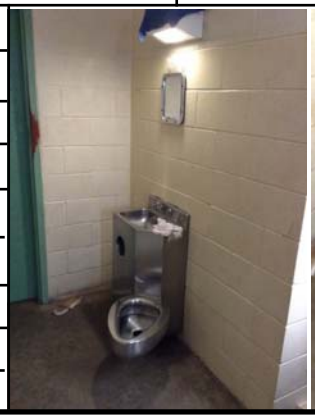
1759	Main Annex Jail	**Priority:**	2
Category	Detention Facility Water Closets (ADULT)

Issue	**Recommendation**
Centerline of toilet not 17"-18" from sidewall or partition in wheel chair accessible toilet compartment	Relocate/adjust as required

ADA Reference:	
N/A	
CBC Reference:	
11B-604.2	
Floor:	5th
Room:	Pod - C
Location:	Cell
Cost:	See *9
Duration:	See *9

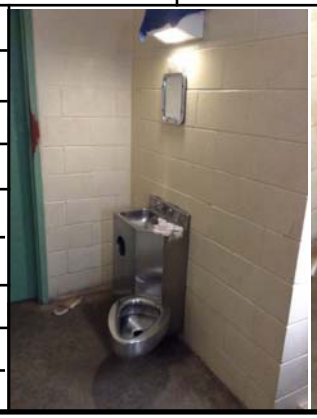
1760	Main Annex Jail	**Priority:**	2
Category	Detention Facility Water Closets (GENERAL)

Issue	**Recommendation**
Grab bars not provided on rear wall	Provide required grab bar

ADA Reference:	
604.5	
CBC Reference:	
11B-604.5	
Floor:	5th
Room:	Pod - C
Location:	Cell
Cost:	See *9
Duration:	See *9
