County of Fresno

Main Annex Jail
ADA Transition Plan

LARS ANDERSEN & ASSOCIATES, INC.

JUNE 30, 2014

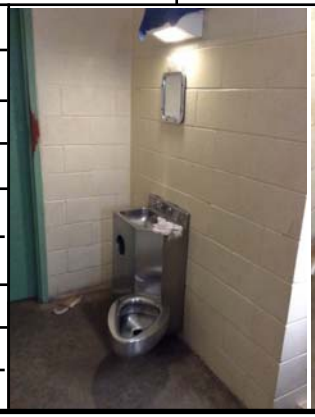
1761	Main Annex Jail	**Priority:**	2
Category	Detention Facility Water Closets (GENERAL)

Issue	**Recommendation**
Grab bars not provided on sidewall	Provide required grab bar

ADA Reference:	
604.5	
CBC Reference:	
11B-604.5	
Floor:	5th
Room:	Pod - C
Location:	Cell
Cost:	See *9
Duration:	See *9

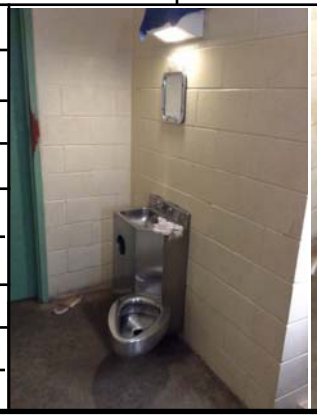
1762	Main Annex Jail	**Priority:**	3
Category	Lavatories (ADULT)

Issue	**Recommendation**
Minimum 29" clearance under lavatory apron not provided (measured at front edge)	Reset lavatory as required

ADA Reference:	
N/A	
CBC Reference:	
11B-606.2	
Floor:	5th
Room:	Pod - C
Location:	Cell
Cost:	See *9
Duration:	See *9

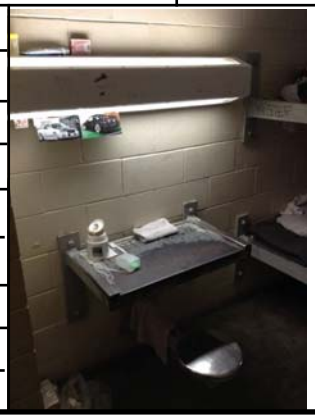
1764	Main Annex Jail	**Priority:**	2
Category	Reach Range

Issue	**Recommendation**
Maximum 48" AFF reach range exceeded /(forward unobstructed reach, 10" maximum reach depth)	Provide required reach range

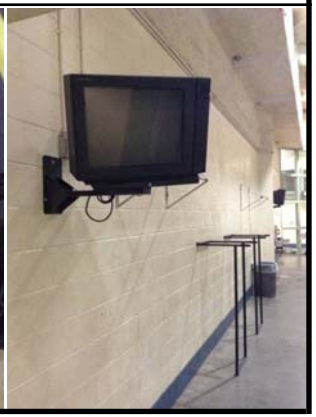
1783	Main Annex Jail	**Priority:**	2
Category	Reach Range

Issue	**Recommendation**
Maximum 48" AFF reach range exceeded /(forward unobstructed reach, 10" maximum reach depth)	Provide required reach range

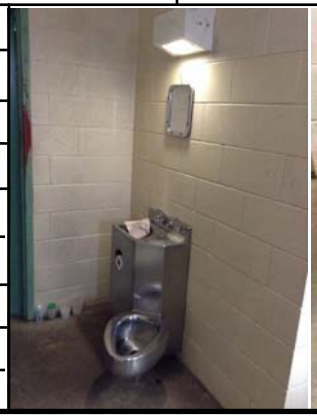
1795	Main Annex Jail	**Priority:**	3
Category	Accessories

Issue	**Recommendation**
Mirror over lavatory or countertop measured over 40" AFF to the bottom edge of the reflecting surface	Reset mirror to maximum 40" AFF to reflecting surface

ADA Reference:	
603.3	
CBC Reference:	
11B-603.3	
Floor:	5th
Room:	Pod - D
Location:	Cell
Cost:	See *9
Duration:	See *9

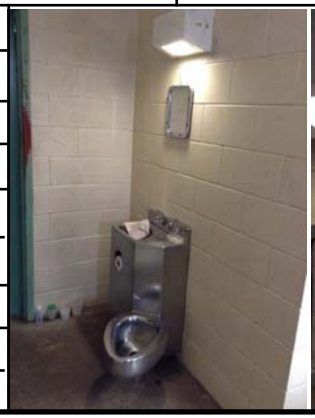
1796	Main Annex Jail	**Priority:**	2
Category	Reach Range

Issue	**Recommendation**
Maximum 48" AFF reach range exceeded /(forward unobstructed reach, 10" maximum reach depth)	Provide required reach range

ADA Reference:	
308.2.1	
CBC Reference:	
11B-308.2.1	
Floor:	5th
Room:	Pod - D
Location:	Cell
Cost:	See *9
Duration:	See *9

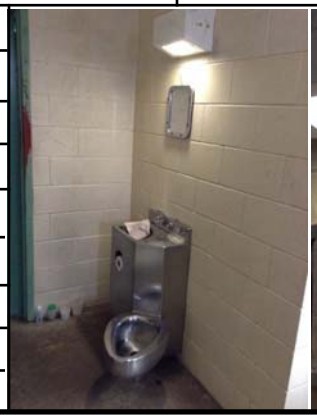
1797	Main Annex Jail	**Priority:**	2
Category	Detention Facility Water Closets (ADULT)

Issue	**Recommendation**
Centerline of toilet not 17"-18" from sidewall or partition in wheel chair accessible toilet compartment	Relocate/adjust as required

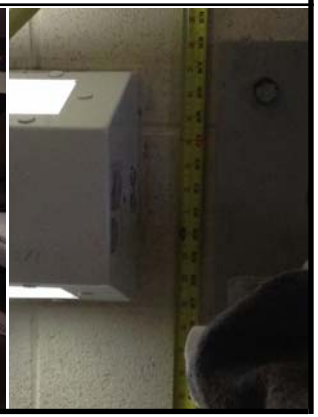
1803	Main Annex Jail	**Priority:**	1
Category	Protruding Objects

Issue	**Recommendation**
Objects with leading edges more than 27" and no more than 80" AFF shall protrude 4" maximum horizontally into the circulation path	Provide required clearance/adjust as required

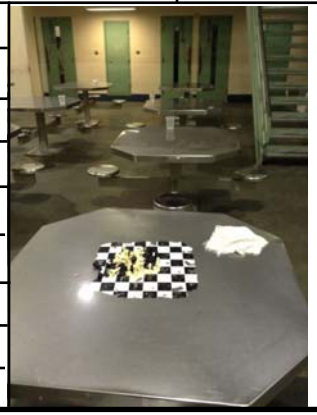
1807	Main Annex Jail	**Priority:**	1
Category	Corridors/Hallways

Issue	**Recommendation**
Minimum 44" width not provided/where serving occupant load over 10	Provide 44" width

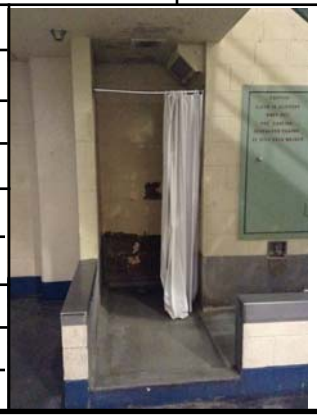
1819	Main Annex Jail	**Priority:**	2
Category	Detention Facility Showers

Issue	**Recommendation**
Shower floor slope greater that 2.083 percent	Provide accessible shower

ADA Reference:	
N/A	
CBC Reference:	
11B-608.9	
Floor:	5th
Room:	Pod - E
Location:	Shower
Cost:	See *7
Duration:	See *7

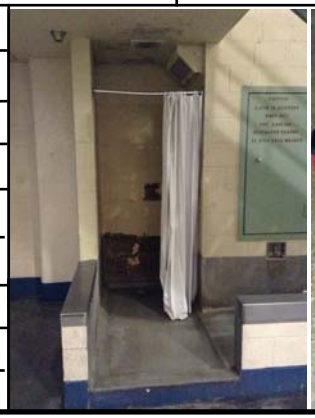
1820	Main Annex Jail	**Priority:**	1
Category	Protruding Objects

Issue	**Recommendation**
Vertical clearance not 80" high minimum	Provide required vertical clearance

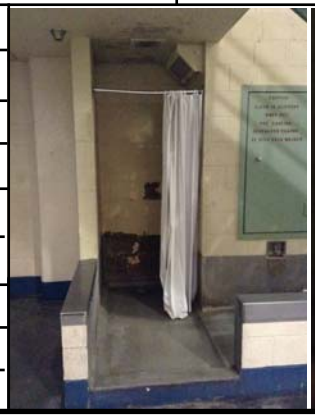
1822	Main Annex Jail	**Priority:**	2
Category	Detention Facility Showers

Issue	**Recommendation**
Folding seat not provided	Provide folding seat

ADA Reference:	
N/A	
CBC Reference:	
11B-610.5	
Floor:	5th
Room:	Pod - E
Location:	Shower
Cost:	See *7
Duration:	See *7

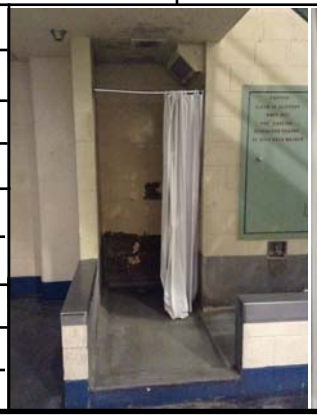
1823	Main Annex Jail	**Priority:**	2
Category	Detention Facility Showers

Issue	**Recommendation**
Grab bar not provided on back wall for standard or alternate shower	Provide new bar per current standards

ADA Reference:	
608.3.2	
CBC Reference:	
11B-608.3.2	
Floor:	5th
Room:	Pod - E
Location:	Shower
Cost:	See *7
Duration:	See *7

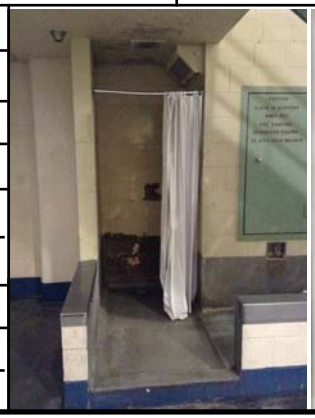
1824	Main Annex Jail	**Priority:**	2
Category	Detention Facility Showers

Issue	**Recommendation**
Grab bar not provided on side wall opposite of entry in alternate shower	Adjust as required and/or provide new bar per current standards

ADA Reference:	
608.3.3	
CBC Reference:	
11B-608.3.3	
Floor:	5th
Room:	Pod - E
Location:	Shower
Cost:	See *7
Duration:	See *7

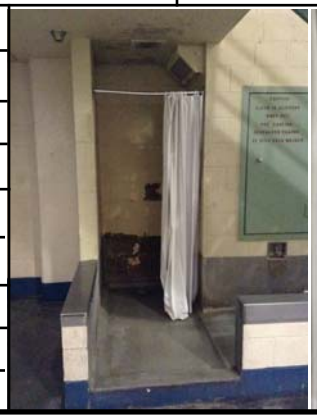
1825	Main Annex Jail	**Priority:**	2
Category	Detention Facility Showers

Issue	**Recommendation**
Grab bar not provided on side wall opposite of seat in standard shower	Provide new bar per current standards

ADA Reference:	
608.3.2	
CBC Reference:	
11B-608.3.2	
Floor:	5th
Room:	Pod - E
Location:	Shower
Cost:	See *7
Duration:	See *7

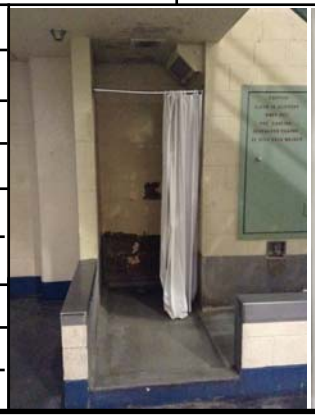
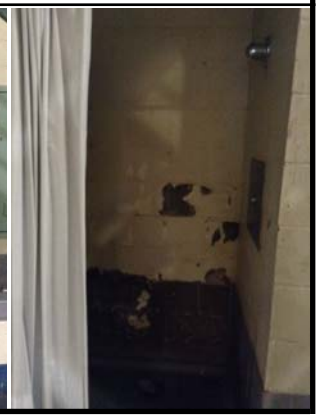
1826	Main Annex Jail	**Priority:**	2
Category	Detention Facility Showers

Issue	**Recommendation**
Minimum 59" long hose not provided	Provide required hose and/or adjust height per current standards

ADA Reference:	
608.6	
CBC Reference:	
11B-608.6	
Floor:	5th
Room:	Pod - E
Location:	Shower
Cost:	See *7
Duration:	See *7

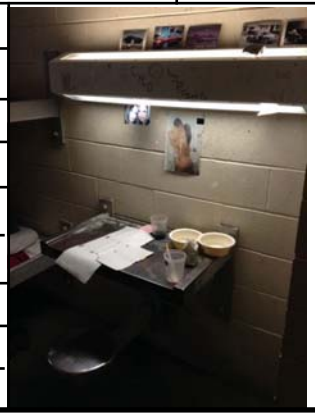
1836	Main Annex Jail	**Priority:**	2
Category	Reach Range

Issue	**Recommendation**
Maximum 48" AFF reach range exceeded /(forward unobstructed reach, 10" maximum reach depth)	Provide required reach range

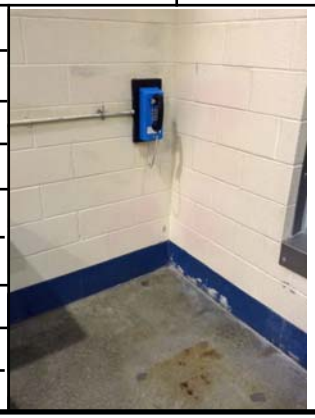
1848	Main Annex Jail	**Priority:**	1
Category	Protruding Objects

Issue	**Recommendation**
Objects with leading edges more than 27" and no more than 80" AFF shall protrude 4" maximum horizontally into the circulation path	Provide required clearance/adjust as required

ADA Reference:	
307.2	
CBC Reference:	
11B-307.2	
Floor:	5th
Room:	Pod - F
Location:	
Cost:	500
Duration:	5 hrs

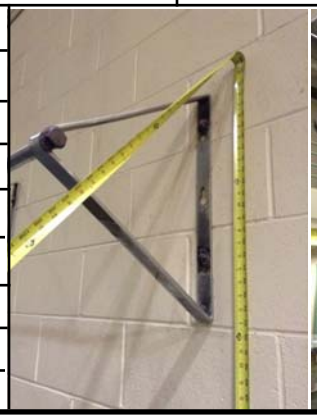
1849	Main Annex Jail	**Priority:**	1
Category	Protruding Objects

Issue	**Recommendation**
Objects with leading edges more than 27" and no more than 80" AFF shall protrude 4" maximum horizontally into the circulation path	Provide required clearance/adjust as required

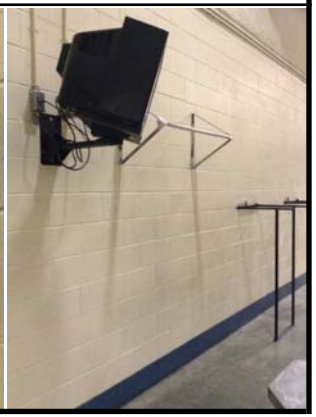
1851	Main Annex Jail	**Priority:**	2
Category	Reach Range

Issue	**Recommendation**
Maximum 48" AFF reach range exceeded /(forward unobstructed reach, 10" maximum reach depth)	Provide required reach range

ADA Reference:	
308.2.1	
CBC Reference:	
11B-308.2.1	
Floor:	5th
Room:	Pod - F
Location:	
Cost:	1000
Duration:	5 hrs

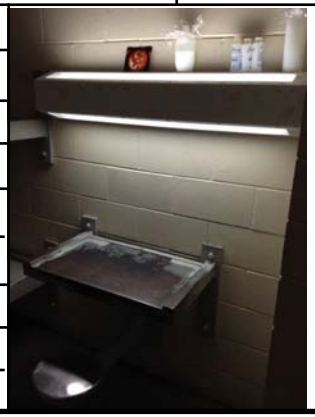
1870	Main Annex Jail	**Priority:**	2
Category	Reach Range

Issue	**Recommendation**
Maximum 48" AFF reach range exceeded /(forward unobstructed reach, 10" maximum reach depth)	Provide required reach range

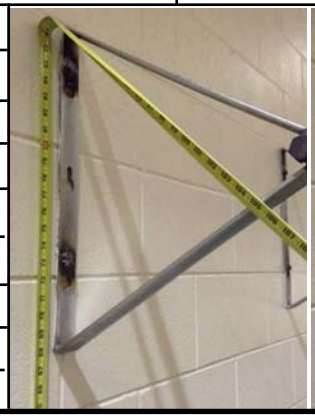
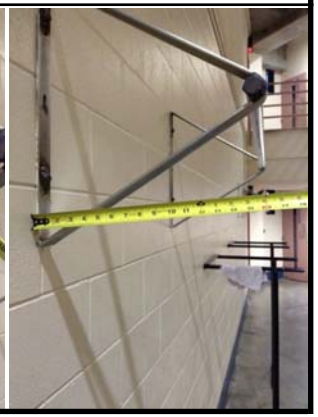
1878	Main Annex Jail	**Priority:**	1
Category	Protruding Objects

Issue	**Recommendation**
Objects with leading edges more than 27" and no more than 80" AFF shall protrude 4" maximum horizontally into the circulation path	Provide required clearance/adjust as required

ADA Reference:	
307.2	
CBC Reference:	
11B-307.2	
Floor:	6th
Room:	Pod - A
Location:	
Cost:	500
Duration:	5 hrs

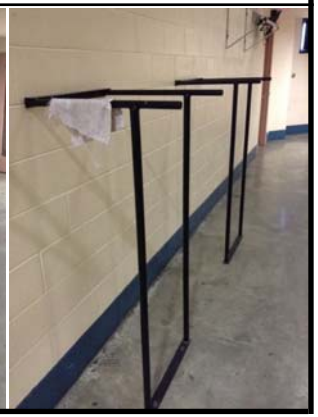
1879	Main Annex Jail	**Priority:**	1
Category	Protruding Objects

Issue	**Recommendation**
Objects with leading edges more than 27" and no more than 80" AFF shall protrude 4" maximum horizontally into the circulation path	Provide required clearance/adjust as required

ADA Reference:	
307.2	
CBC Reference:	
11B-307.2	
Floor:	6th
Room:	Pod - A
Location:	
Cost:	500
Duration:	5 hrs

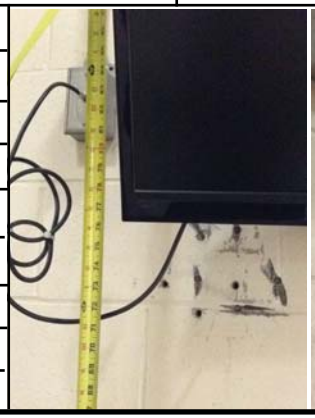
1880	Main Annex Jail	**Priority:**	2
Category	Reach Range

Issue	**Recommendation**
Maximum 48" AFF reach range exceeded /(forward unobstructed reach, 10" maximum reach depth)	Provide required reach range

ADA Reference:	
308.2.1	
CBC Reference:	
11B-308.2.1	
Floor:	6th
Room:	Pod - A
Location:	
Cost:	1000
Duration:	5 hrs

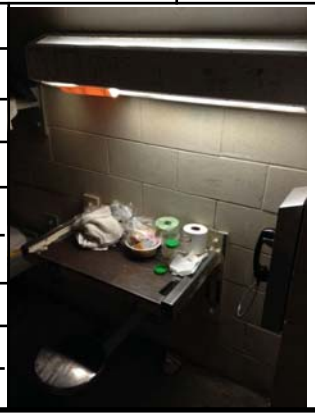
1900	Main Annex Jail	**Priority:**	2
Category	Reach Range

Issue	**Recommendation**
Maximum 48" AFF reach range exceeded /(forward unobstructed reach, 10" maximum reach depth)	Provide required reach range

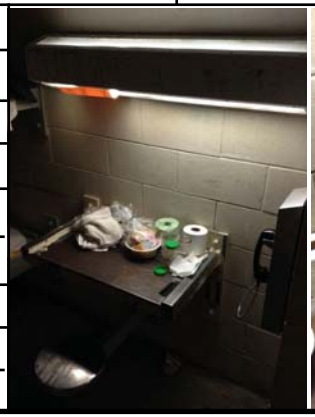
1902	Main Annex Jail	**Priority:**	4
Category	Telephones

Issue	**Recommendation**
Clear floor space not provided for wheelchair accessible telephone	Reconfigure telephone location to provide required clear floor space

ADA Reference:	
704.2.1	
CBC Reference:	
11B-704.2.1	
Floor:	6th
Room:	Pod - A
Location:	Cell
Cost:	See *9
Duration:	See *9

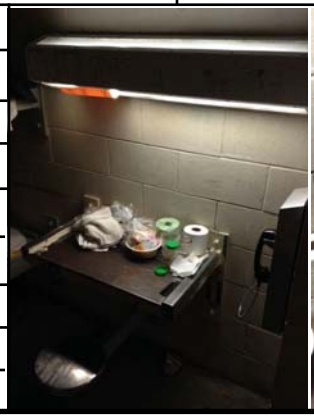
1903	Main Annex Jail	**Priority:**	1
Category	Protruding Objects

Issue	**Recommendation**
Objects with leading edges more than 27" and no more than 80" AFF shall protrude 4" maximum horizontally into the circulation path	Provide required clearance/adjust as required

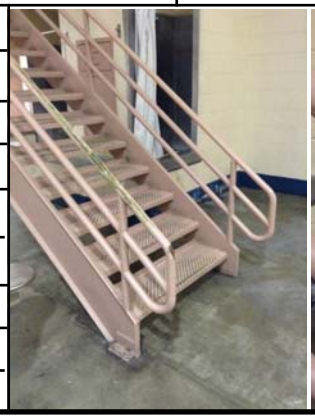
1908	Main Annex Jail	**Priority:**	1
Category	Stairs

Issue	**Recommendation**
Open risers provided interior stairways only	Install closer strip at open risers or remove and replace stairs for compliance

ADA Reference:	
504.3	
CBC Reference:	
11B-504.3	
Floor:	6th
Room:	Pod - A
Location:	
Cost:	6000
Duration:	30 hrs

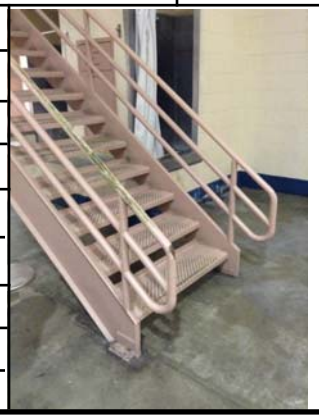
1909	Main Annex Jail	**Priority:**	1
Category	Protruding Objects

Issue	**Recommendation**
Vertical clearance not 80" high minimum	Provide required vertical clearance

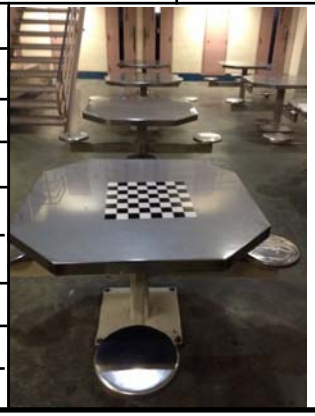
1912	Main Annex Jail	**Priority:**	1
Category	Corridors/Hallways

Issue	**Recommendation**
Minimum 44" width not provided/where serving occupant load over 10	Provide 44" width

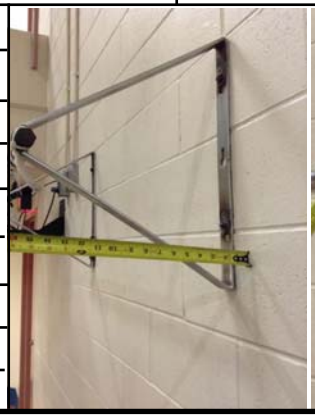
Issue	**Recommendation**
Objects with leading edges more than 27" and no more than 80" AFF shall protrude 4" maximum horizontally into the circulation path	Provide required clearance/adjust as required

ADA Reference:	
307.2	
CBC Reference:	
11B-307.2	
Floor:	6th
Room:	Pod - B
Location:	
Cost:	500
Duration:	5 hrs

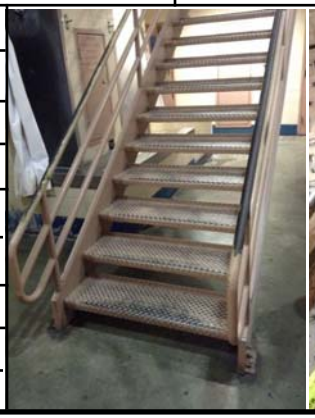
Issue	**Recommendation**
Width of stairs not 44" minimum	Provide stairs with minimum 44" width

ADA Reference:	
N/A	
CBC Reference:	
1009.4	
Floor:	6th
Room:	Pod - B
Location:	
Cost:	N/A
Duration:	N/A

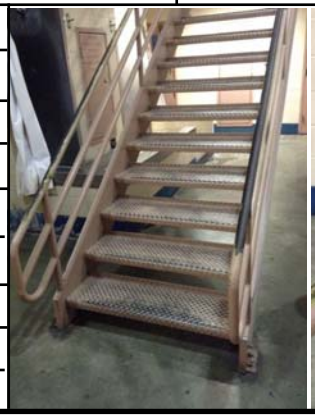
1921	Main Annex Jail	**Priority:**	1
Category	Stairs

Issue	**Recommendation**
Height of handrail(s) less than 34" above nosing of threads	Provide handrails per current standards

ADA Reference:	
505.4	
CBC Reference:	
11B-505.4	
Floor:	6th
Room:	Pod - B
Location:	
Cost:	5000
Duration:	20 hrs

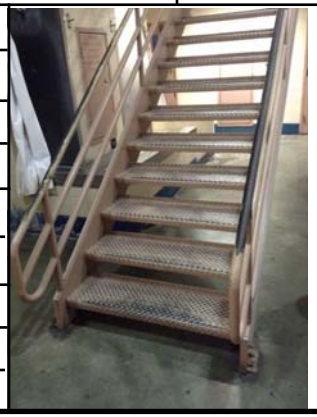
1922	Main Annex Jail	**Priority:**	1
Category	Stairs

Issue	**Recommendation**
Extension of handrail at bottom of stairs not a minimum of tread width; plus 12" beyond bottom nosing horizontal with ground or floor surface	Modify handrail(s) to provide required extensions or replace per current standards

ADA Reference:	
505.10.3	
CBC Reference:	
11B-505.10.3	
Floor:	6th
Room:	Pod - B
Location:	
Cost:	1500
Duration:	2 hrs

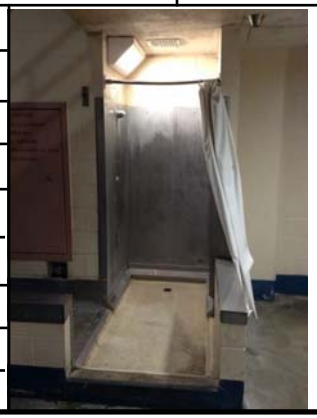
Issue	**Recommendation**
Threshold into shower greater than 1/2" height	Provide transition into shower

ADA Reference:	
608.7	
CBC Reference:	
11B-608.7	
Floor:	6th
Room:	Pod - B
Location:	Shower
Cost:	See *7
Duration:	See *7

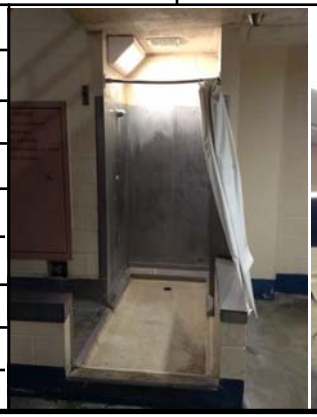
Issue	**Recommendation**
Vertical clearance not 80" high minimum	Provide required vertical clearance

ADA Reference:	
307.4	
CBC Reference:	
11B-307.4	
Floor:	6th
Room:	Pod - B
Location:	Shower
Cost:	See *7
Duration:	See *7

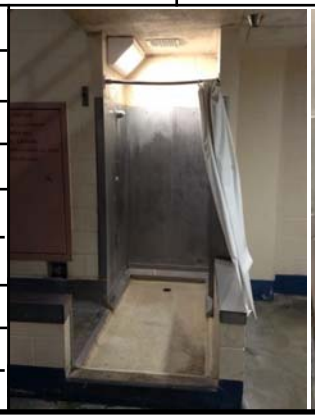
1927	Main Annex Jail	**Priority:**	2
Category	Detention Facility Showers

Issue	**Recommendation**
Centerline of water control not 39"-41" above shower floor and top of unit not greater than 48"	Adjust as required

ADA Reference:	
N/A	
CBC Reference:	
11B-608.5.2	
Floor:	6th
Room:	Pod - B
Location:	Shower
Cost:	See *7
Duration:	See *7

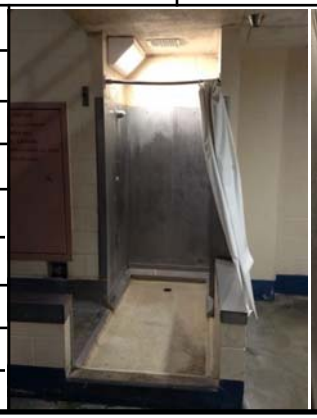
1928	Main Annex Jail	**Priority:**	2
Category	Detention Facility Showers

Issue	**Recommendation**
Folding seat not provided	Provide folding seat

ADA Reference:	
N/A	
CBC Reference:	
11B-610.5	
Floor:	6th
Room:	Pod - B
Location:	Shower
Cost:	See *7
Duration:	See *7

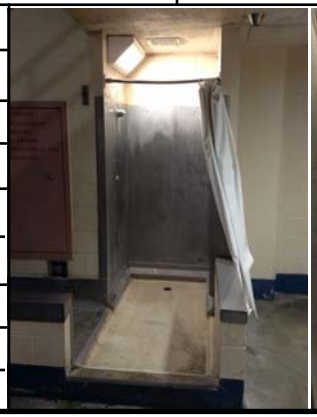
Issue	**Recommendation**
Grab bar not provided on side wall opposite of entry in alternate shower	Adjust as required and/or provide new bar per current standards

ADA Reference:	
608.3.3	
CBC Reference:	
11B-608.3.3	
Floor:	6th
Room:	Pod - B
Location:	Shower
Cost:	See *7
Duration:	See *7

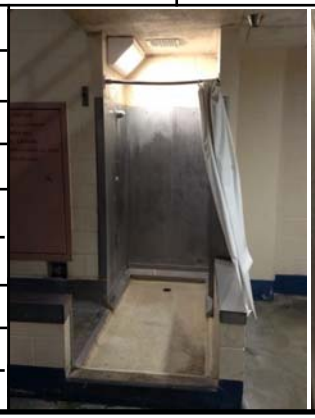
1931	Main Annex Jail	**Priority:**	2
Category	Detention Facility Showers

Issue	**Recommendation**
Grab bar not provided on side wall opposite of seat in standard shower	Provide new bar per current standards

ADA Reference:	
608.3.2	
CBC Reference:	
11B-608.3.2	
Floor:	6th
Room:	Pod - B
Location:	Shower
Cost:	See *7
Duration:	See *7

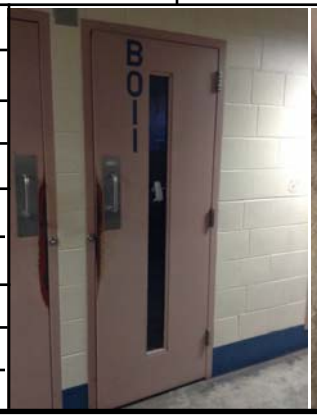
Issue	**Recommendation**
Minimum 32" wide clear width not provided	Provide 32" wide clear width

ADA Reference:	
404.2.3	
CBC Reference:	
11B-404.2.3	
Floor:	6th
Room:	Pod - B
Location:	Cell
Cost:	See *9
Duration:	See *9

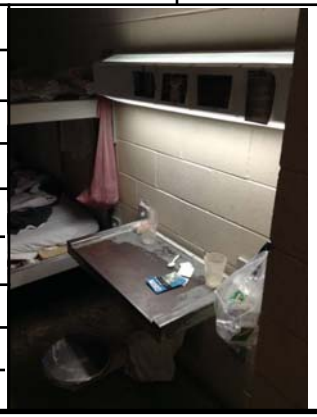
Issue	**Recommendation**
Required 30" by 48" clear floor space not provided at accessible seating spaces	Provide required clear floor space at accessible seating

ADA Reference:	
902.2	
CBC Reference:	
11B-902.2	
Floor:	6th
Room:	Pod - B
Location:	Cell
Cost:	See *9
Duration:	See *9

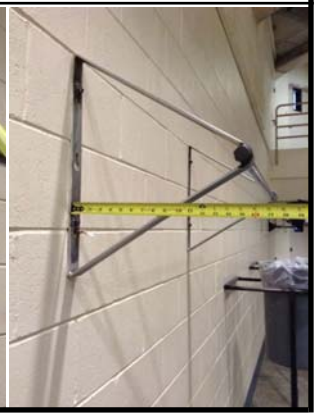
Issue	Recommendation
Objects with leading edges more than 27" and no more than 80" AFF shall protrude 4" maximum horizontally into the circulation path	Provide required clearance/adjust as required

ADA Reference:	
307.2	
CBC Reference:	
11B-307.2	
Floor:	6th
Room:	Pod - C
Location:	
Cost:	500
Duration:	5 hrs

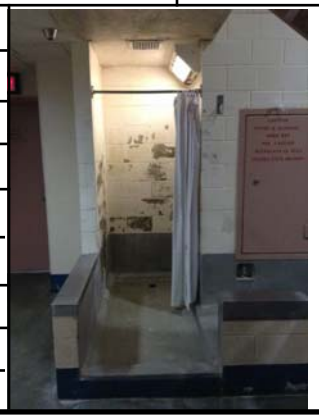
Issue	**Recommendation**
Threshold into shower greater than 1/2" height	Provide transition into shower

ADA Reference:	
608.7	
CBC Reference:	
11B-608.7	
Floor:	6th
Room:	Pod - C
Location:	Shower
Cost:	See *7
Duration:	See *7

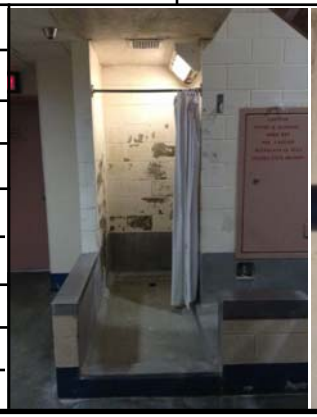
Issue	**Recommendation**
Vertical clearance not 80" high minimum	Provide required vertical clearance

ADA Reference:	
307.4	
CBC Reference:	
11B-307.4	
Floor:	6th
Room:	Pod - C
Location:	Shower
Cost:	See *7
Duration:	See *7

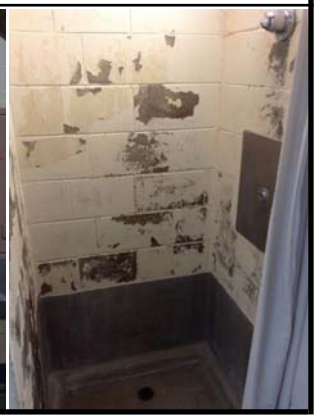
Issue	**Recommendation**
Folding seat not provided	Provide folding seat

ADA Reference:	
N/A	
CBC Reference:	
11B-610.5	
Floor:	6th
Room:	Pod - C
Location:	Shower
Cost:	See *7
Duration:	See *7

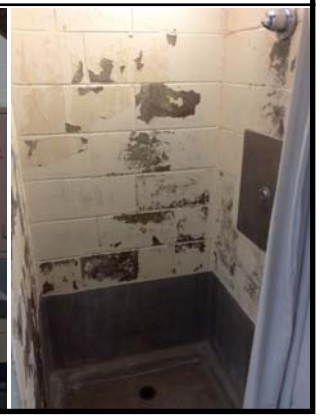
1961	Main Annex Jail	**Priority:**	2
Category	Detention Facility Showers

Issue	**Recommendation**
Grab bar not provided on back wall for standard or alternate shower	Provide new bar per current standards

ADA Reference:	
608.3.2	
CBC Reference:	
11B-608.3.2	
Floor:	6th
Room:	Pod - C
Location:	Shower
Cost:	See *7
Duration:	See *7

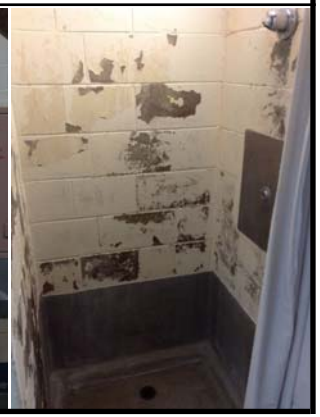
1962	Main Annex Jail	**Priority:**	2
Category	Detention Facility Showers

Issue	**Recommendation**
Grab bar not provided on side wall opposite of entry in alternate shower	Adjust as required and/or provide new bar per current standards

ADA Reference:	
608.3.3	
CBC Reference:	
11B-608.3.3	
Floor:	6th
Room:	Pod - C
Location:	Shower
Cost:	See *7
Duration:	See *7

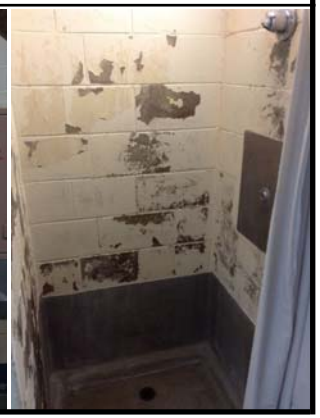
1963	Main Annex Jail	**Priority:**	2
Category	Detention Facility Showers

Issue	**Recommendation**
Grab bar not provided on side wall opposite of seat in standard shower	Provide new bar per current standards

ADA Reference:	
608.3.2	
CBC Reference:	
11B-608.3.2	
Floor:	6th
Room:	Pod - C
Location:	Shower
Cost:	See *7
Duration:	See *7

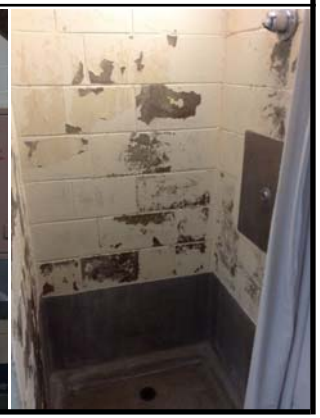
1964	Main Annex Jail	**Priority:**	2
Category	Detention Facility Showers

Issue	**Recommendation**
Minimum 59" long hose not provided	Provide required hose and/or adjust height per current standards

ADA Reference:	
608.6	
CBC Reference:	
11B-608.6	
Floor:	6th
Room:	Pod - C
Location:	Shower
Cost:	See *7
Duration:	See *7

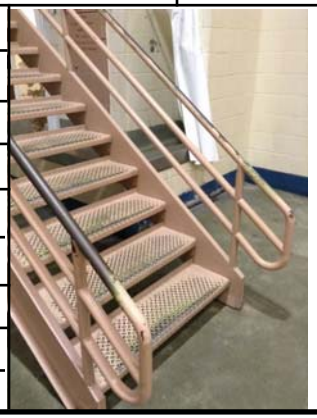
Issue	**Recommendation**
Extension of handrail at bottom of stairs not a minimum of tread width; plus 12" beyond bottom nosing horizontal with ground or floor surface	Modify handrail(s) to provide required extensions or replace per current standards

ADA Reference:	
505.10.3	
CBC Reference:	
11B-505.10.3	
Floor:	6th
Room:	Pod - C
Location:	
Cost:	1500
Duration:	2 hrs

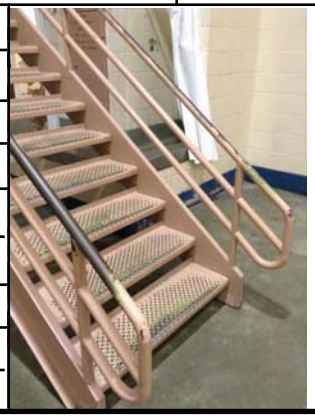
1969	Main Annex Jail	**Priority:**	1
Category	Stairs

Issue	**Recommendation**
Open risers provided interior stairways only	Install closer strip at open risers or remove and replace stairs for compliance

ADA Reference:	
504.3	
CBC Reference:	
11B-504.3	
Floor:	6th
Room:	Pod - C
Location:	
Cost:	6000
Duration:	30 hrs

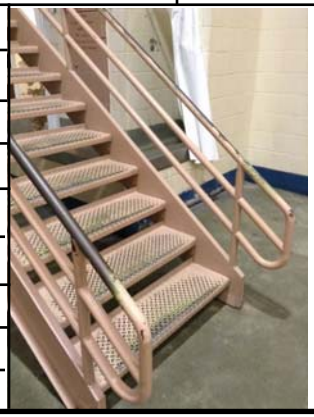
1970	Main Annex Jail	**Priority:**	1
Category	Protruding Objects

Issue	**Recommendation**
Vertical clearance not 80" high minimum	Provide required vertical clearance

ADA Reference:	
307.4	
CBC Reference:	
11B-307.4	
Floor:	6th
Room:	Pod - C
Location:	
Cost:	10000
Duration:	50 hrs

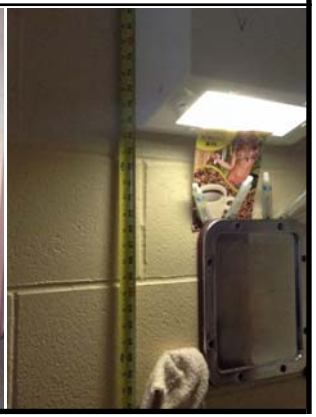
Issue	**Recommendation**
Mirror over lavatory or countertop measured over 40" AFF to the bottom edge of the reflecting surface	Reset mirror to maximum 40" AFF to reflecting surface

ADA Reference:	
603.3	
CBC Reference:	
11B-603.3	
Floor:	6th
Room:	Pod - C
Location:	Cell
Cost:	See *9
Duration:	See *9

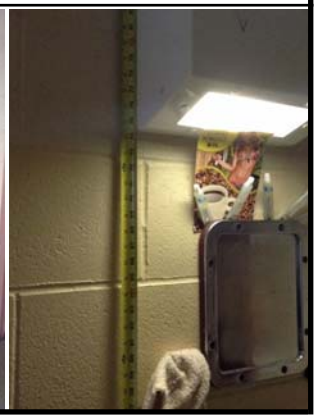
1975	Main Annex Jail	**Priority:**	2
Category	Reach Range

Issue	**Recommendation**
Maximum 48" AFF reach range exceeded /(forward unobstructed reach, 10" maximum reach depth)	Provide required reach range

ADA Reference:	
308.2.1	
CBC Reference:	
11B-308.2.1	
Floor:	6th
Room:	Pod - C
Location:	Cell
Cost:	See *9
Duration:	See *9

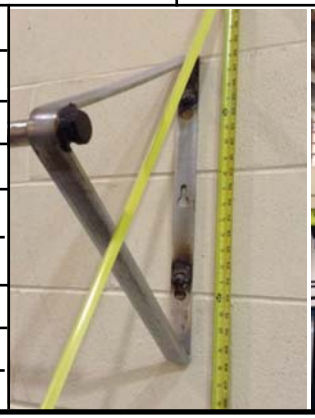
Issue	**Recommendation**
Objects with leading edges more than 27" and no more than 80" AFF shall protrude 4" maximum horizontally into the circulation path	Provide required clearance/adjust as required

ADA Reference:	
307.2	
CBC Reference:	
11B-307.2	
Floor:	6th
Room:	Pod - D
Location:	
Cost:	500
Duration:	5 hrs

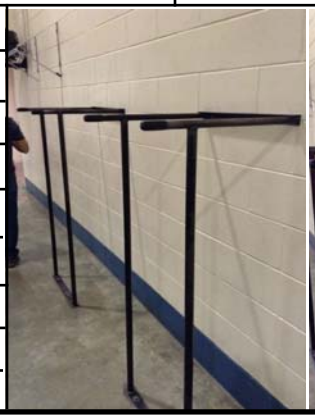
1992	Main Annex Jail	**Priority:**	1
Category	Protruding Objects

Issue	**Recommendation**
Objects with leading edges more than 27" and no more than 80" AFF shall protrude 4" maximum horizontally into the circulation path	Provide required clearance/adjust as required

ADA Reference:	
307.2	
CBC Reference:	
11B-307.2	
Floor:	6th
Room:	Pod - D
Location:	
Cost:	500
Duration:	5 hrs

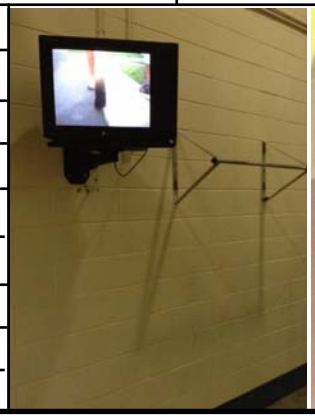
1993	Main Annex Jail	**Priority:**	1
Category	Protruding Objects

Issue	**Recommendation**
Objects with leading edges more than 27" and no more than 80" AFF shall protrude 4" maximum horizontally into the circulation path	Provide required clearance/adjust as required

ADA Reference:	
307.2	
CBC Reference:	
11B-307.2	
Floor:	6th
Room:	Pod - D
Location:	
Cost:	500
Duration:	5 hrs

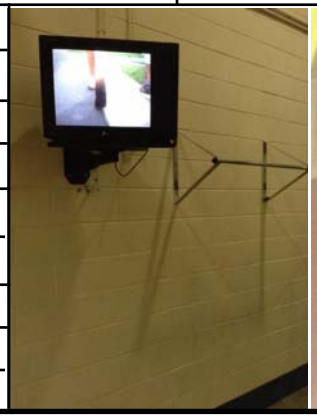
1994	Main Annex Jail	**Priority:**	2
Category	Reach Range

Issue	**Recommendation**
Maximum 48" AFF reach range exceeded /(forward unobstructed reach, 10" maximum reach depth)	Provide required reach range

ADA Reference:	
308.2.1	
CBC Reference:	
11B-308.2.1	
Floor:	6th
Room:	Pod - D
Location:	
Cost:	1000
Duration:	5 hrs

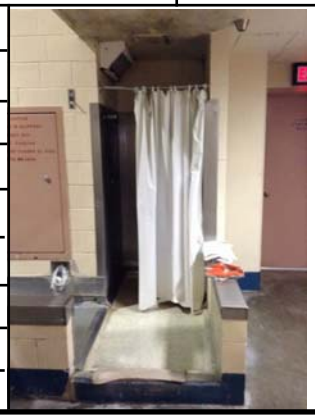
1995	Main Annex Jail	**Priority:**	2
Category	Detention Facility Showers

Issue	**Recommendation**
Threshold into shower greater than 1/2" height	Provide transition into shower

ADA Reference:	
608.7	
CBC Reference:	
11B-608.7	
Floor:	6th
Room:	Pod - D
Location:	Shower
Cost:	See *7
Duration:	See *7

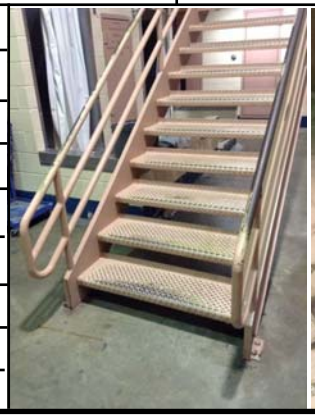
Issue	**Recommendation**
Width of stairs not 44" minimum	Provide stairs with minimum 44" width

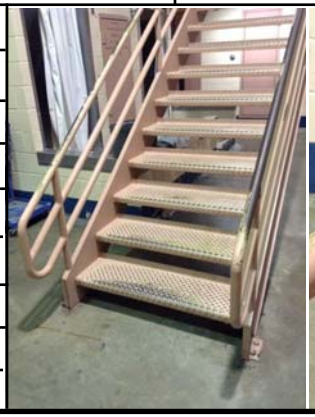
2006	Main Annex Jail	**Priority:**	1
Category	Stairs

Issue	**Recommendation**
Height of handrail(s) less than 34" above nosing of threads	Provide handrails per current standards

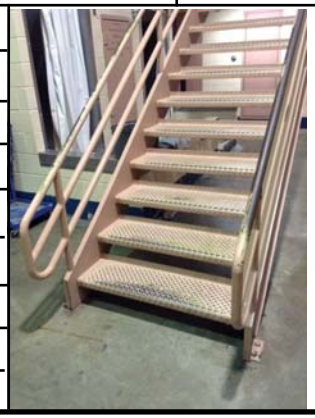
2007	Main Annex Jail	**Priority:**	1
Category	Stairs

Issue	**Recommendation**
Extension of handrail at bottom of stairs not a minimum of tread width; plus 12" beyond bottom nosing horizontal with ground or floor surface	Modify handrail(s) to provide required extensions or replace per current standards

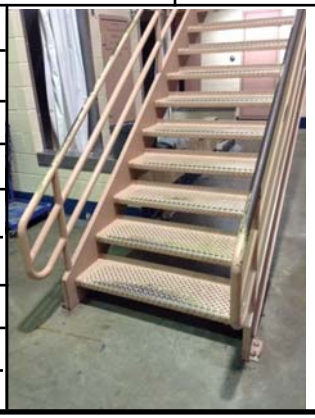
2008	Main Annex Jail	**Priority:**	1
Category	Stairs

Issue	**Recommendation**
Open risers provided interior stairways only	Install closer strip at open risers or remove and replace stairs for compliance

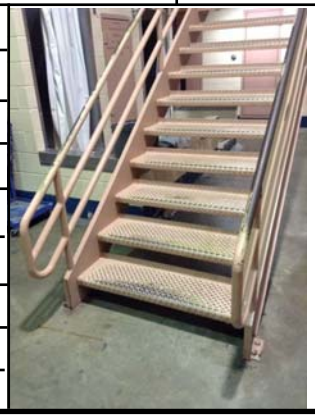
2009	Main Annex Jail	**Priority:**	1
Category	Protruding Objects

Issue	**Recommendation**
Vertical clearance not 80" high minimum	Provide required vertical clearance

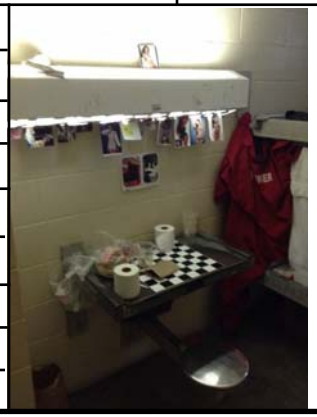
Issue	**Recommendation**
Required 30" by 48" clear floor space not provided at accessible seating spaces	Provide required clear floor space at accessible seating

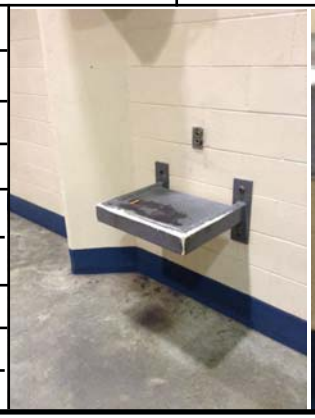
Issue	**Recommendation**
Minimum 27" high x 8" deep clearance under counter not provided	Provide minimum 27" high X 8" deep clearance under counter

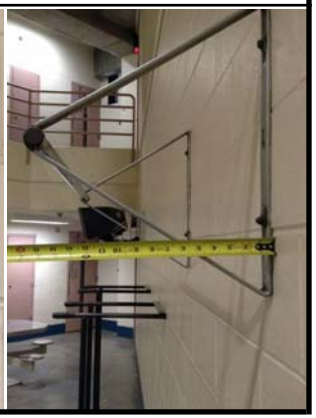
2028	Main Annex Jail	**Priority:**	1
Category	Protruding Objects

Issue	**Recommendation**
Objects with leading edges more than 27" and no more than 80" AFF shall protrude 4" maximum horizontally into the circulation path	Provide required clearance/adjust as required

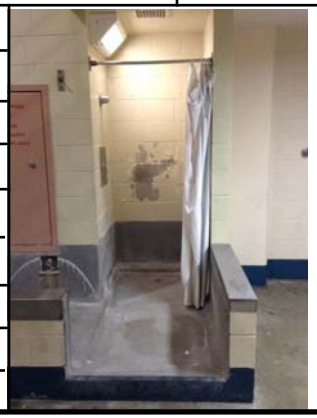
Issue	**Recommendation**
Threshold into shower greater than 1/2" height	Provide transition into shower

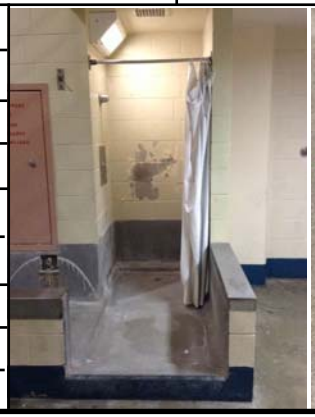
2033	Main Annex Jail	**Priority:**	2
Category	Detention Facility Showers

Issue	**Recommendation**
Shower floor slope greater that 2.083 percent	Provide accessible shower

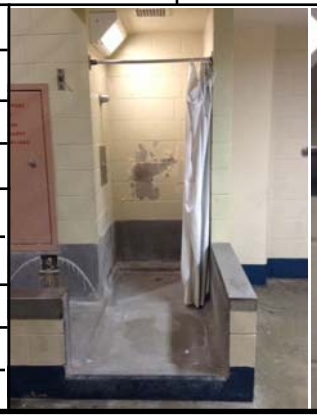
2034	Main Annex Jail	**Priority:**	1
Category	Protruding Objects

Issue	**Recommendation**
Vertical clearance not 80" high minimum	Provide required vertical clearance

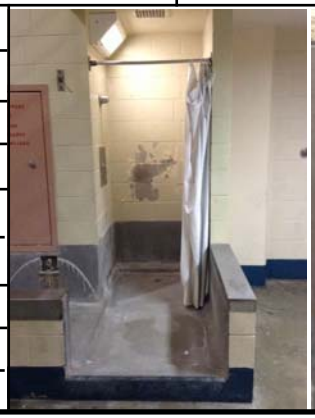
2035	Main Annex Jail	**Priority:**	2
Category	Detention Facility Showers

Issue	**Recommendation**
Centerline of water control not 39"-41" above shower floor and top of unit not greater than 48"	Adjust as required

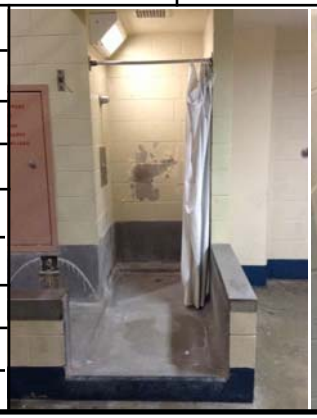
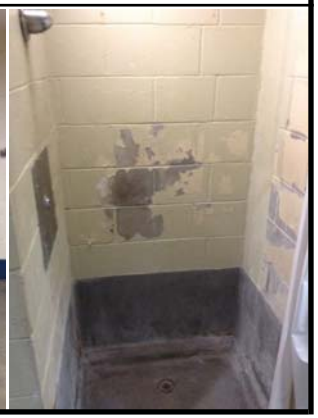
2036	Main Annex Jail	**Priority:**	2
Category	Detention Facility Showers

Issue	**Recommendation**
Folding seat not provided	Provide folding seat

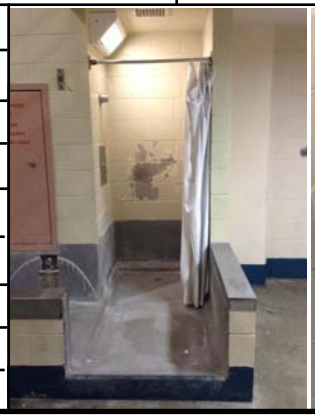
2037	Main Annex Jail	**Priority:**	2
Category	Detention Facility Showers

Issue	**Recommendation**
Grab bar not provided on back wall for standard or alternate shower	Provide new bar per current standards

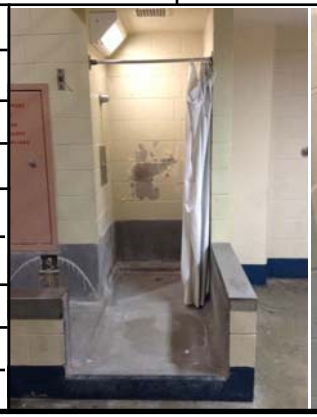
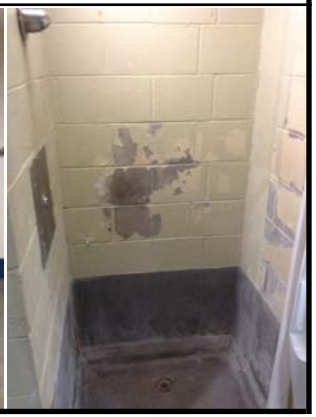
2038	Main Annex Jail	**Priority:**	2
Category	Detention Facility Showers

Issue	**Recommendation**
Grab bar not provided on side wall opposite of entry in alternate shower	Adjust as required and/or provide new bar per current standards

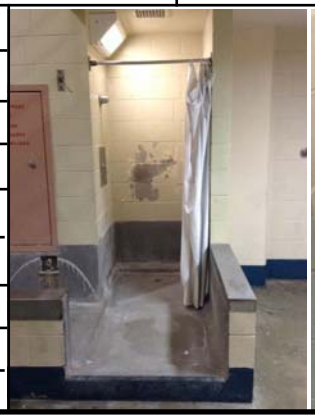
2039	Main Annex Jail	**Priority:**	2
Category	Detention Facility Showers

Issue	**Recommendation**
Grab bar not provided on side wall opposite of seat in standard shower	Provide new bar per current standards

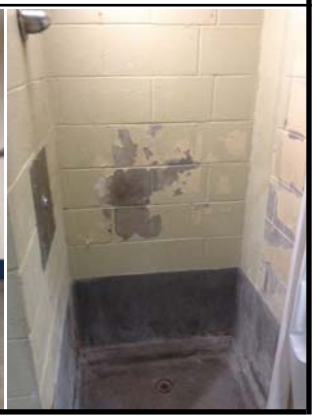
2040	Main Annex Jail	**Priority:**	2
Category	Detention Facility Showers

Issue	**Recommendation**
Minimum 59" long hose not provided	Provide required hose and/or adjust height per current standards

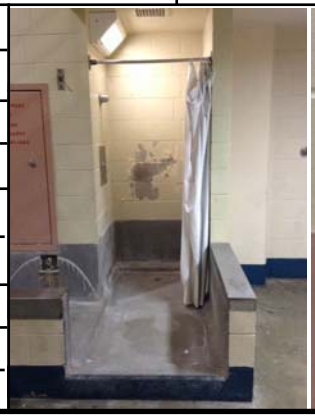
2041	Main Annex Jail	**Priority:**	2
Category	Detention Facility Accessories

Issue	**Recommendation**
Coat hook measured over 48" AFF	Reset hook to maximum 48" AFF

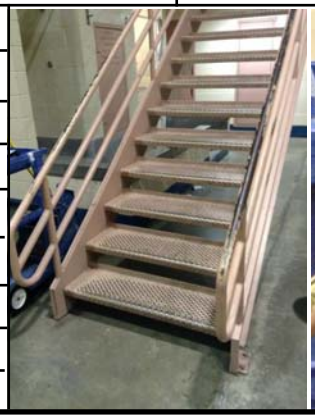
Issue	**Recommendation**
Height of handrail(s) less than 34" above nosing of threads	Provide handrails per current standards

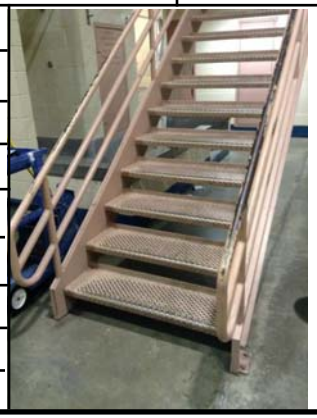
2044	Main Annex Jail	**Priority:**	1
Category	Stairs

Issue	**Recommendation**
Open risers provided interior stairways only	Install closer strip at open risers or remove and replace stairs for compliance

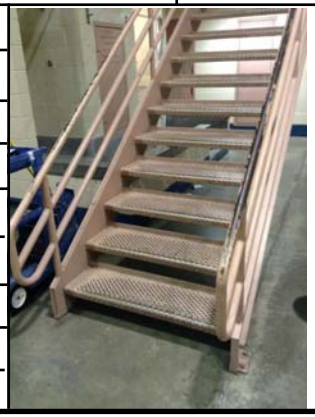
2045	Main Annex Jail	**Priority:**	1
Category	Stairs

Issue	**Recommendation**
Extension of handrail at bottom of stairs not a minimum of tread width; plus 12" beyond bottom nosing horizontal with ground or floor surface	Modify handrail(s) to provide required extensions or replace per current standards

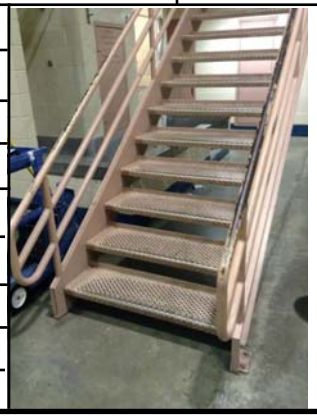
2046	Main Annex Jail	**Priority:**	1
Category	Protruding Objects

Issue	**Recommendation**
Vertical clearance not 80" high minimum	Provide required vertical clearance

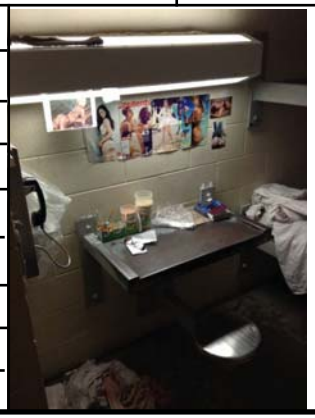
Issue	**Recommendation**
Required 30" by 48" clear floor space not provided at accessible seating spaces	Provide required clear floor space at accessible seating

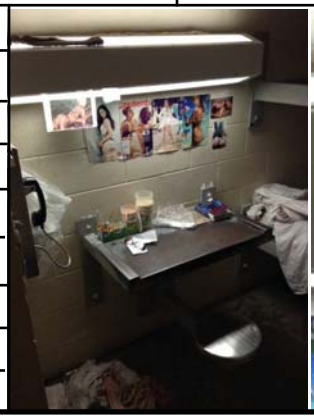
2056	Main Annex Jail	**Priority:**	2
Category	Reach Range

Issue	**Recommendation**
Maximum 48" AFF reach range exceeded /(forward unobstructed reach, 10" maximum reach depth)	Provide required reach range

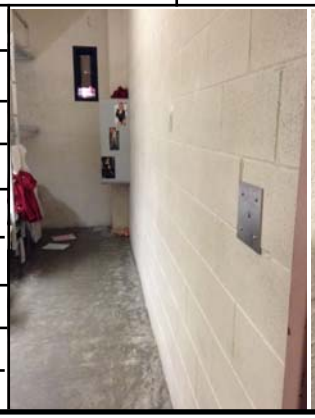
Issue	**Recommendation**
Maximum 48" AFF reach range exceeded /(forward unobstructed reach, 10" maximum reach depth)	Provide required reach range

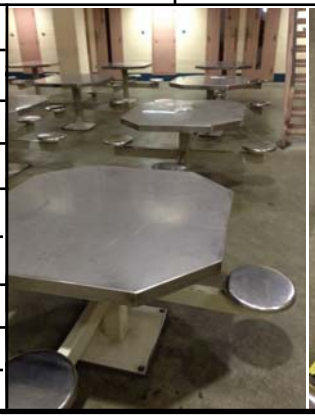
Issue	**Recommendation**
Minimum 44" width not provided/where serving occupant load over 10	Provide 44" width

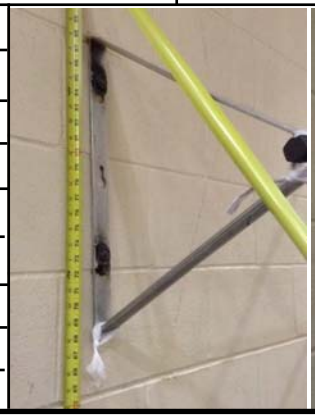
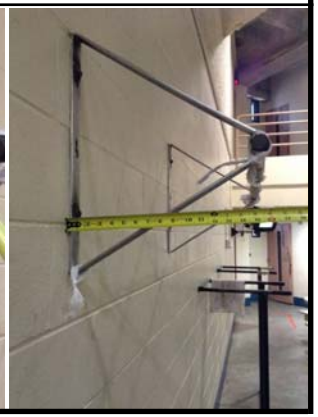
Issue	**Recommendation**
Objects with leading edges more than 27" and no more than 80" AFF shall protrude 4" maximum horizontally into the circulation path	Provide required clearance/adjust as required

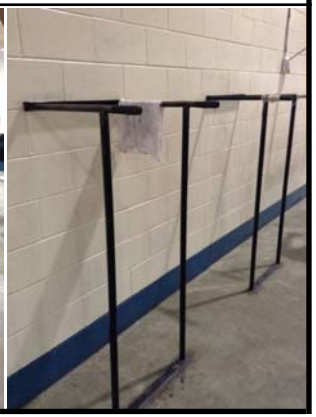
2066	Main Annex Jail	**Priority:**	1
Category	Protruding Objects

Issue	**Recommendation**
Objects with leading edges more than 27" and no more than 80" AFF shall protrude 4" maximum horizontally into the circulation path	Provide required clearance/adjust as required

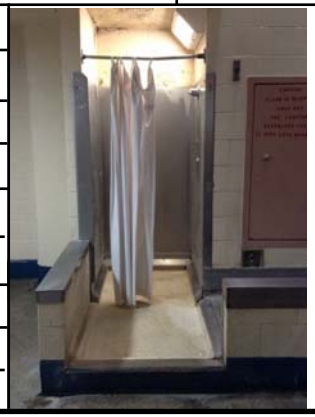
Issue	**Recommendation**
Threshold into shower greater than 1/2" height	Provide transition into shower

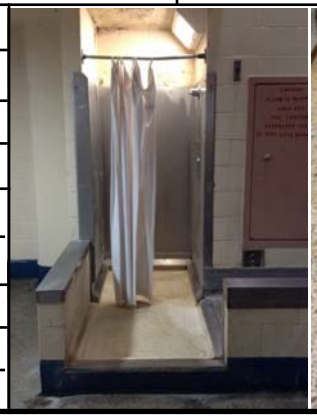
2070	Main Annex Jail	**Priority:**	2
Category	Detention Facility Showers

Issue	**Recommendation**
Shower floor slope greater that 2.083 percent	Provide accessible shower

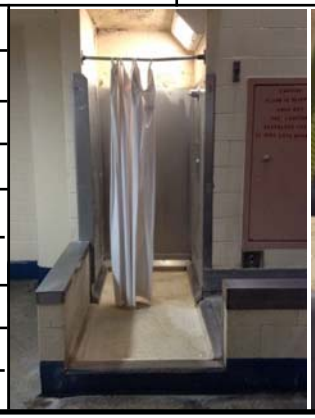
2071	Main Annex Jail	**Priority:**	1
Category	Protruding Objects

Issue	**Recommendation**
Vertical clearance not 80" high minimum	Provide required vertical clearance

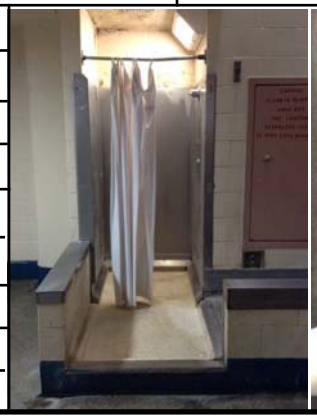
2072	Main Annex Jail	**Priority:**	2
Category	Detention Facility Showers

Issue	**Recommendation**
Centerline of water control not 39"-41" above shower floor and top of unit not greater than 48"	Adjust as required

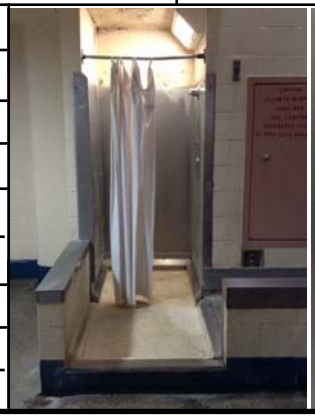
2073	Main Annex Jail	**Priority:**	2
Category	Detention Facility Showers

Issue	**Recommendation**
Folding seat not provided	Provide folding seat

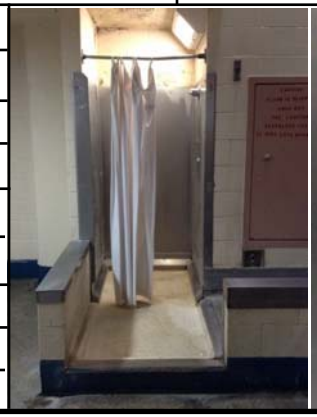
2074	Main Annex Jail	**Priority:**	2
Category	Detention Facility Showers

Issue	**Recommendation**
Grab bar not provided on back wall for standard or alternate shower	Provide new bar per current standards

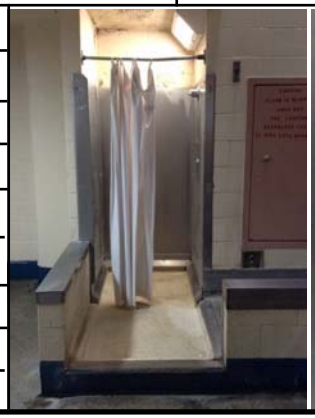
2075	Main Annex Jail	**Priority:**	2
Category	Detention Facility Showers

Issue	**Recommendation**
Grab bar not provided on side wall opposite of entry in alternate shower	Adjust as required and/or provide new bar per current standards

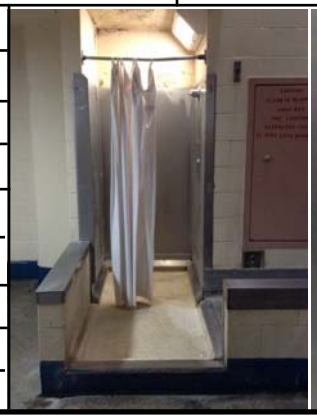
Issue	**Recommendation**
Grab bar not provided on side wall opposite of seat in standard shower	Provide new bar per current standards

ADA Reference:	
608.3.2	
CBC Reference:	
11B-608.3.2	
Floor:	6th
Room:	Pod - E
Location:	Shower
Cost:	See *7
Duration:	See *7

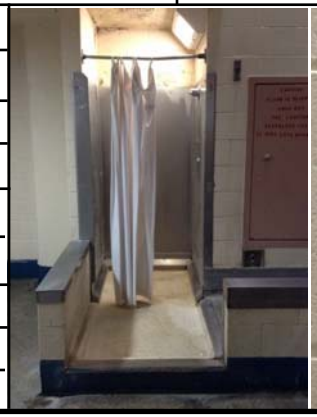
Issue	**Recommendation**
Coat hook measured over 48" AFF	Reset hook to maximum 48" AFF

ADA Reference:	
603.4	
CBC Reference:	
11B-603.4	
Floor:	6th
Room:	Pod - E
Location:	Shower
Cost:	See *7
Duration:	See *7

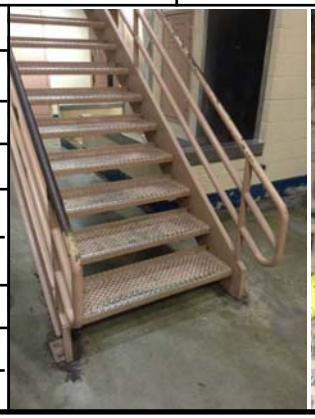
Issue	**Recommendation**
Width of stairs not 44" minimum	Provide stairs with minimum 44" width

ADA Reference:	
N/A	
CBC Reference:	
1009.4	
Floor:	6th
Room:	Pod - E
Location:	
Cost:	N/A
Duration:	N/A

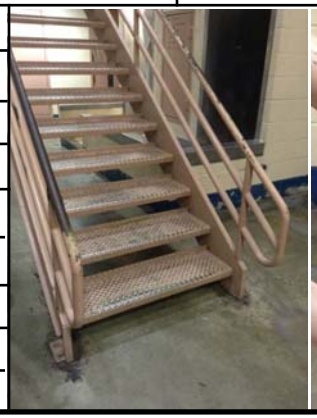
Issue	**Recommendation**
Height of handrail(s) less than 34" above nosing of threads	Provide handrails per current standards

ADA Reference:	
505.4	
CBC Reference:	
11B-505.4	
Floor:	6th
Room:	Pod - E
Location:	
Cost:	5000
Duration:	20 hrs

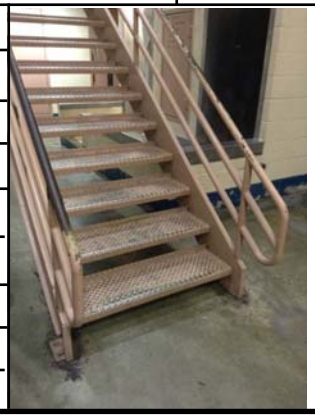
Issue	**Recommendation**
Extension of handrail at bottom of stairs not a minimum of tread width; plus 12" beyond bottom nosing horizontal with ground or floor surface	Modify handrail(s) to provide required extensions or replace per current standards

ADA Reference:	
505.10.3	
CBC Reference:	
11B-505.10.3	
Floor:	6th
Room:	Pod - E
Location:	
Cost:	1500
Duration:	2 hrs

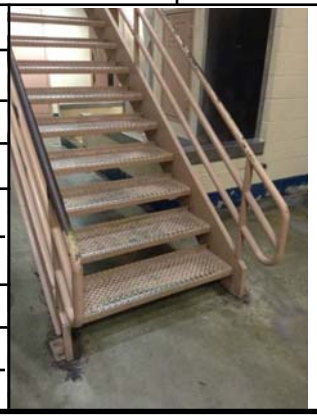
Issue	**Recommendation**
Open risers provided interior stairways only	Install closer strip at open risers or remove and replace stairs for compliance

ADA Reference:	
504.3	
CBC Reference:	
11B-504.3	
Floor:	6th
Room:	Pod - E
Location:	
Cost:	6000
Duration:	30 hrs

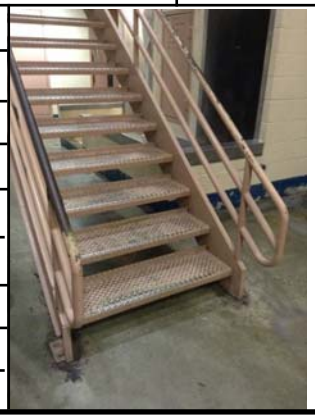
Issue	**Recommendation**
Vertical clearance not 80" high minimum	Provide required vertical clearance

ADA Reference:	
307.4	
CBC Reference:	
11B-307.4	
Floor:	6th
Room:	Pod - E
Location:	
Cost:	10000
Duration:	50 hrs

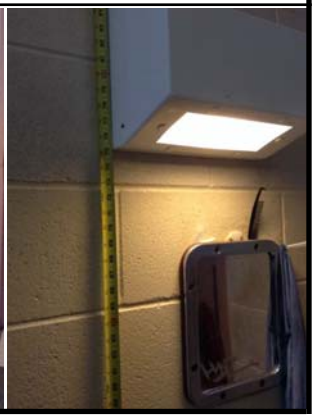
Issue	**Recommendation**
Maximum 48" AFF reach range exceeded /(forward unobstructed reach, 10" maximum reach depth)	Provide required reach range

ADA Reference:	
308.2.1	
CBC Reference:	
11B-308.2.1	
Floor:	6th
Room:	Pod - E
Location:	Cell
Cost:	See *9
Duration:	See *9

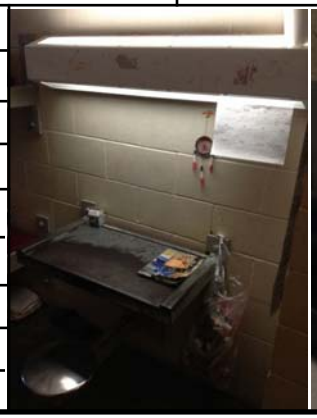
Issue	**Recommendation**
Maximum 48" AFF reach range exceeded /(forward unobstructed reach, 10" maximum reach depth)	Provide required reach range

ADA Reference:	
308.2.1	
CBC Reference:	
11B-308.2.1	
Floor:	6th
Room:	Pod - E
Location:	Cell
Cost:	See *9
Duration:	See *9

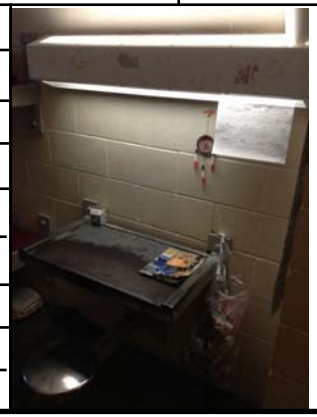
Issue	**Recommendation**
Required 30" by 48" clear floor space not provided at accessible seating spaces	Provide required clear floor space at accessible seating

ADA Reference:	
902.2	
CBC Reference:	
11B-902.2	
Floor:	6th
Room:	Pod - E
Location:	Cell
Cost:	See *9
Duration:	See *9

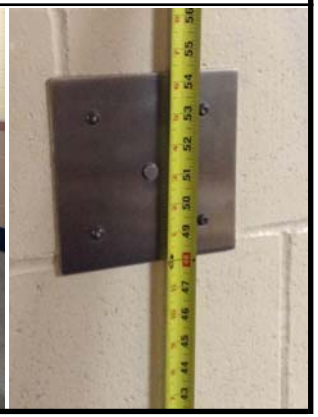
Issue	**Recommendation**
Maximum 48" AFF reach range exceeded /(forward unobstructed reach, 10" maximum reach depth)	Provide required reach range

ADA Reference:	
308.2.1	
CBC Reference:	
11B-308.2.1	
Floor:	6th
Room:	Cell FF
Location:	Cell
Cost:	See *10
Duration:	See *10

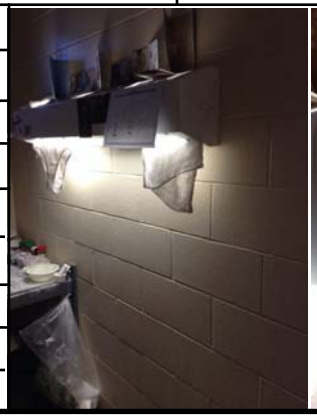
Issue	**Recommendation**
Maximum 48" AFF reach range exceeded /(forward unobstructed reach, 10" maximum reach depth)	Provide required reach range

ADA Reference:	
308.2.1	
CBC Reference:	
11B-308.2.1	
Floor:	6th
Room:	Cell FF
Location:	Cell
Cost:	See *10
Duration:	See *10
