County of Fresno

Main Annex Jail
ADA Transition Plan

LARS ANDERSEN & ASSOCIATES, INC.

JUNE 30, 2014

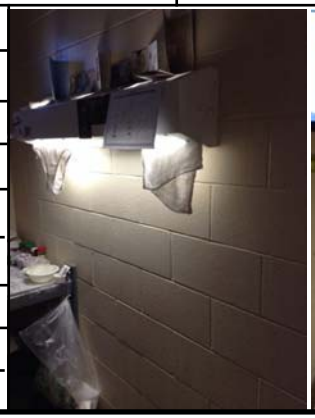
Issue	**Recommendation**
Objects with leading edges more than 27" and no more than 80" AFF shall protrude 4" maximum horizontally into the circulation path	Provide required clearance/adjust as required

ADA Reference:	
307.2	
CBC Reference:	
11B-307.2	
Floor:	6th
Room:	Cell FF
Location:	Cell
Cost:	See *10
Duration:	See *10

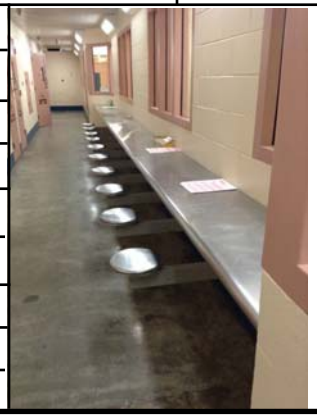
Issue	**Recommendation**
At least 5% of total seating is not accessible	Provide accessible seating spaces as required

ADA Reference:	
226.1	
CBC Reference:	
11B-226.1	
Floor:	6th
Room:	Cell FF
Location:	
Cost:	500
Duration:	5 hrs

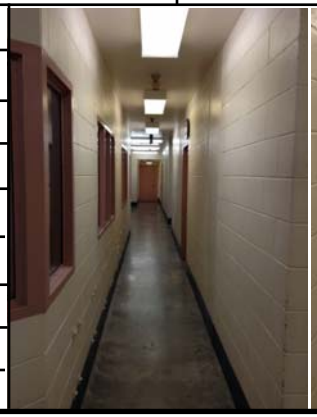
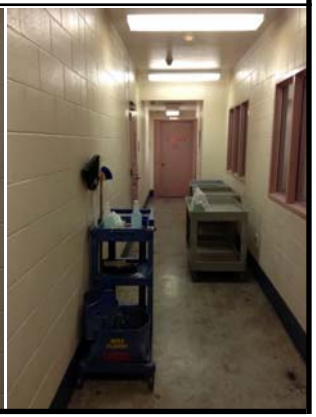
Issue	**Recommendation**
Audible Fire Alarm not provided in public or common use areas	Provide audible and visual fire alarm per current standards

ADA Reference:	
215.2	
CBC Reference:	
11B-215.2	
Floor:	6th
Room:	Corridor
Location:	
Cost:	See *4
Duration:	See *4

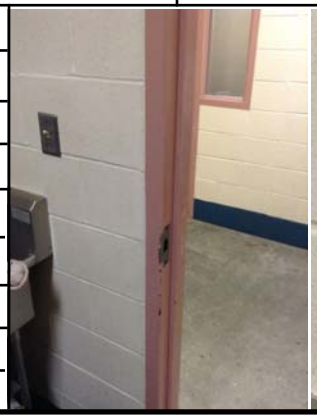
Issue	**Recommendation**
Switch measured over 48" AFF / measure to top of switch box	Provide occupancy room sensor or lower switch

ADA Reference:	
308.2.1	
CBC Reference:	
11B-308.2.1	
Floor:	6th
Room:	Scullery
Location:	
Cost:	See *6
Duration:	See *6

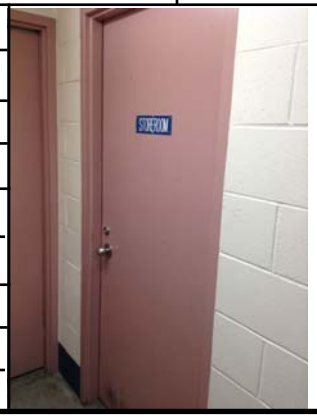
Issue	**Recommendation**
Lever-type hardware not provided	Remove and replace with lever-type hardware

ADA Reference:
404.2.7
CBC Reference:
11B-404.2.7

Floor:	6th
Room:	Storage
Location:	South
Cost:	500
Duration:	1 hr

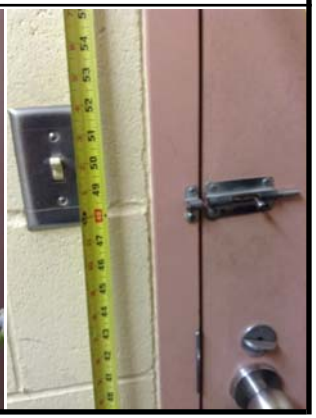
Issue	**Recommendation**
Operable part requires tight grasping, pinching or twisting of the wrist	Remove and replace operable part

ADA Reference:
309.4
CBC Reference:
11B-309.4

Floor:	6th
Room:	Staff Restroom
Location:	
Cost:	50
Duration:	.5 hr

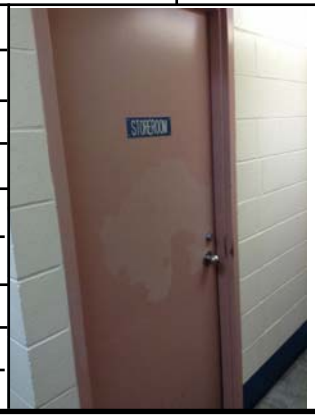
Issue	**Recommendation**
Room identification sign not provided in Braille	Provide sign per current standards

ADA Reference:	
703.3	
CBC Reference:	
11B-703.3	
Floor:	6th
Room:	Storage
Location:	North
Cost:	See *1
Duration:	See *1

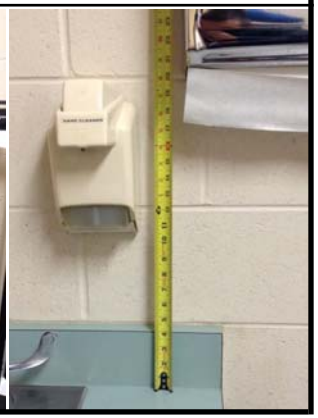
Issue	**Recommendation**
Maximum 48" AFF reach range exceeded /(forward unobstructed reach, 10" maximum reach depth)	Provide assistance placard

ADA Reference:	
308.2.1	
CBC Reference:	
11B-308.2.1	
Floor:	6th
Room:	Infirmary
Location:	
Cost:	50
Duration:	.5 hrs

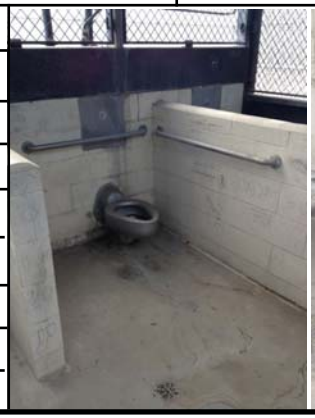
Issue	**Recommendation**
Seat height measured less than 17" AFF	Provide water closet per current standards

ADA Reference:	
604.4	
CBC Reference:	
11B-604.4	
Floor:	Roof
Room:	Yard
Location:	Open for 2nd
Cost:	2000
Duration:	16 hrs

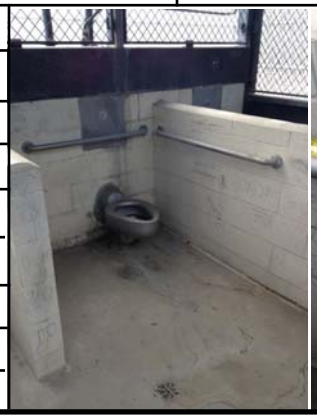
Issue	**Recommendation**
Sidewall grab bar minimum extension 54" from rear wall	Adjust as required and/or provide new bar per current standards

ADA Reference:	
604.5.1	
CBC Reference:	
11B-604.5.1	
Floor:	Roof
Room:	Yard
Location:	Open for 2nd
Cost:	500
Duration:	1 hr

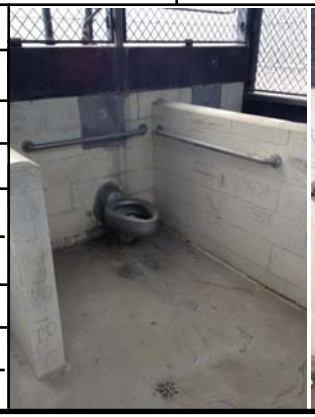
Issue	**Recommendation**
Rear wall grab bar not 24" minimum length from C/L of toilet towards open side	Adjust as required and/or provide new bar per current standards

ADA Reference:	
604.5.2	
CBC Reference:	
11B-604.5.2	
Floor:	Roof
Room:	Yard
Location:	Open for 2nd
Cost:	500
Duration:	1 hr

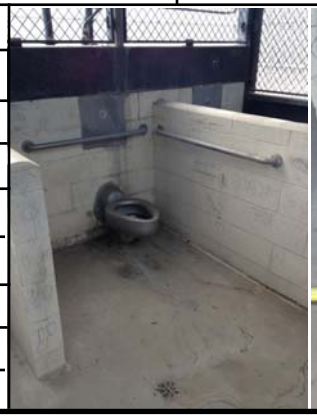
Issue	**Recommendation**
Water closet clearance not 60" wide measured perpendicular from the side wall	Provide required clearance or provide alternative accessible water closet

ADA Reference:	
604.3.1	
CBC Reference:	
11B-604.3.1	
Floor:	Roof
Room:	Yard
Location:	Open for 2nd
Cost:	8000
Duration:	40 hrs

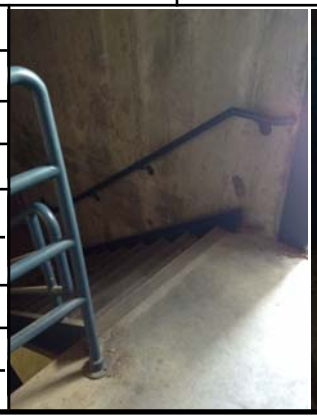
Issue	**Recommendation**
Width of stairs not 44" minimum	Provide stairs with minimum 44" width

ADA Reference:	
N/A	
CBC Reference:	
1009.4	
Floor:	Roof
Room:	Stairwell
Location:	South
Cost:	N/A
Duration:	N/A

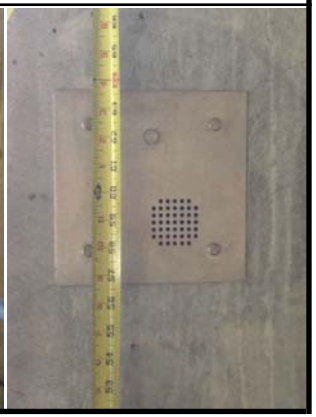
Issue	**Recommendation**
Maximum 48" AFF reach range exceeded /(forward unobstructed reach, 10" maximum reach depth)	Provide required reach range

ADA Reference:	
308.2.1	
CBC Reference:	
11B-308.2.1	
Floor:	Roof
Room:	Stairwell
Location:	North
Cost:	See *6
Duration:	See *6

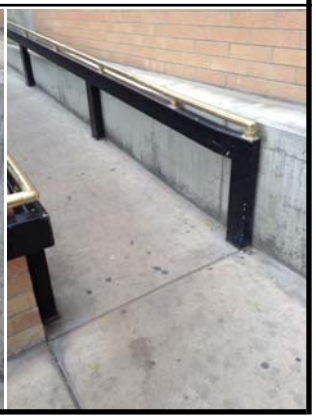
Issue	**Recommendation**
Extension of handrail at bottom of ramp not 12" minimum of level distance beyond ramp	Provide handrails to current standards with required extensions

ADA Reference:	
505.10.1	
CBC Reference:	
11B-505.10.1	
Floor:	Outdoor
Room:	
Location:	M Street
Cost:	1500
Duration:	8 hrs
